Accessibility Audit

Kingsway Primary School
Valley Gardens
Gloucester
GL2 2ZZ

Date 13/11/2013

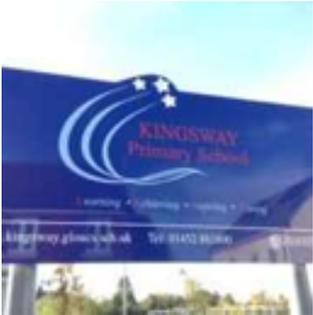
<p data-bbox="255 708 360 730">Appendix 5</p> </div> <div style="text-align: center;">

Question	Response	Details
1.5 - Is the location of the school clearly identified from the street? Visual clues and sufficient landmarks to aid orientation?	No	The Kingsway signage is in capital letters which is not the preferred format and the red letters are not suitably colour contrasted against blue background for people with impaired vision.
<div style="display: flex; justify-content: space-around; align-items: center;"> <div style="text-align: center;">

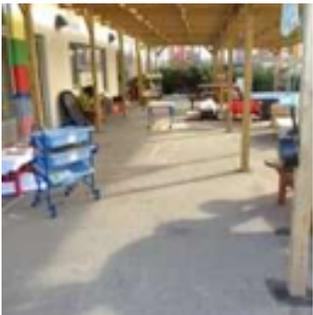
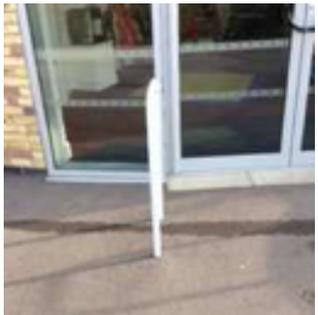
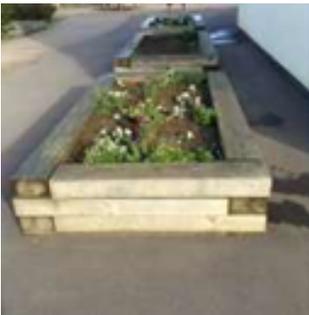
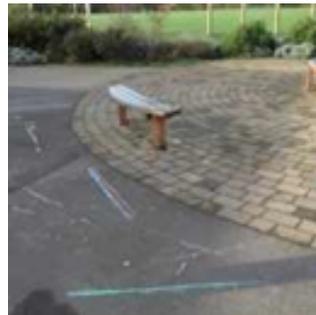
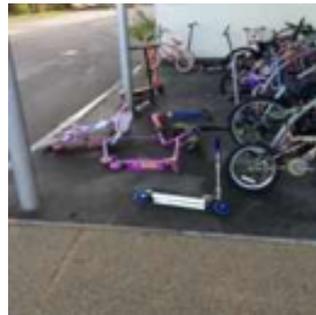
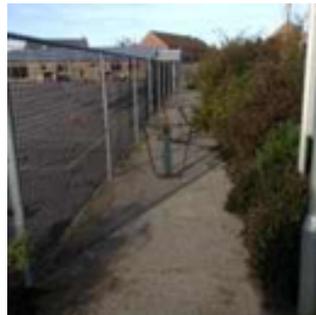
<p>Appendix 7</p>	<p>Appendix 8</p>	<p>Appendix 9</p>	<p>Appendix 10</p>	<p>Appendix 11</p>	<p>Appendix 12</p>

Question	Response	Details			
<p>1.6 - Free from hazards such as bollards, litter bins? Are planting features kept to a minimum and are they colour contrasted?</p>	<p>No</p>	<p>All door barriers and bike racks are not suitably colour contrasted against the background to aid people with impaired vision.</p> <p>The low level planting boxes and small seats needs to be made more visible by e.g. back rest/high level plantings as they could cause a stumbling/trip hazard and they are not suitably colour contrasted against the background.</p> <p>There are numerous trip hazards such as bikes, toy equipment and net poles.</p>

PRIORITY B				
1.6	All door barriers and bike racks are not suitably colour contrasted against the background to aid people with impaired vision.	Add colour contrast to the door barriers and bike racks.	M	
	The low level planting boxes and small seats needs to be made more visible by e.g., back rest/high level plantings as they could cause a stumbling/trip hazard and they are not suitably colour contrasted against the background.	Remedial works should be implemented to remove the trip hazards. In the short term the low level planting boxes and small seats should be highlighted/contrasted. In the long term these needs to be protected to avoid a potential hazard.		
	There are numerous trip hazards such as bikes, toy equipment and net poles.

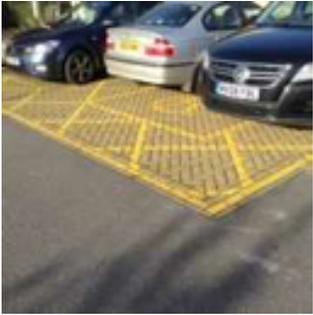
Question	Response	Details
2.3 - Are bays marked out appropriately and easily identified? Can car doors be fully opened to allow disabled drivers and passengers to transfer to a wheel chair parked alongside?	Yes	The markings are in accordance with BS8300.

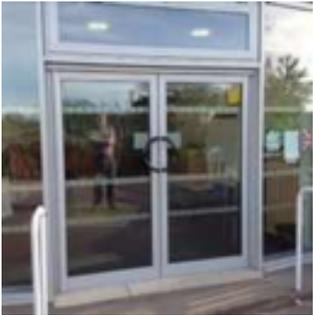
<p>Appendix 30</p> </div> <div style="text-align: center;">

Question	Response	Details
Checklist 5 - Entrances		
5.1 - Main school entrances easy to find? Is the entrance clearly distinguishable from facade?	No	The grey doors are not clearly seen on approach owing to a lack of colour contrast against the grey facade to aid people with impaired vision.
<div style="display: flex; justify-content: space-around; align-items: center;"> <div style="text-align: center;">

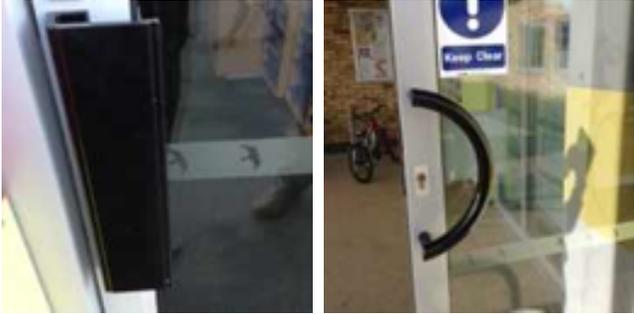
<p data-bbox="248 1265 367 1289">Appendix 33</p> <p data-bbox="573 1265 692 1289">Appendix 34</p>

5.6 - Door control at a suitable height for both standing and seated users? Are door handles clearly located, easy to use and grip?	No	<p data-bbox="1272 738 2011 802">Black door handles against dark glazed background are not suitably contrasted to aid people with impaired vision.</p> <p data-bbox="1272 842 2022 906">All fire exit door handles are not of the preferred profile to aid people with dexterity impairments.</p>

5.6	<p>Black door handles against dark glazed background are not suitably contrasted to aid people with impaired vision.</p> <p>All fire exit door handles are not of the preferred profile to aid people with dexterity impairments.</p>	<p>Add colour contrast to the door handles and surround.</p> <p>Replace with well contrasted BS8300 compliant door handles.</p>	OG

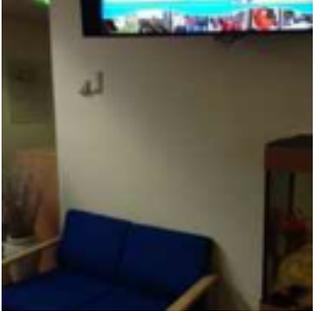
6.8 - Seating designed for ease of use? Is there a management procedure to ensure spaces are provided for wheelchair users?	No	<p>Standard chairs, all are at the same height and feature armrests to aid people with ambulant disabilities however there is a TV projecting from the wall over the seating area which could cause a potential impact injury for people with impaired vision when using the chairs because they may not be able to detect the hazard with their assistance cane.</p> <p>A management procedure is in place to accommodate wheelchair users when required.</p>

6.8	Standard chairs, all are at the same height and feature armrests to aid people with ambulant disabilities however there is a TV projecting from the wall over the seating area which could cause a potential impact injury for people with impaired vision when using the chairs because they may not be able to detect the hazard with their assistance cane.	Reposition the TV.	M

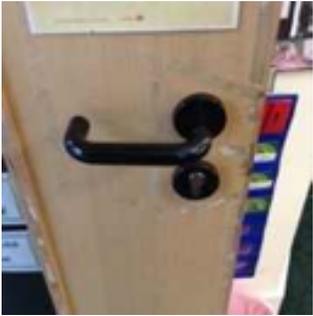
<p data-bbox="248 710 367 730">Appendix 55</p>

Question	Response	Details
8.5 - Door control at a height suitable for both standing and seated users? Easily gripped and operated? Control clearly distinguishable from the door itself?	Yes	All doors have suitable black tubular lever door handles that are easy to use for people with dexterity impairments and handles that are well colour contrasted against the background to aid people with impaired vision.

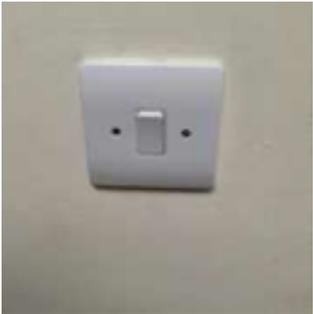
<p data-bbox="248 1315 367 1337">Appendix 92</p>

16.3 - Can occupiers control lighting? Are light switch plates suitably colour contrasted and appropriately positioned for a wheelchair user?	No	<p>Throughout the site the light switches are the same colour as the walls.</p> <p>All light switches are not positioned too high off the floor level making them easy to reach for wheelchair users or people of small stature.</p>
