Boundary Wall at 39-52 Bushell Close,
London SW2 3LL

Structural Engineer's Report

Prepared for:
Lambeth Housing Management

April 2024

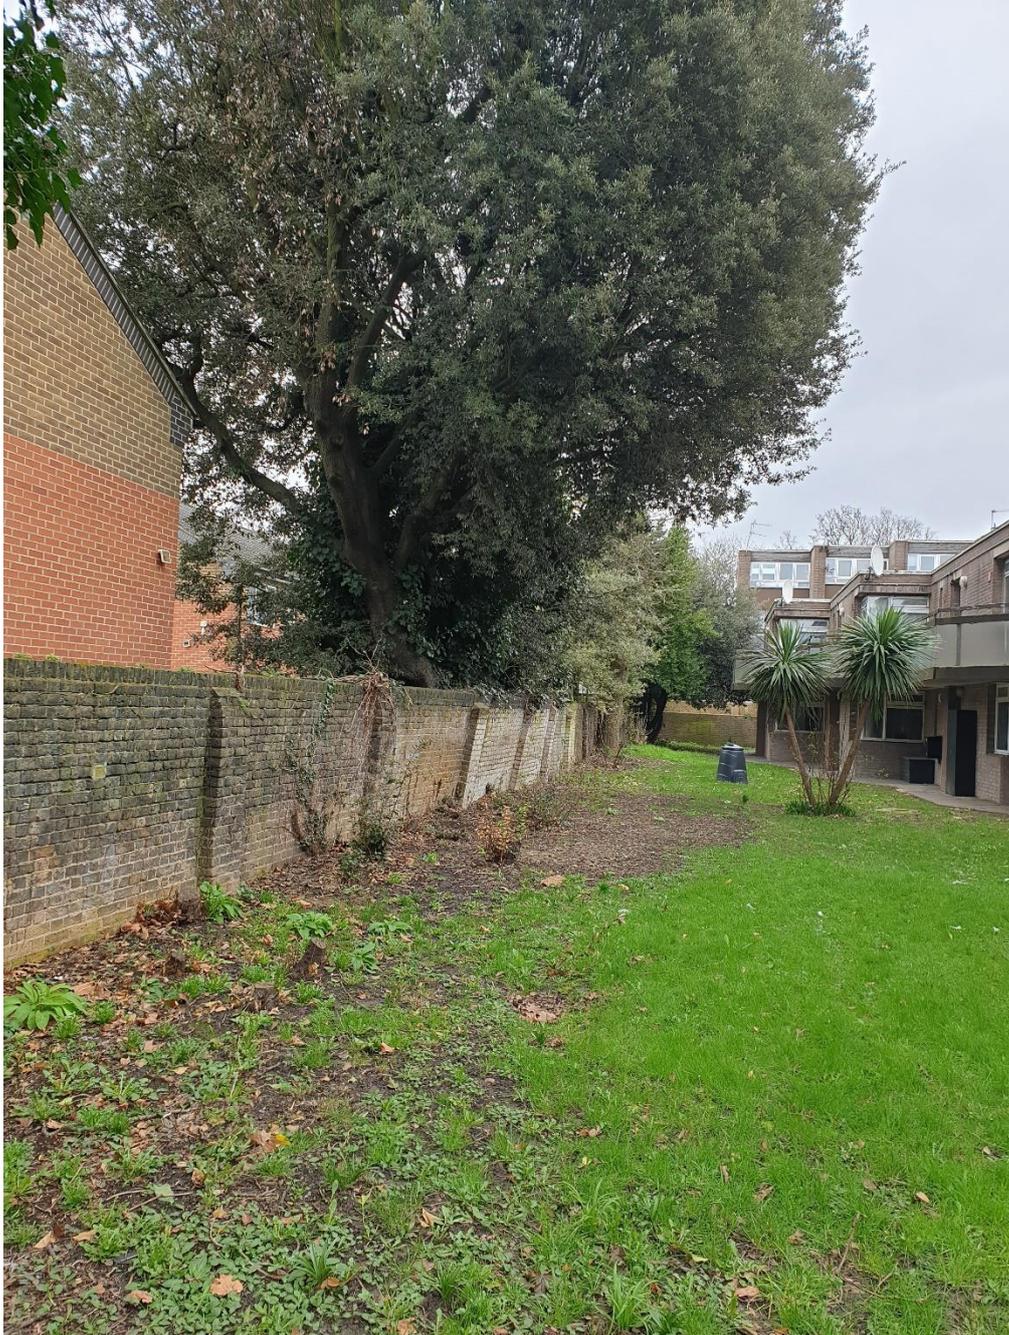
6.1 View looking north-east along the wall. Note that parts of the wall are visibly out of plumb. Also note the presence of tree stumps

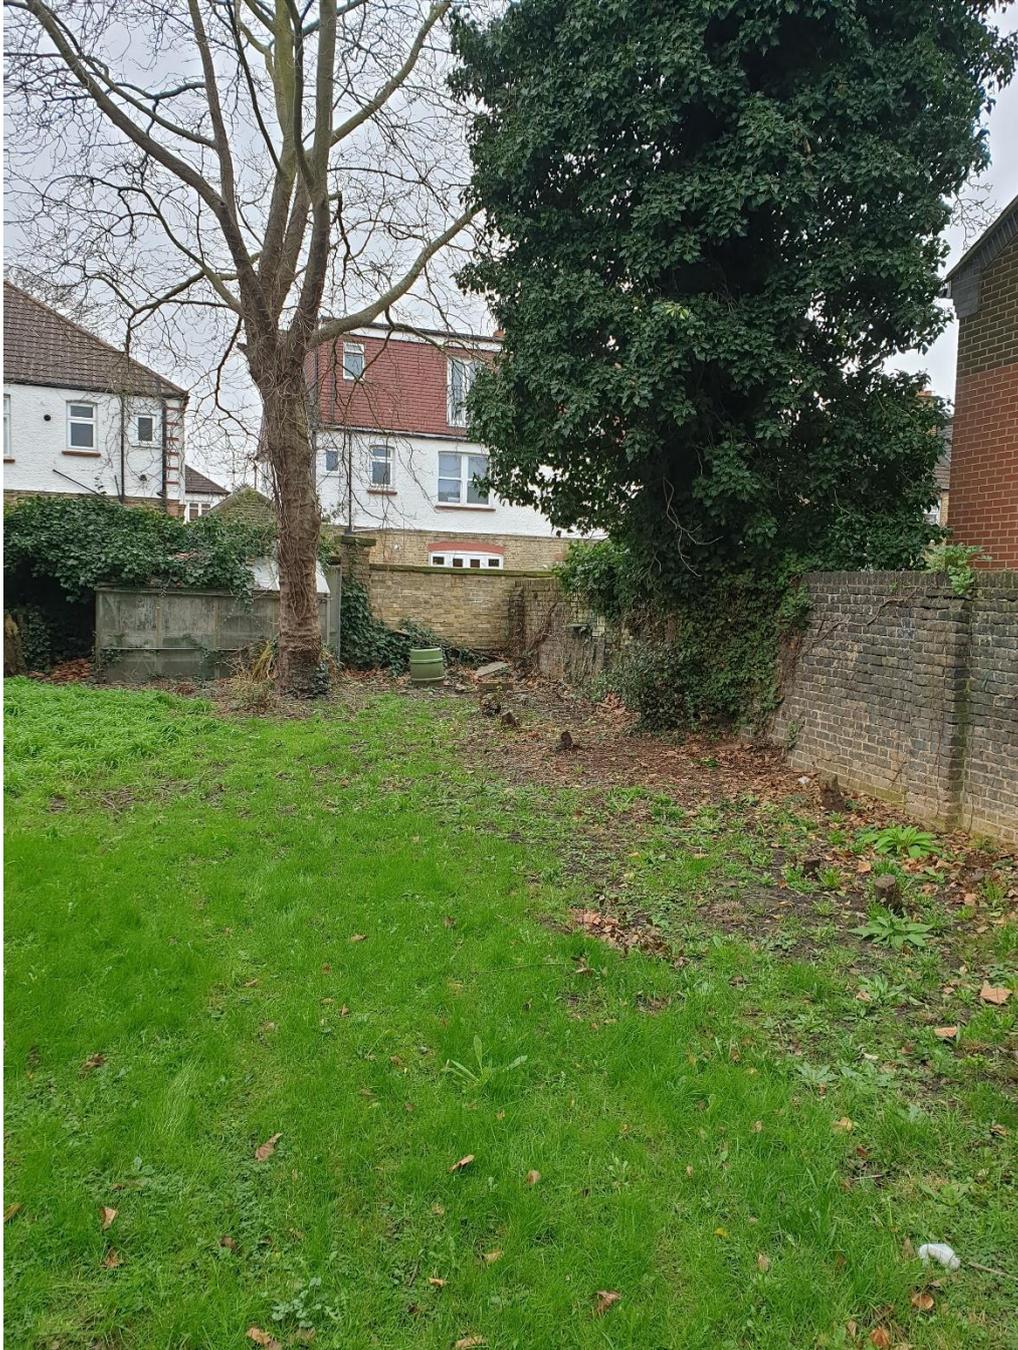
6.2 View looking south-west along the wall. Note the tree close to the wall and tree stumps.

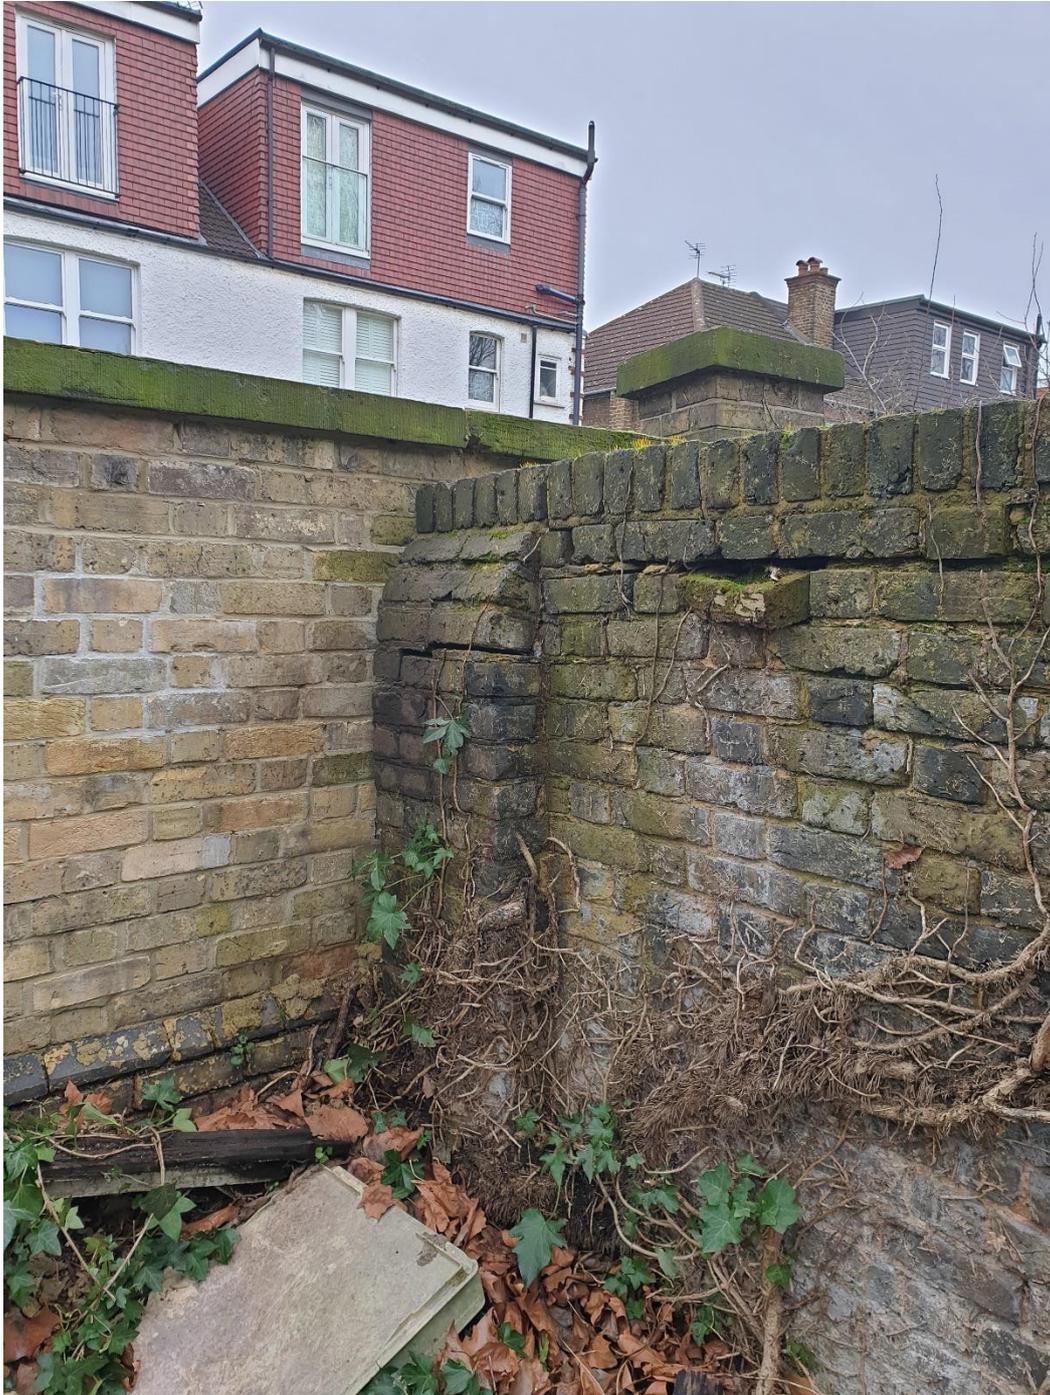
- 3.1 The wall was seen to be in relatively poor structural condition, with loose and missing bricks (see photographs 6.3 and 6.7), extensive areas of eroded pointing (see photographs 6.3, 6.5, 6.7-6.10), and much foliage growing on, or out of, the wall.

6.3 South-west end of wall. Note loose brick and eroded pointing

- 5.6 Subject to input from insurers, if the wall is to remain in place in the long term, it is recommended that it is repointed, missing bricks are replaced, loose bricks are properly bedded into the wall, and roots that are growing into the wall are removed.

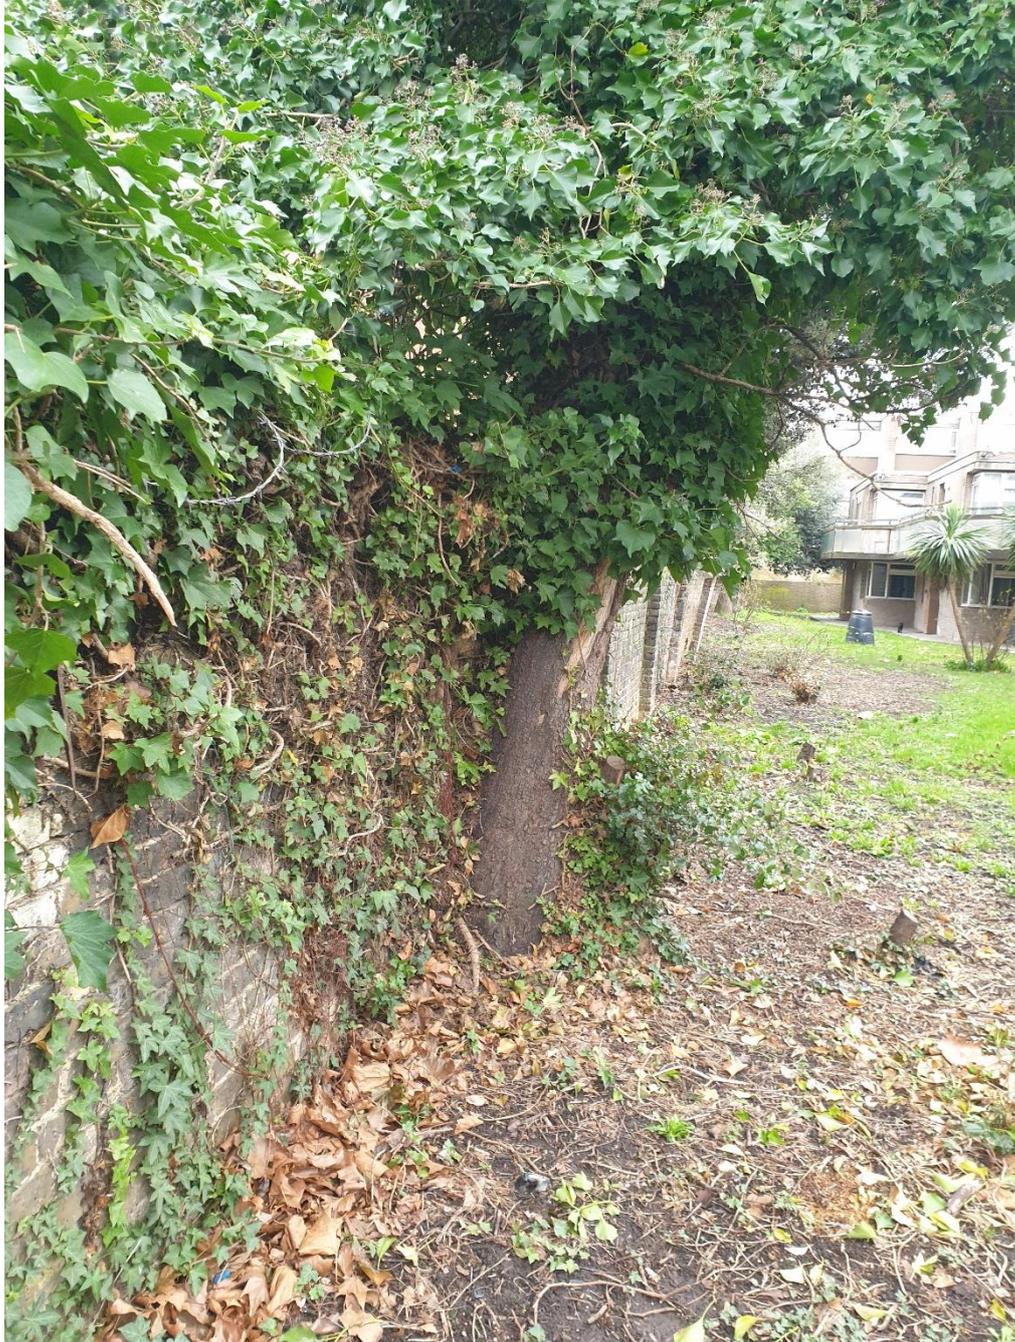
6.4 Tree growing close to the wall. Note also foliage growing on and over the wall.

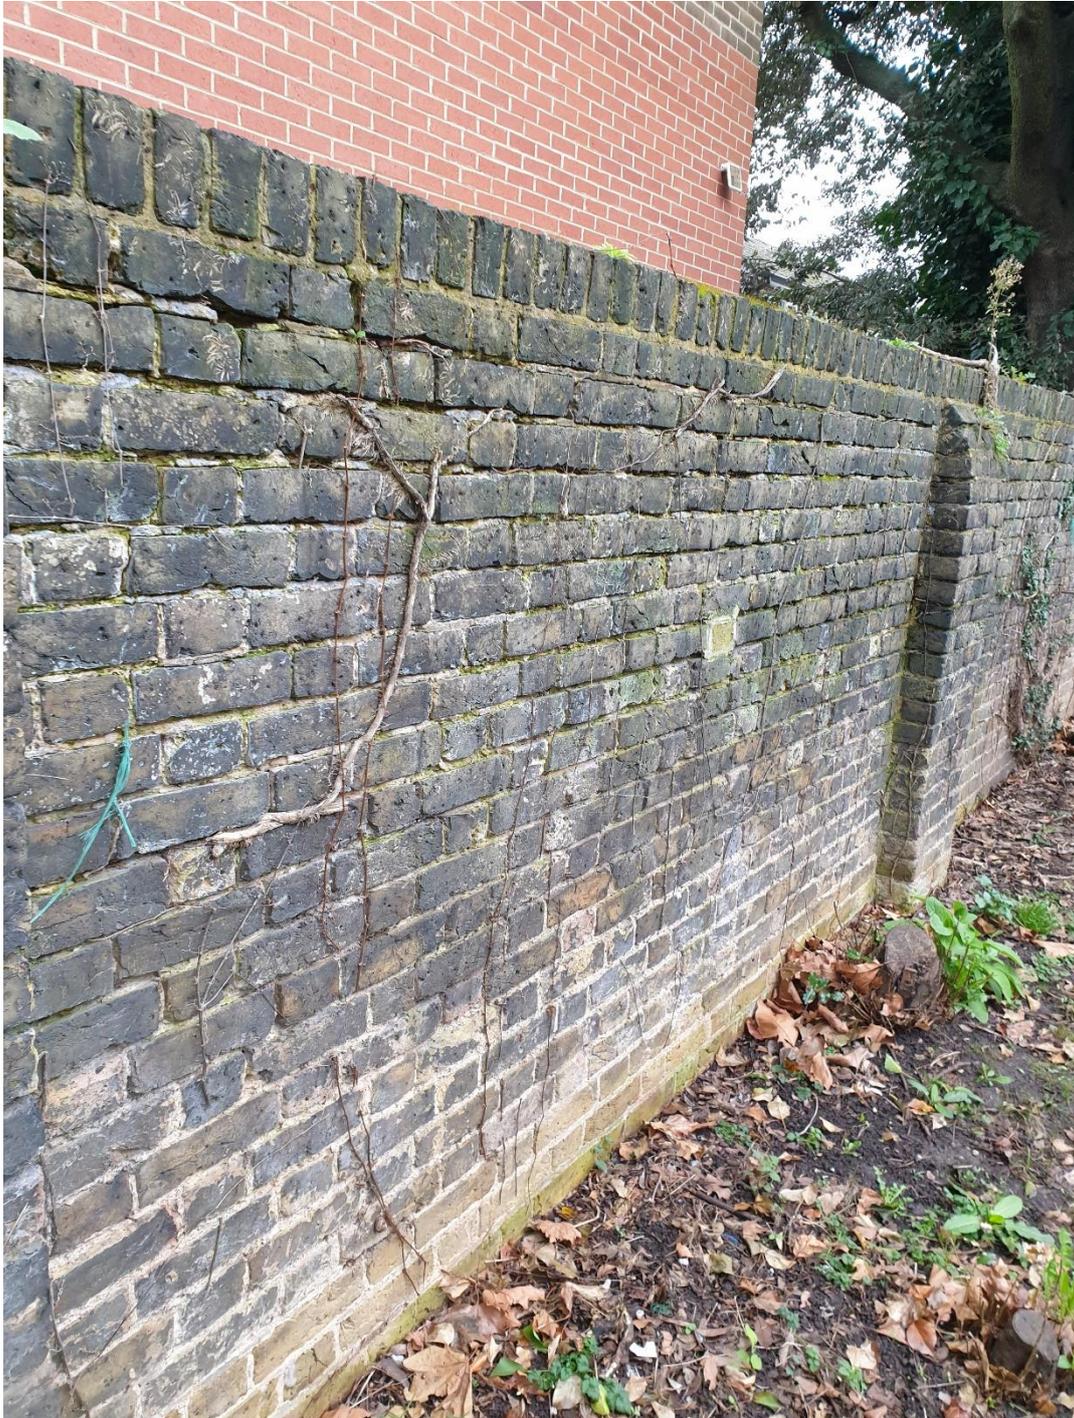
6.5 Eroded pointing and foliage growing out of the wall

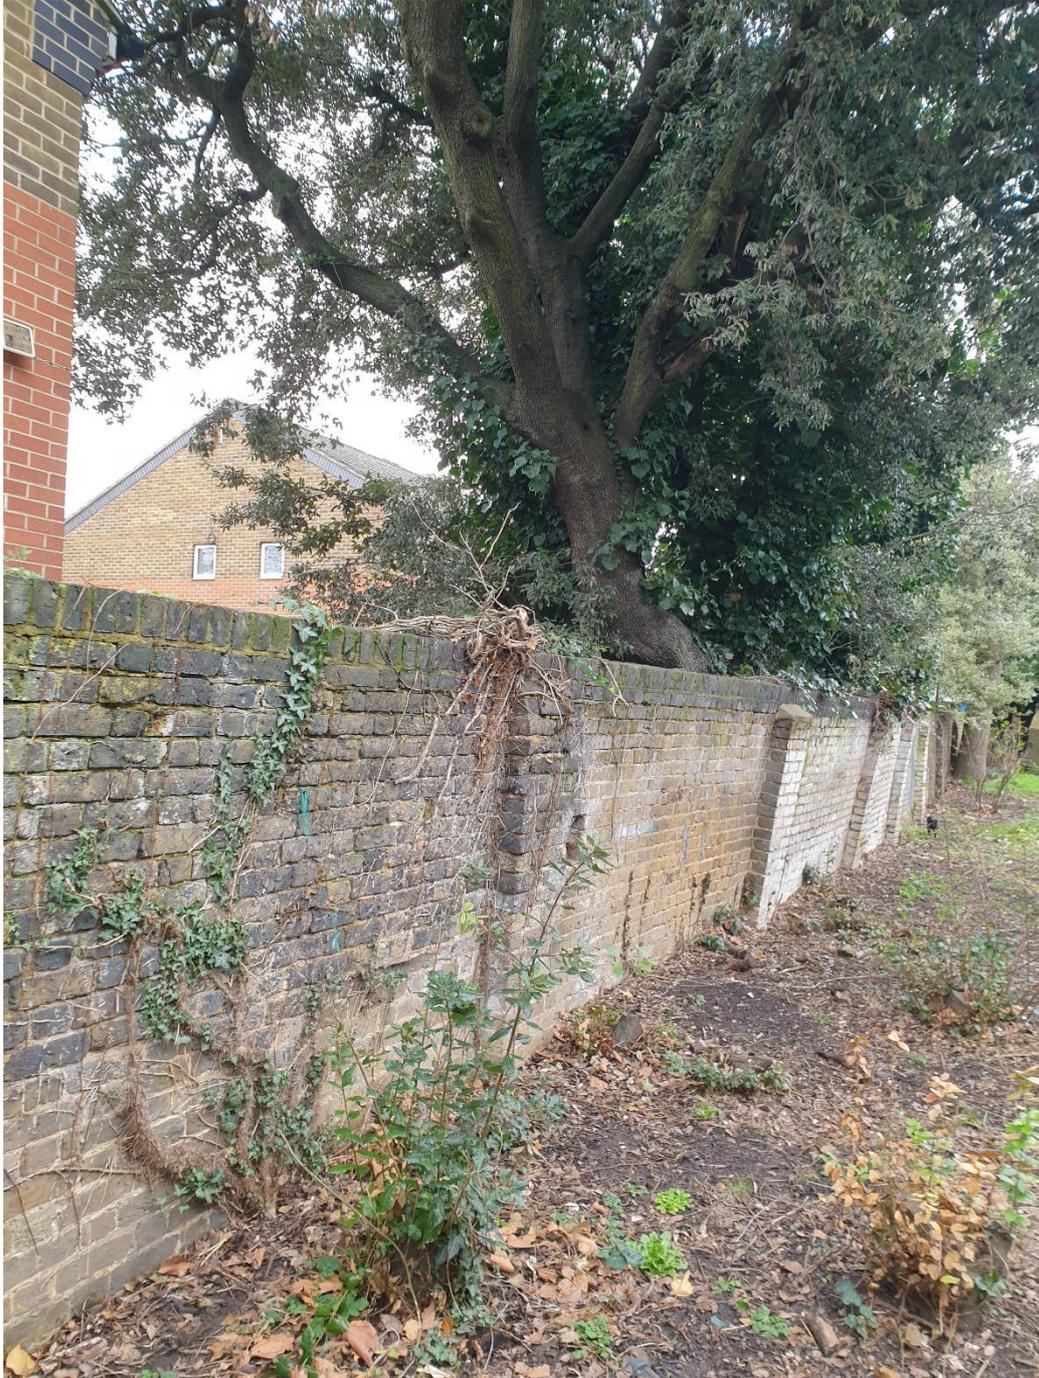
- 3.2 The wall was seen to be leaning inwards significantly in an area in which trees are growing close to the wall on the Presentation Mews site (see photograph 6.6). The wall leans inward at a slope of approximately 1 in 8.

6.6 Wall significantly out of plumb near trees on the other side of the wall.

- 5.1 We recommended, in an email dated 19th February, that Lambeth installs Heras fencing to prevent people from getting close to the wall in the area in which the wall is leaning significantly into the site. It is understood that this has been done.
- 5.2 It is recommended that Lambeth checks the legal ownership of the wall and legal responsibility for its maintenance.

- 5.4 Subject to any input from insurers, we recommend that Lambeth approaches the relevant adjoining owners with a view to having the trees that are causing the wall to lean over into the Bushell Close site removed, so that lengths of wall that are leaning over can be re-built vertical.

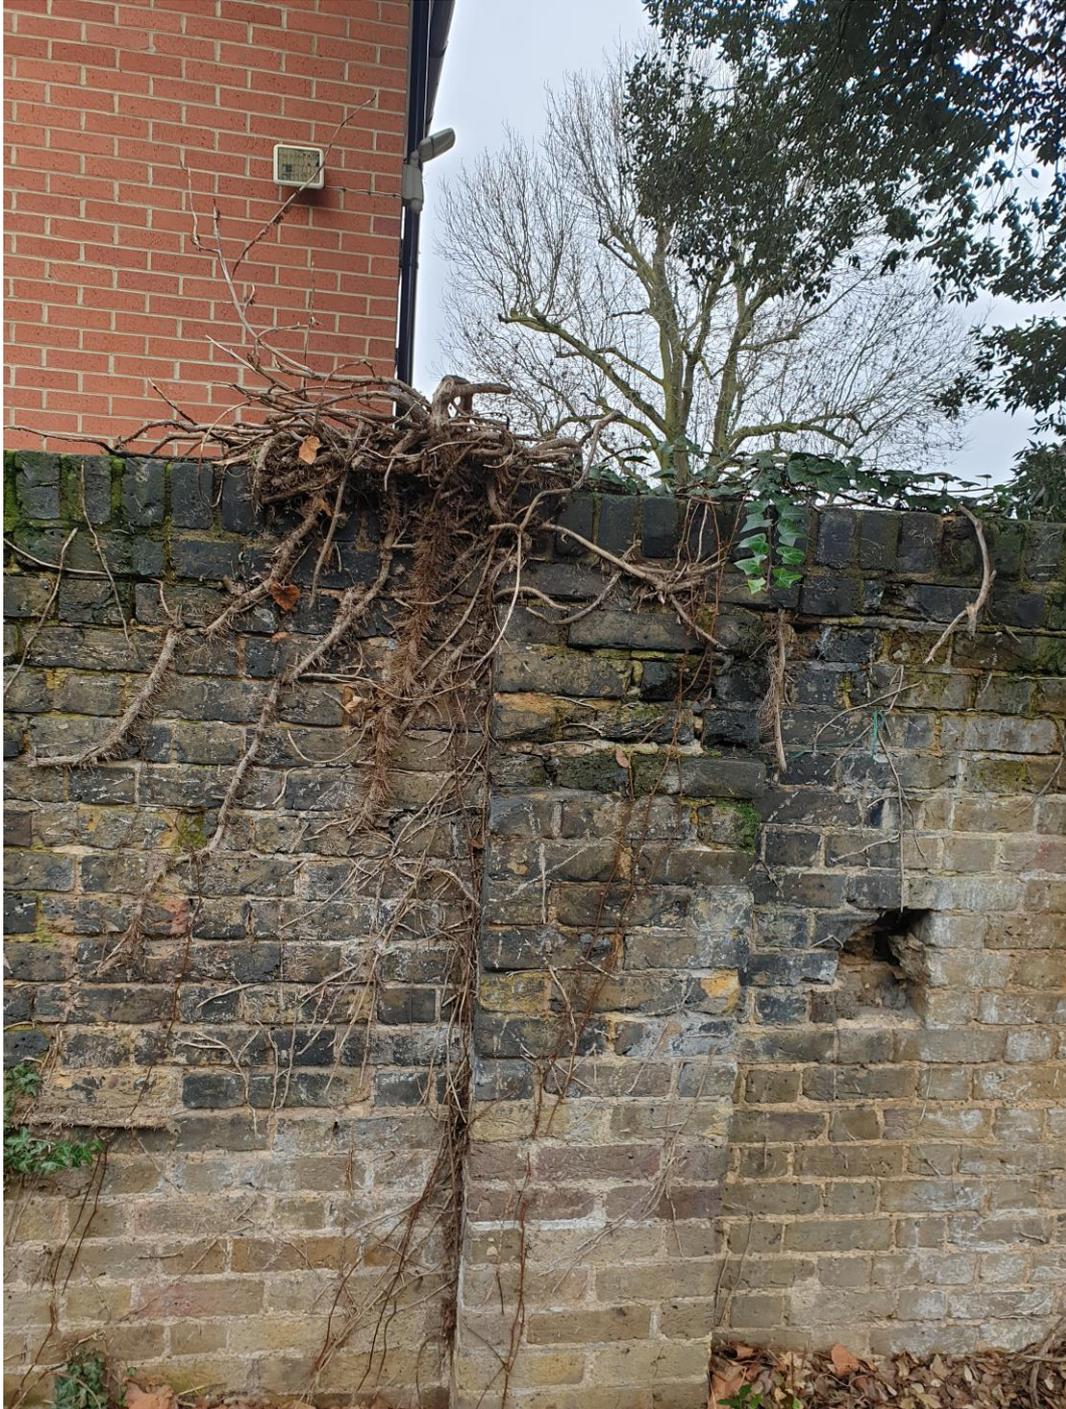
6.7 Eroded pointing, missing bricks and damage apparently caused by rootlets.

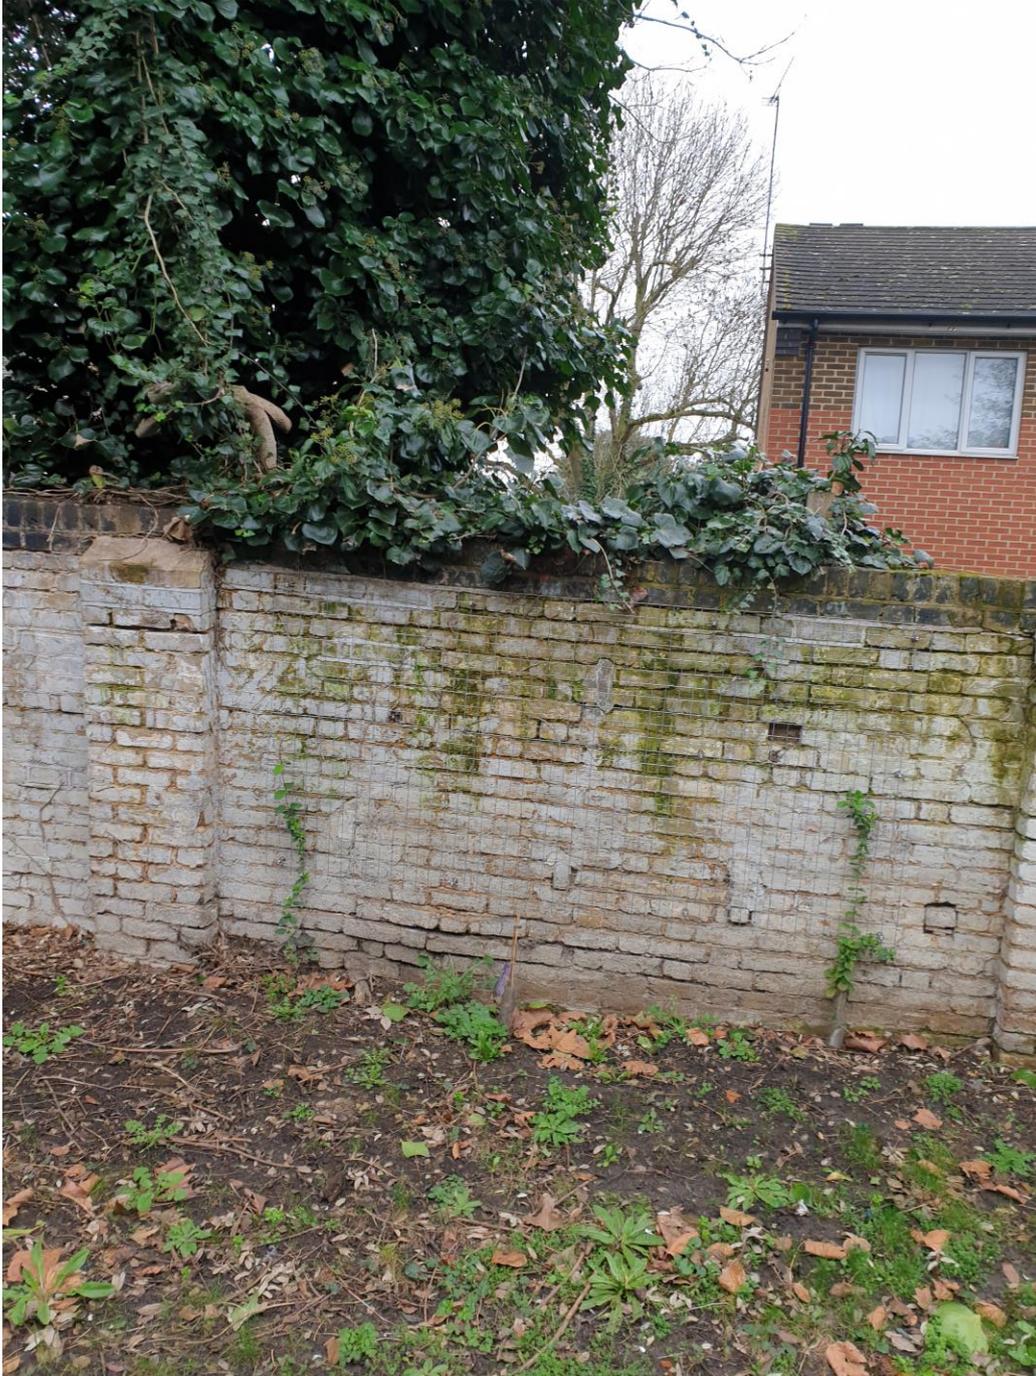
6.8 Eroded pointing.

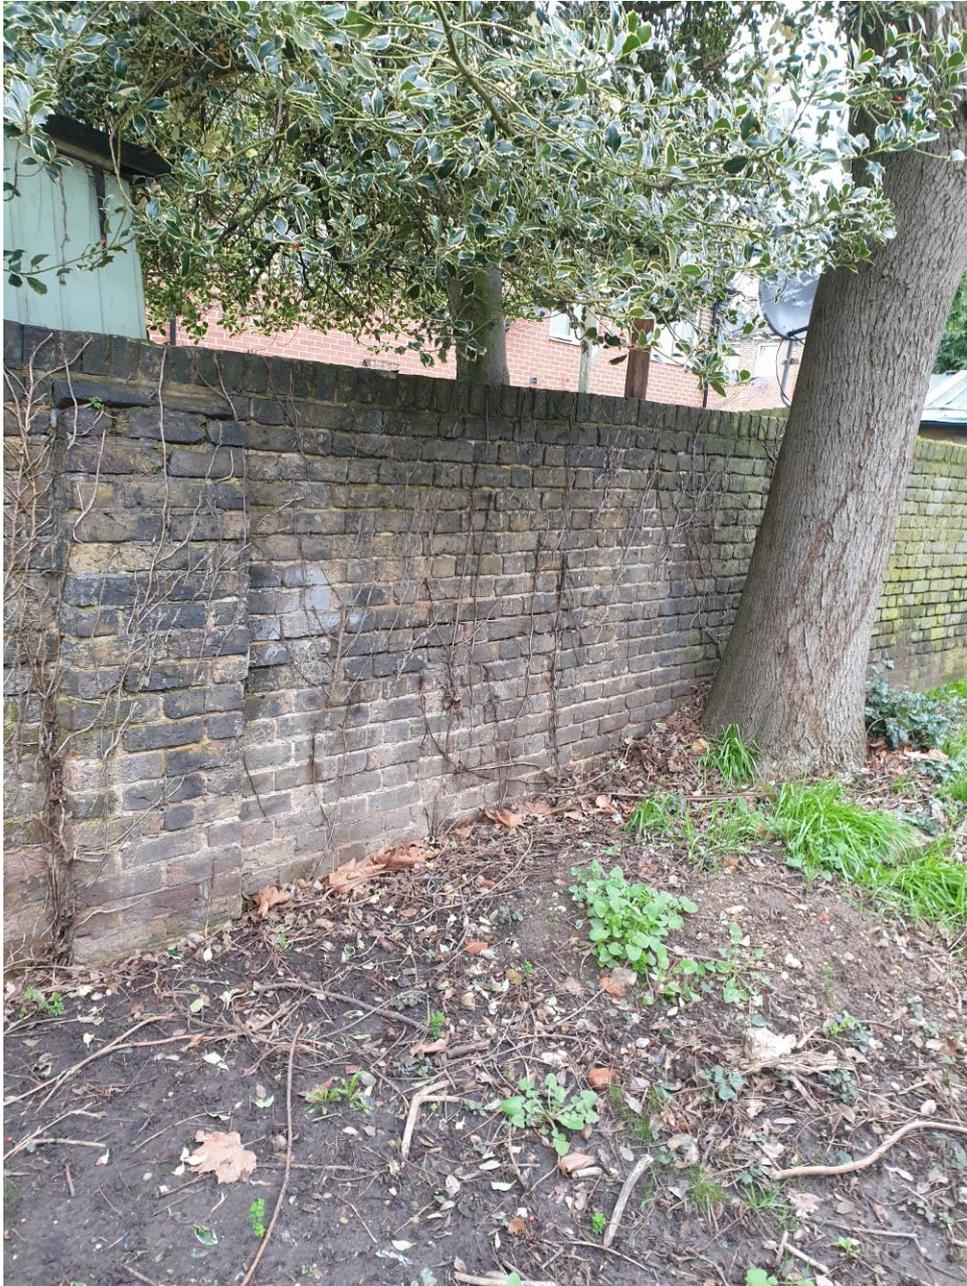
6.9 Tree growing close to the north-east end of the wall. Note eroded pointing

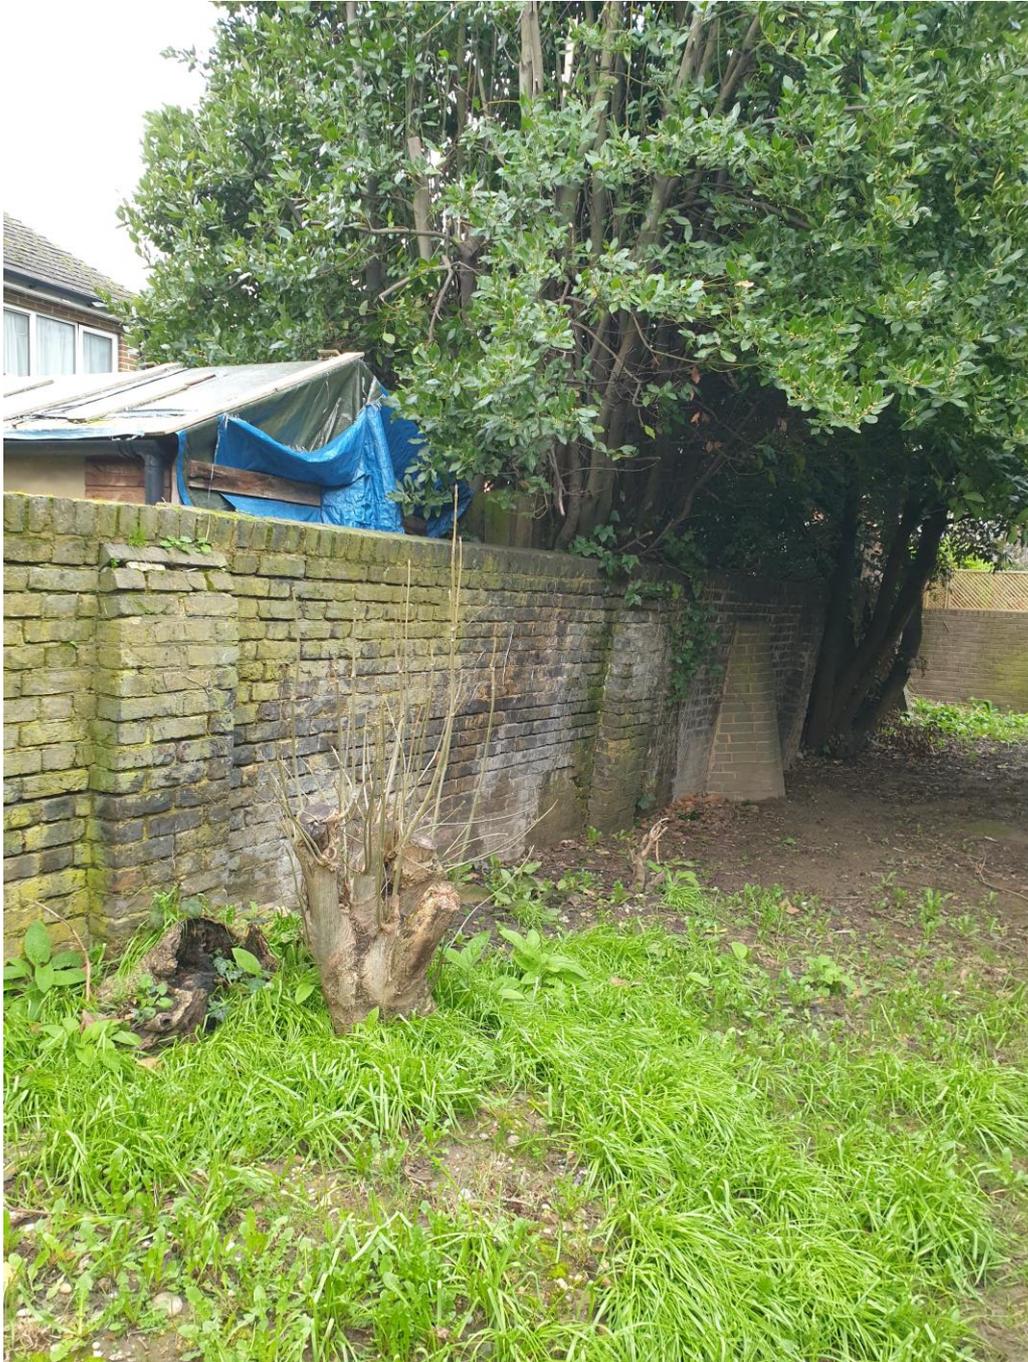
6.10 Group of trees on the other side of the wall, in the rear garden of a property in Presentation Mews. Note eroded pointing and remedial buttress.

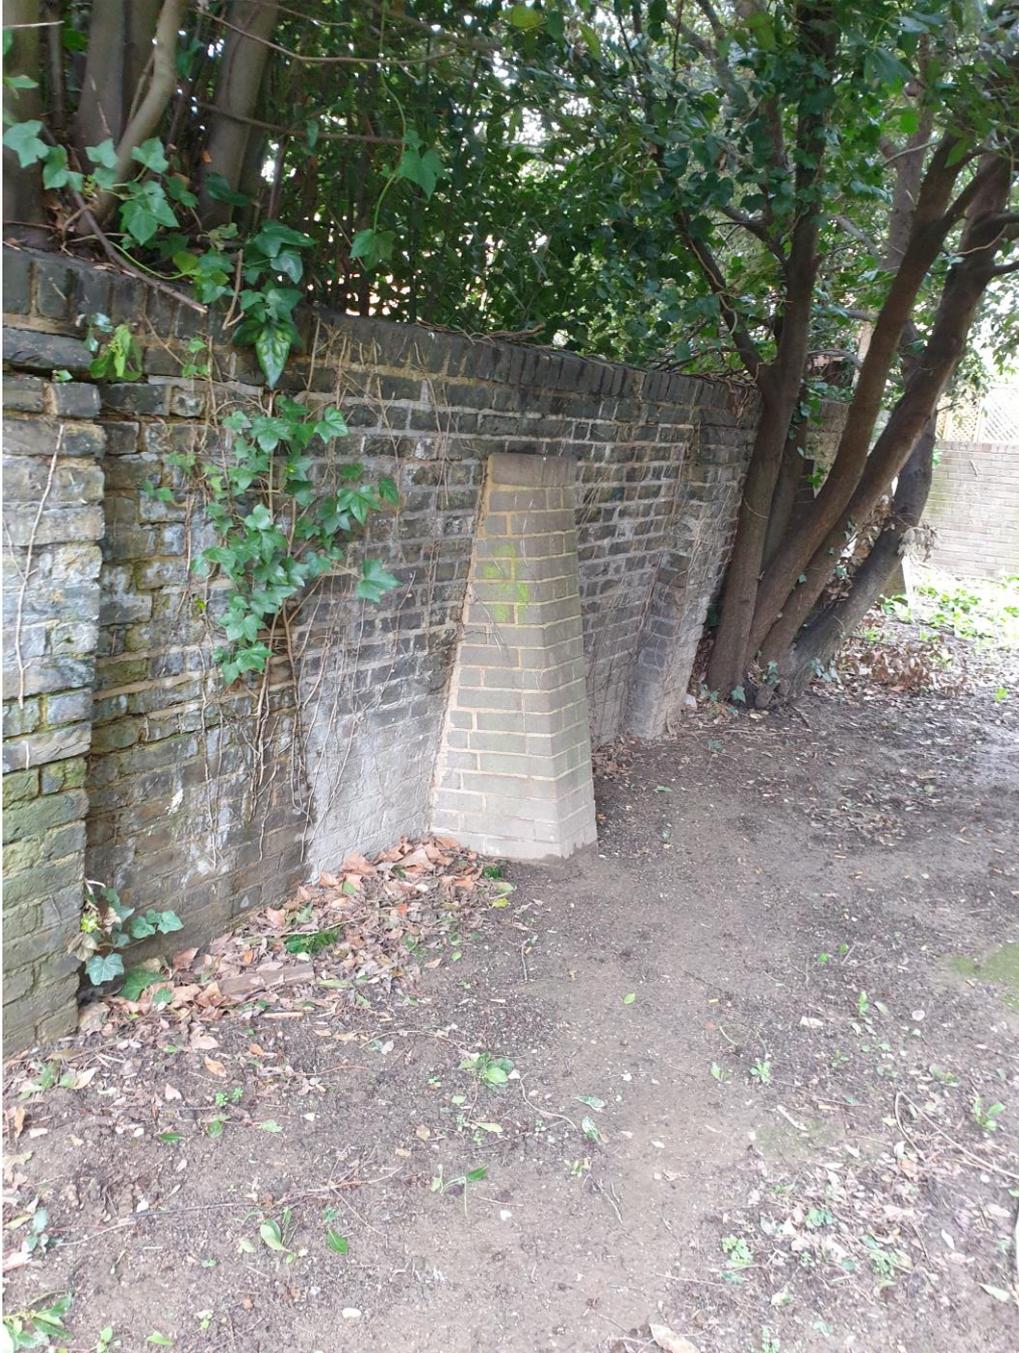
- 3.3 Towards the north-east end of the wall, in an area in which a group of trees is growing close to the wall on the Presentation Mews site and the wall is leaning into the Bushell Close site, two remedial buttresses, one of which has fractured, were seen to have been constructed next to the wall (see photographs 6.11-6.13).

6.11 Remedial buttress. A second remedial buttress can be seen beyond the group of trees

- 5.5 If trees close to the wall on adjoining sites remain in place, then Lambeth may wish to consider the building of further remedial buttresses, and the repair of the fractured buttress, though these measures may not achieve long-term stability of the wall. Alternatively, a fence could be provided on the grassed area (which would permanently reduce it in width) so that stability of the wall would be of less concern.

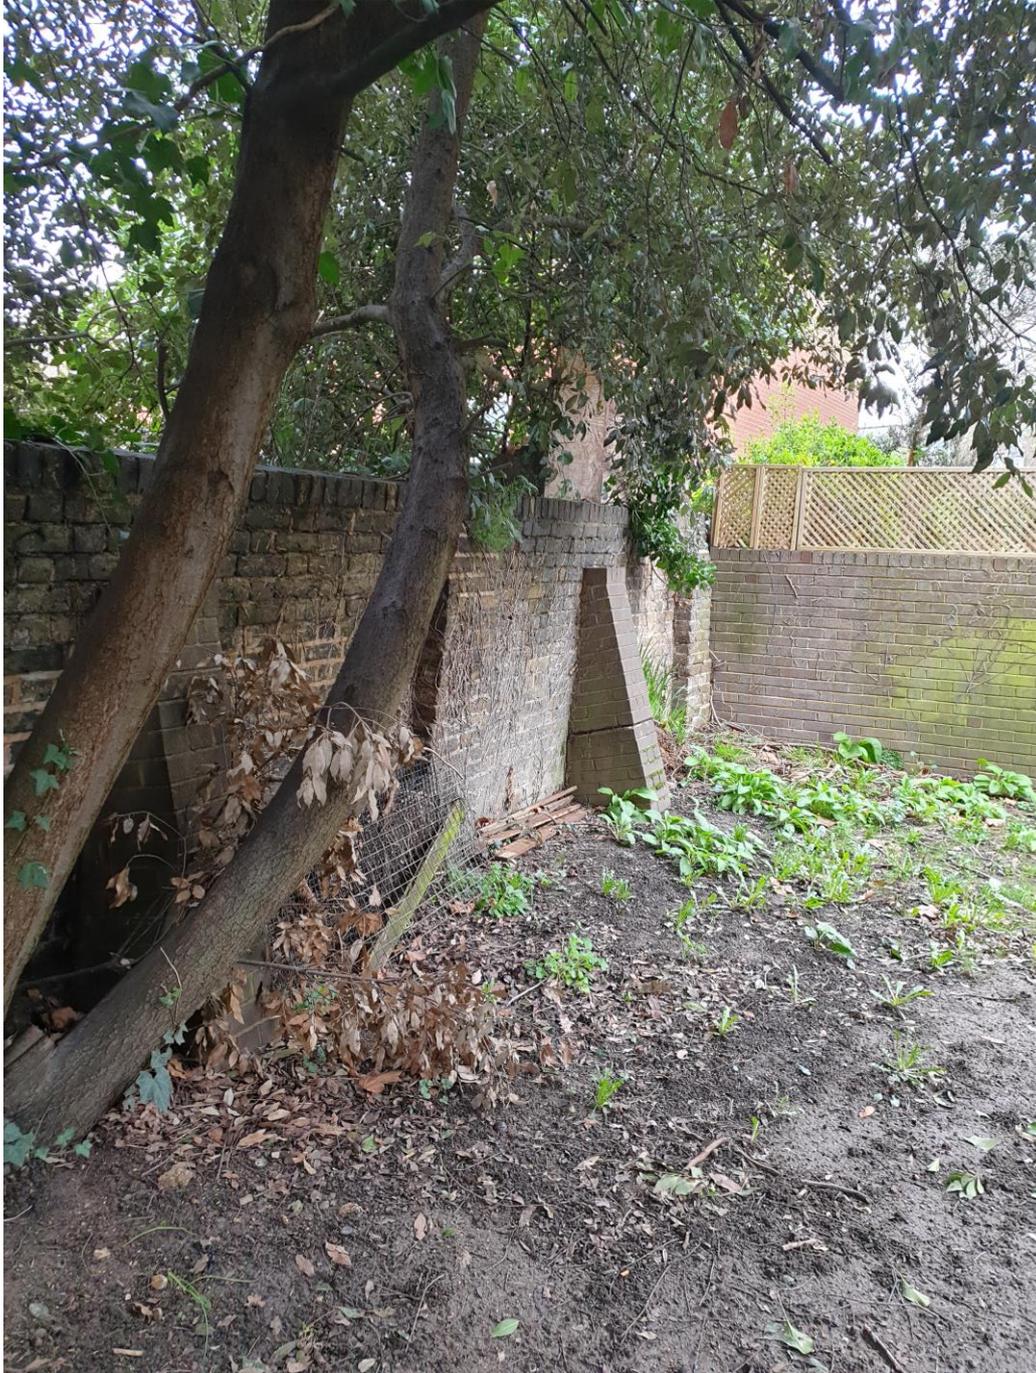
6.12 Fractured remedial buttress near north-east end of the wall.

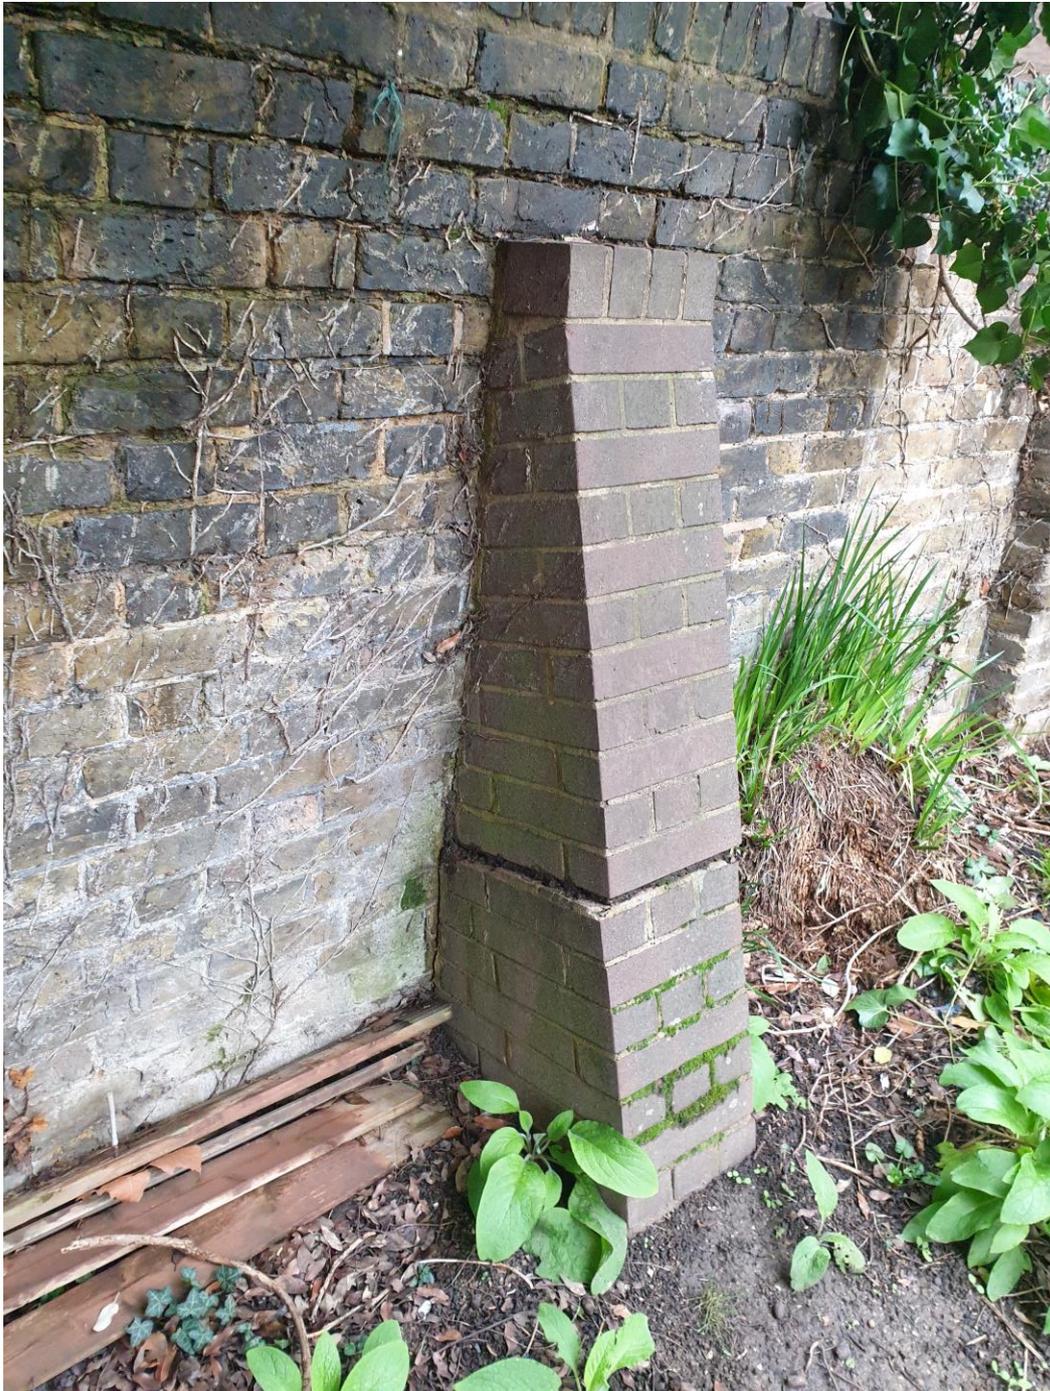
6.13 Fractured remedial buttress near north-east end of the wall.

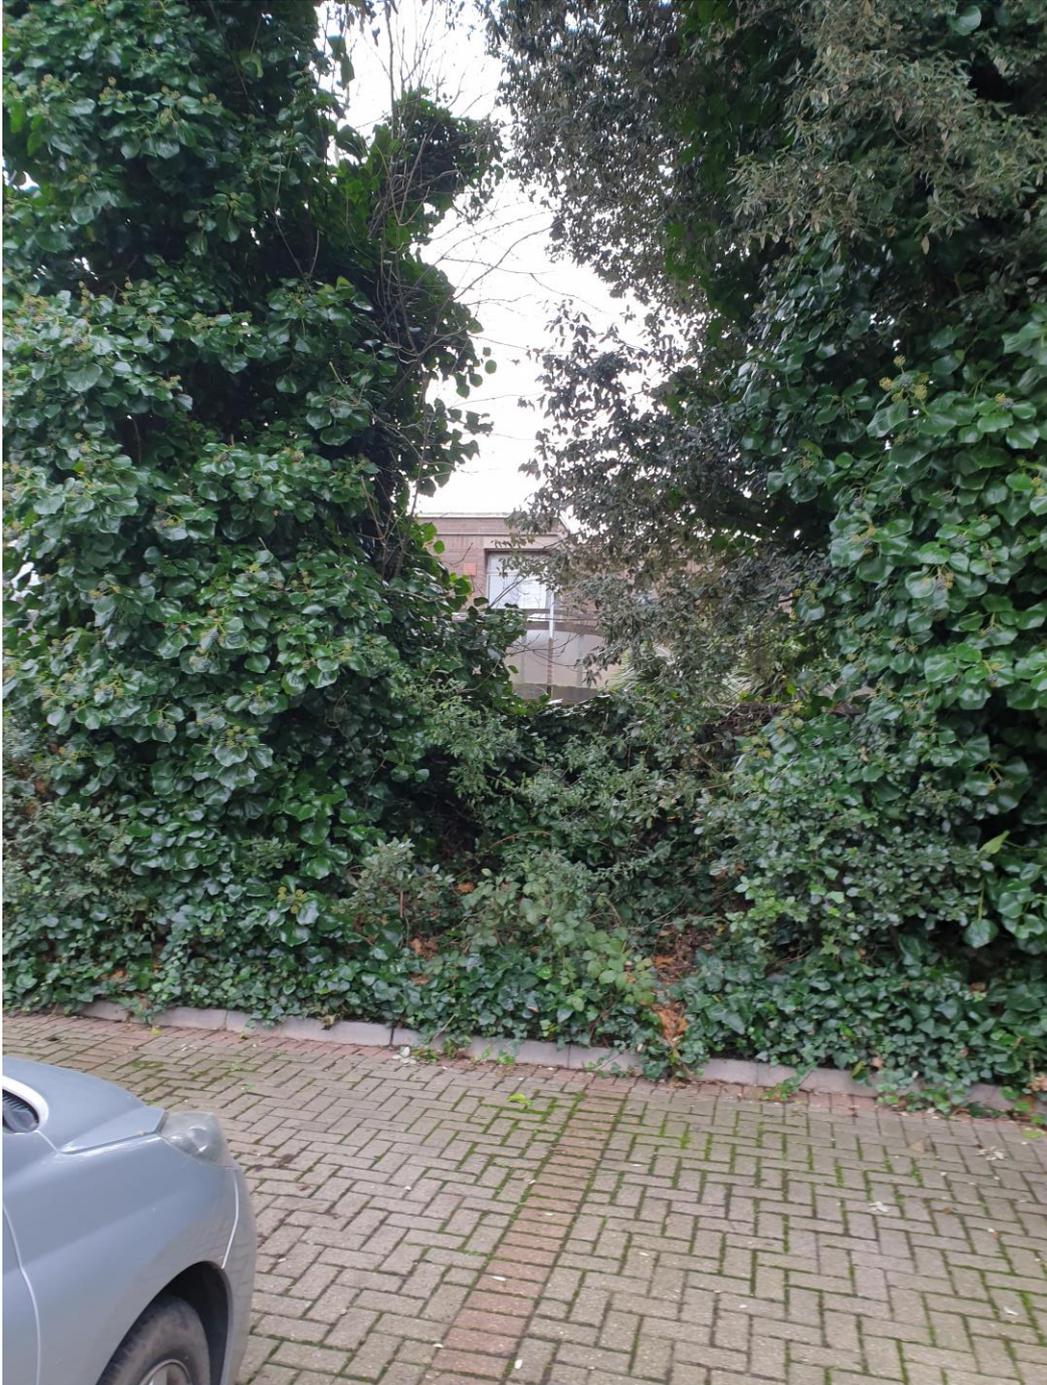
- 3.4 Viewed from the Presentation Mews side of the wall, it was seen that the trees seen in photograph 6.6 are growing in a verge next to a car-parking area (see photograph 6.14). Ground level in this area on the Presentation Mews side for the wall appeared to be higher than the ground level on the Bushell Close side, although heavy undergrowth prevented a clear view of the wall height above the ground.

6.14 View from car-park area off Presentation Mews. These are the trees also shown in photograph 6.6.

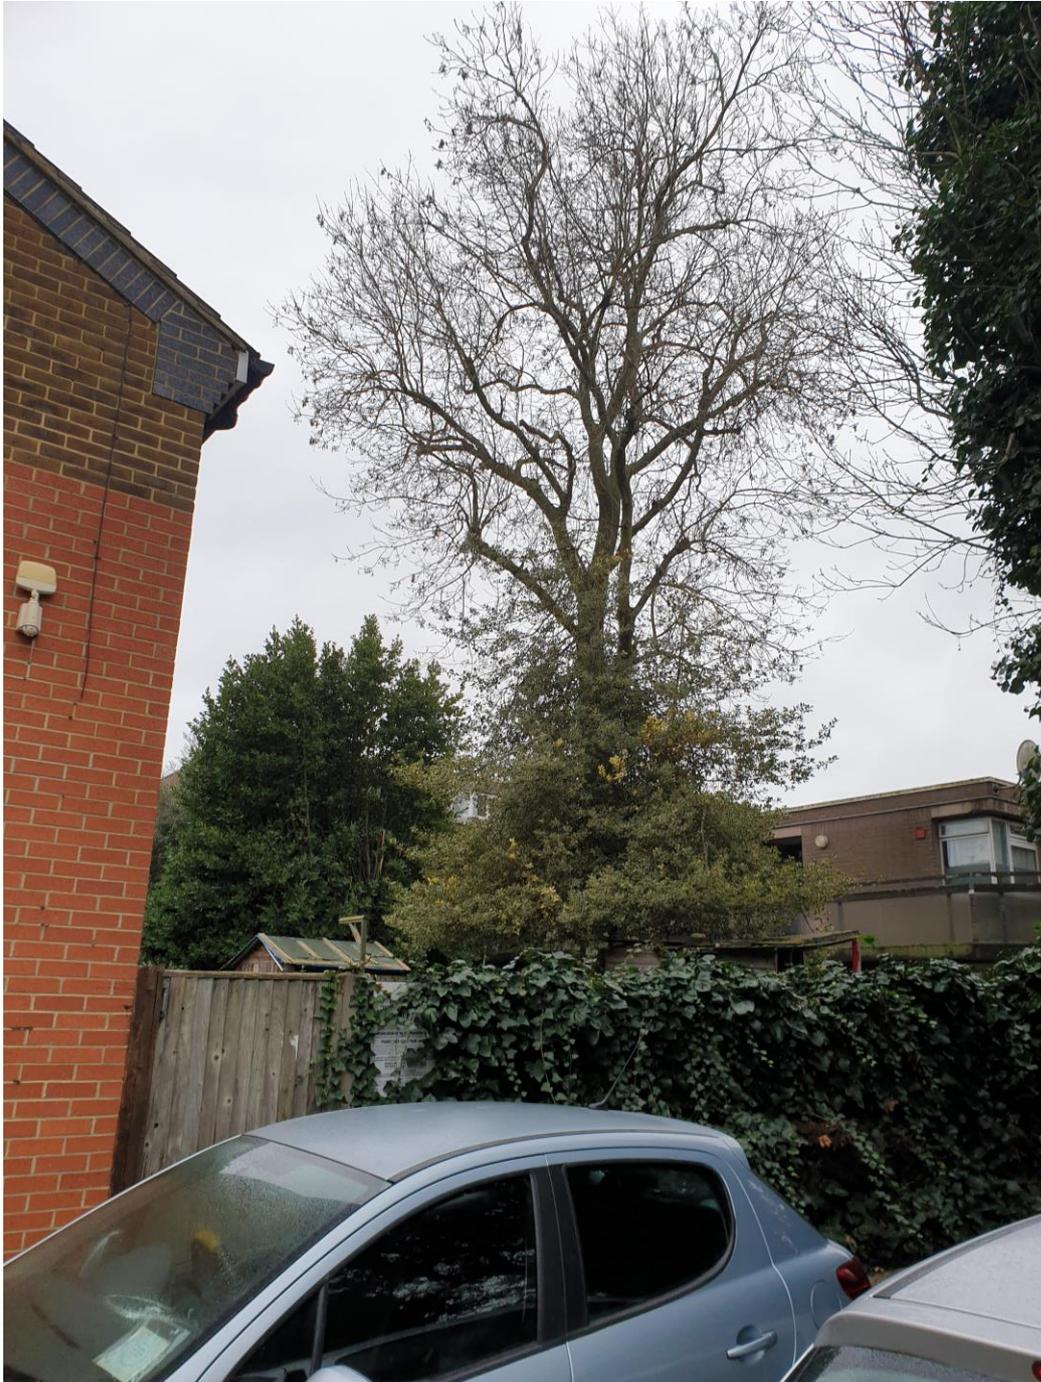
- 3.5 Viewed from the Presentation Mews side of the wall, it was seen that the trees seen in photograph 6.10 are growing in a rear garden area of properties in Presentation Mews (see photograph 6.15).

6.15 View looking over towards the rear gardens of properties in Presentation Mews.
