**STRUCTURAL BEHAVIOUR OF PRESTRESSED
CONCRETE HOLLOW CORE FLOORS
EXPOSED TO FIRE**

Wim Jansze (The Netherlands)

ISBN 978-90-8891-812-4

Published 24 January 2014

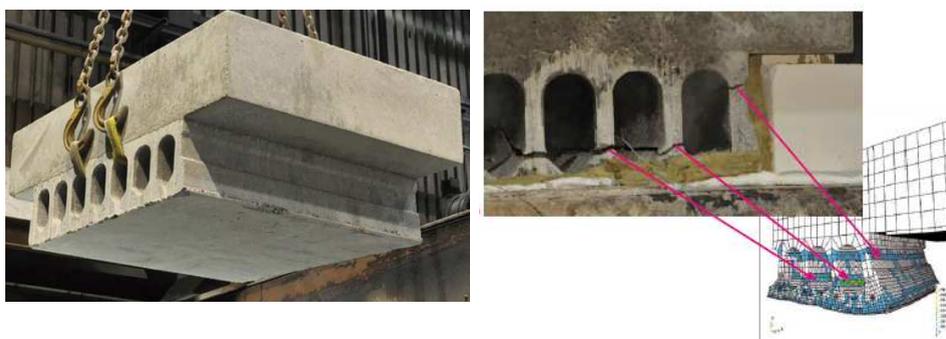
Figure 2.17. Fire test H153 with 300 mm topping and horizontal cracks through the webs

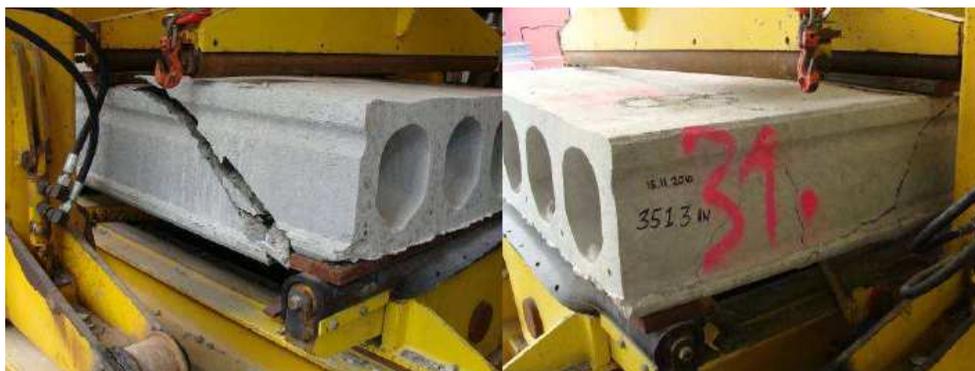
Figure 3.7. Shear tension failure crack at ambient temperature in slab #31 at both sides

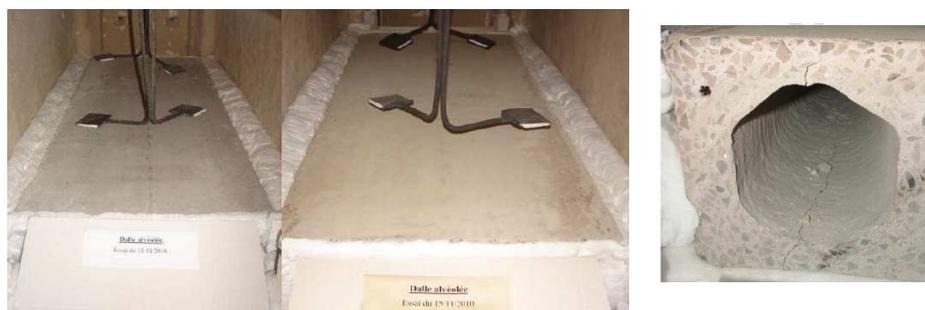
Figure 3.8. Specimen G1: before test (left) and after 2 hour fire test (middle). Vertical cracks in core after one day (right) (Note that slab was turned up-side-down in test so the soffit was facing upwards)

On 15.11.2010 a fire spalling test was carried out in the small furnace of CERIB, France. In this furnace, the hollow core slab is placed up-side-down in the furnace, and is laid just on the floor without any particular boundary conditions. The slab is heated from the top side, see Figure 3.8. The test concluded that after 2 hours of ISO fire no spalling was observed under unrestrained and unloaded conditions. One day after the test vertical cracks were observed in the core at the soffit and the topside, which seems normal for these tests, see also Figure 3.8.

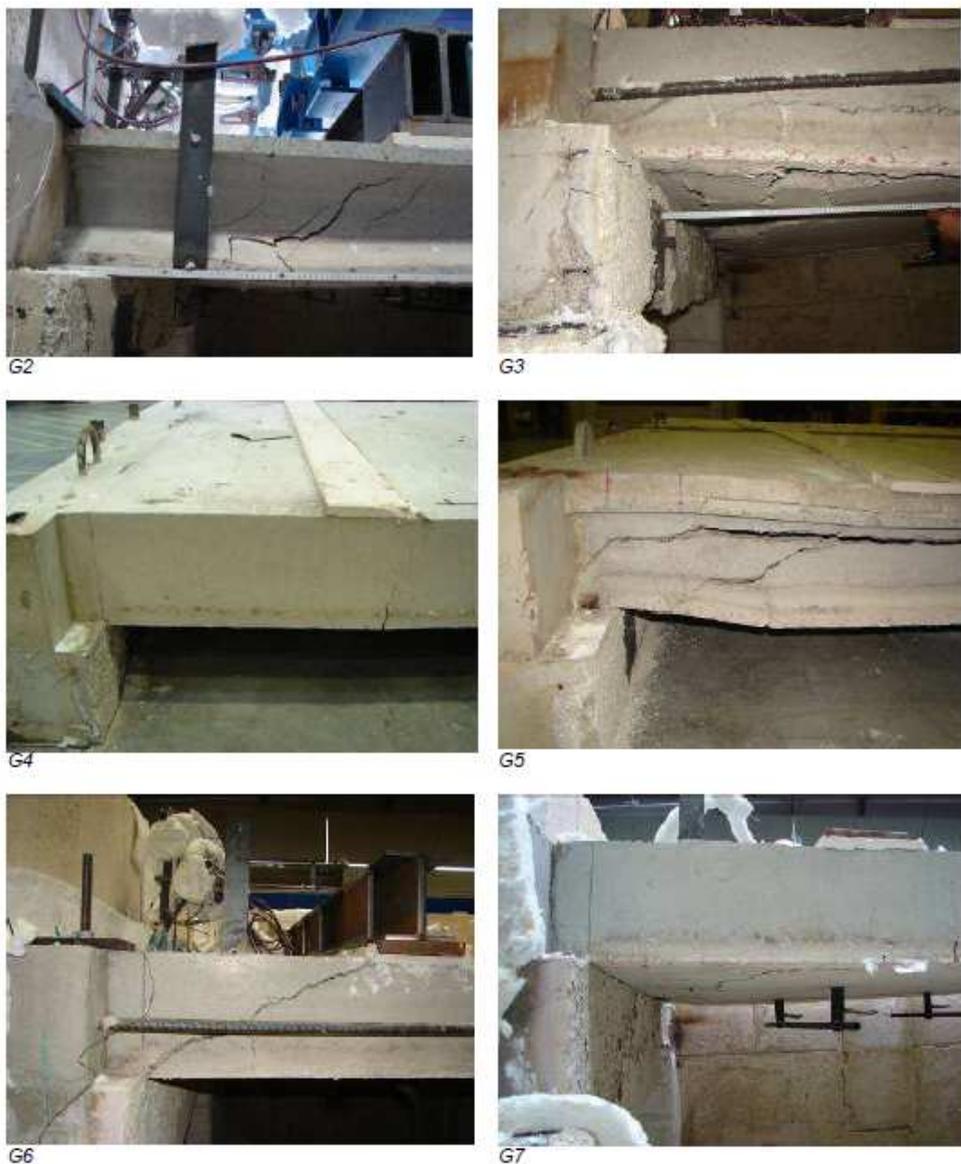
Figure 3.11. Photos of failure cracks at the sides of the floors after further loading up to failure after the fire was stopped

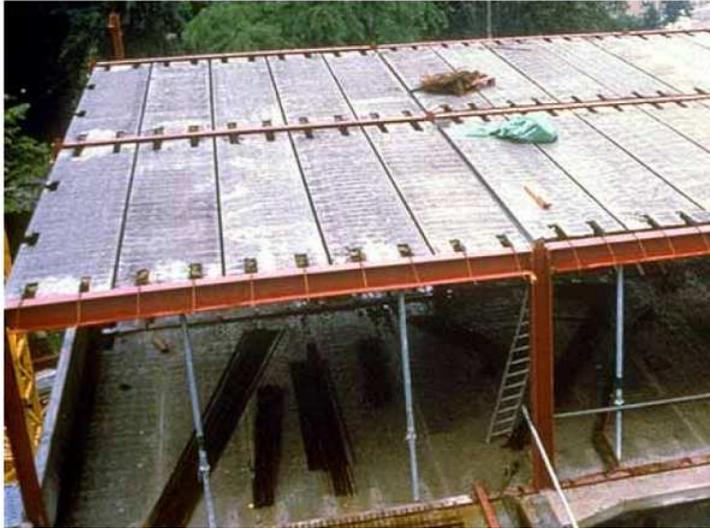
Figure 4.1. Slim floor structure with hollow core slabs (up) [4.17]; various types of slender concrete and steel beams (down) [4.4]

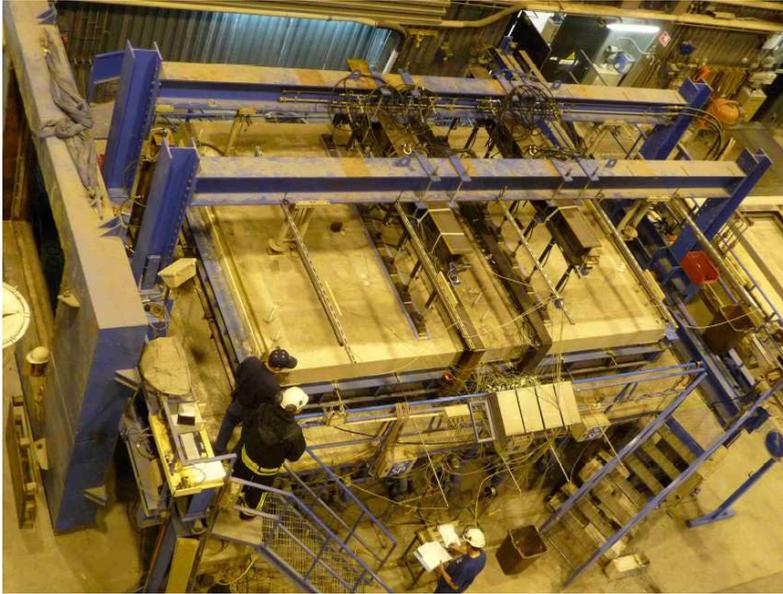
Figure 4.8. Top view of flexible support test by Peikko with Deltabeam [4.15]

Deltabeam was 3.915 m, and the span length of the hollow core 265 was 2.35 m (Figure 4.8). The concrete filling of the voids in the hollow core units was 50 mm. The hollow core units were connected to the Deltabeam with $1\varnothing 12$ in each longitudinal joint. The load was 48 kN/m at a distance of 675 mm ($2.5 \times H_{\text{slab}}$) from the Deltabeam in the first and third test, 57.6 kN/m in the second test, and 30 kN/m in the last test. All four tests were successful, because the floors maintained their load bearing capacity during the entire test periods.

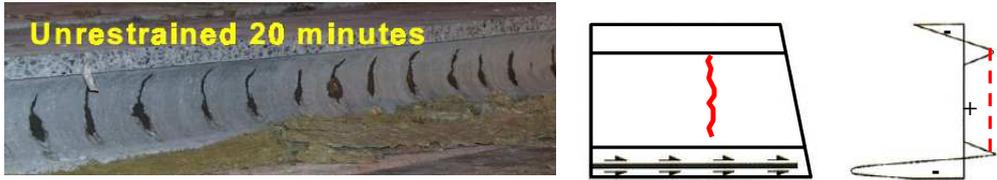
Figure 4.9. Vertical thermal cracks in hollow core slabs due to temperature gradient over cross section [4.14]

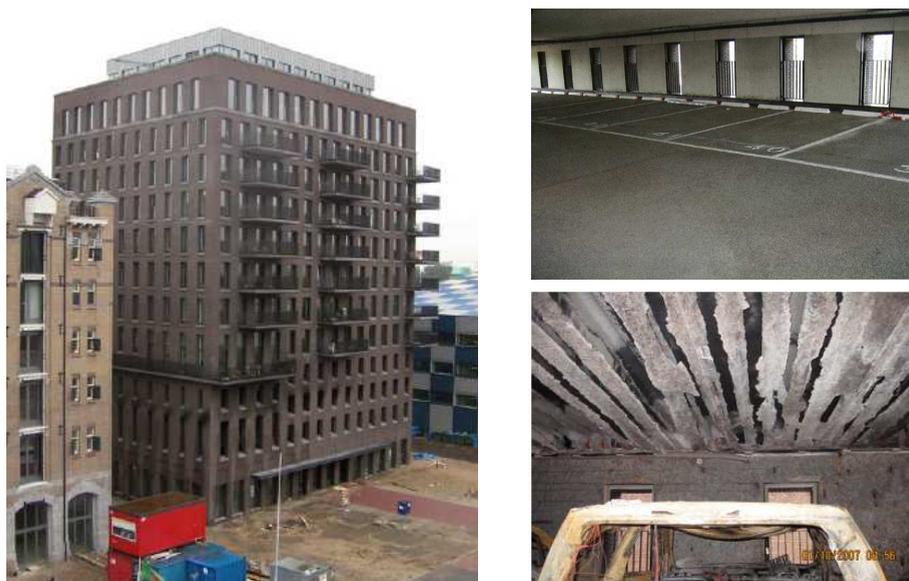
Figure 5.1. Building Harbour Edge in the Lloydstraat after fire (left). Level 3: intact floor above the fire where cars were removed the day after (right, top). Level 2: locally damaged ceiling above burned car on the level where the fire took place (right, bottom) [5.4]

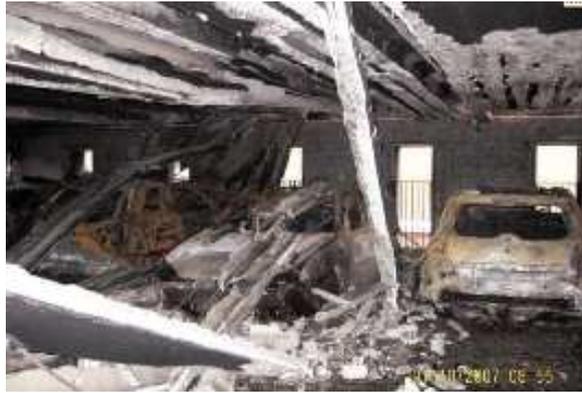
Figure 5.3-right. Hollow core floor ceiling with local damage, visible are cars 2, 1 and 3

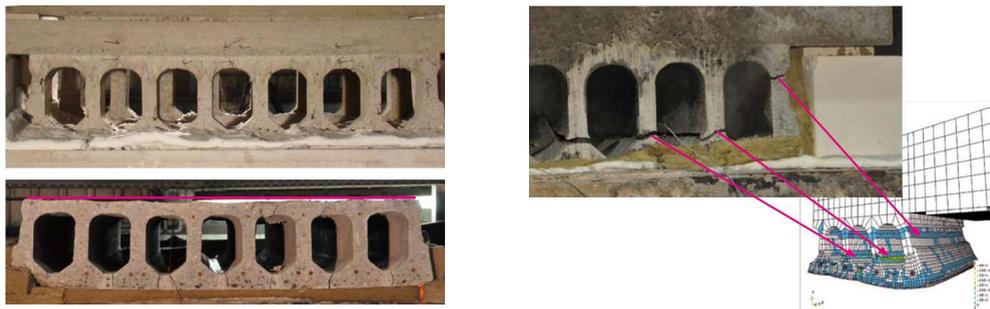
Figure 5.9. Experimental studies of part of hollow core slab with and without topping, restrained conditions and FEM

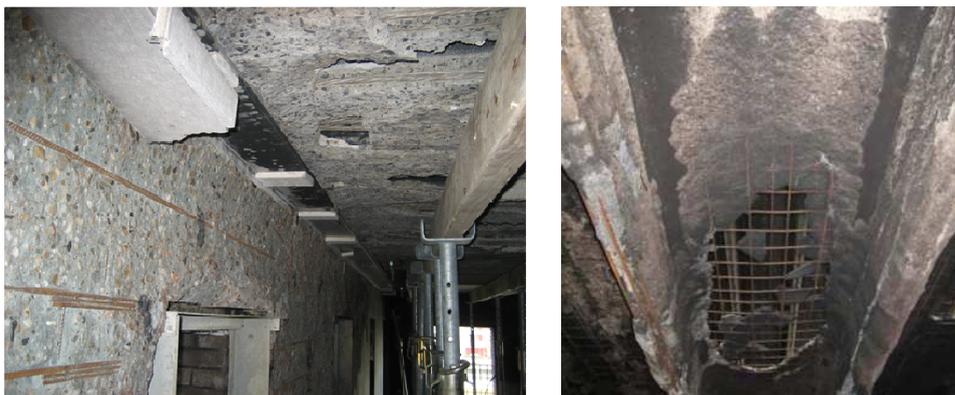
Figure 7.1. Examples of buckling spalling combined with explosive spalling on walls and floors [7.1, 7.11]

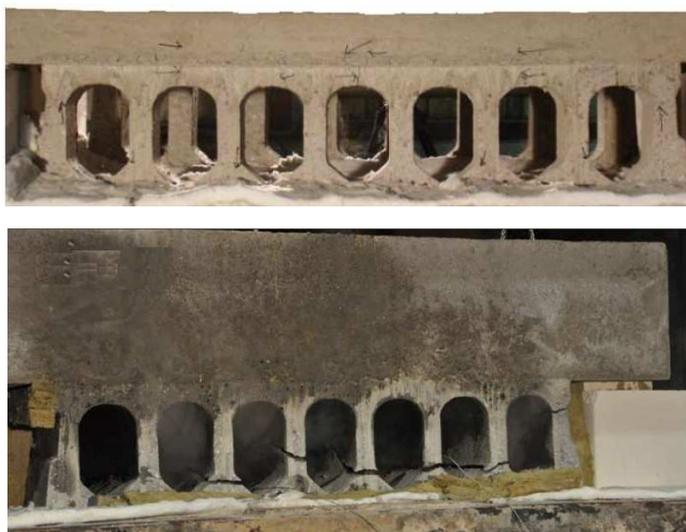
Figure 7.4. Fire tests on small samples of hollow core in The Netherlands. Up: Slices with a structural topping. Down: free part of hollow core 1.20x1.20 m² with extreme thick topping of 300 mm

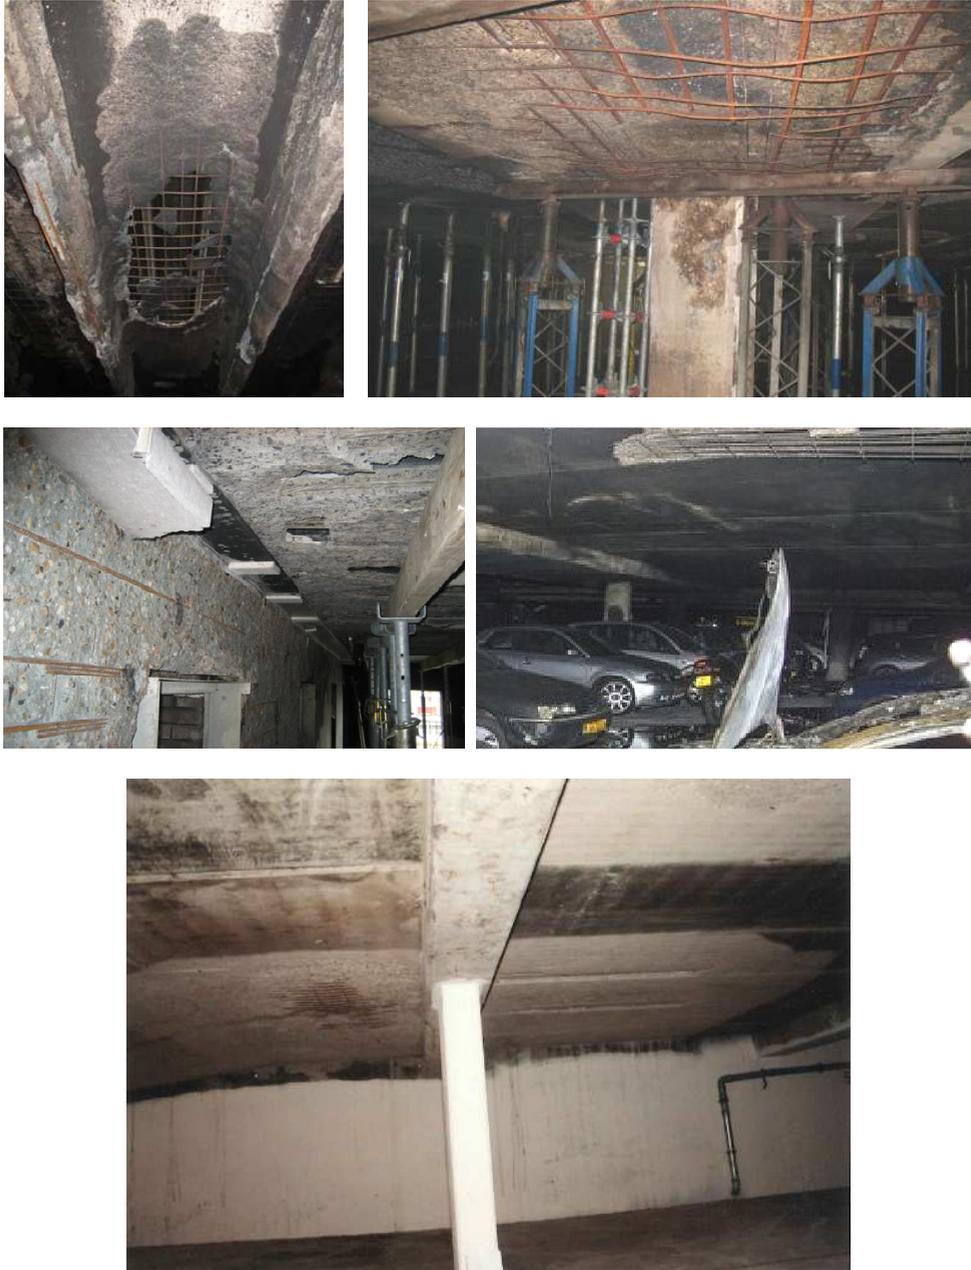
Figure 7.29. Different concrete structures; same type of damage

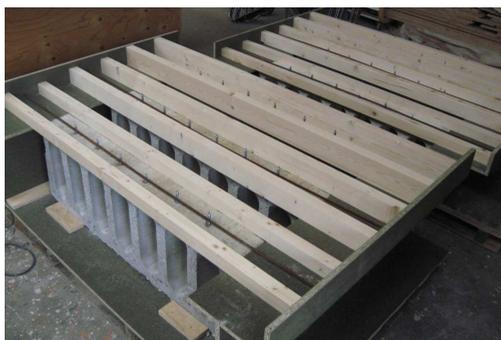
Figure 30. Production of the samples of slices of hollow core slabs
