Acta Astronautica

Can a pile of scrap unmask a new high technology? The A4/V-2 No V89 *Bäckebo-torpeden*

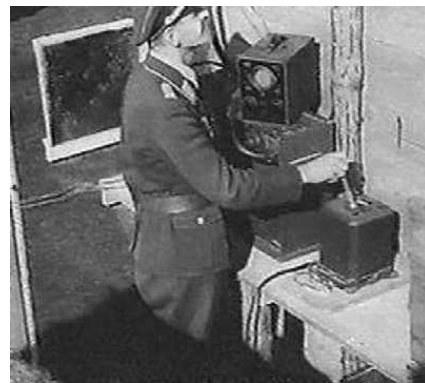
Fig. 3. Wasserfall joystick guidance system.

directly beneath the war head compartment. The purpose of this additional (Fig. 5c) equipment was to test the guidance system of the Wasserfall anti-aircraft missile also under development at Peenemünde. Wasserfall was guided by sight with a joystick (Fig. 3). The A4/V-2 No V89 was for the initial part of the flight to be guided in a zigzag course around the normal 70°E direction, which would take the rocket out over the Baltic and south of the island Bornholm.

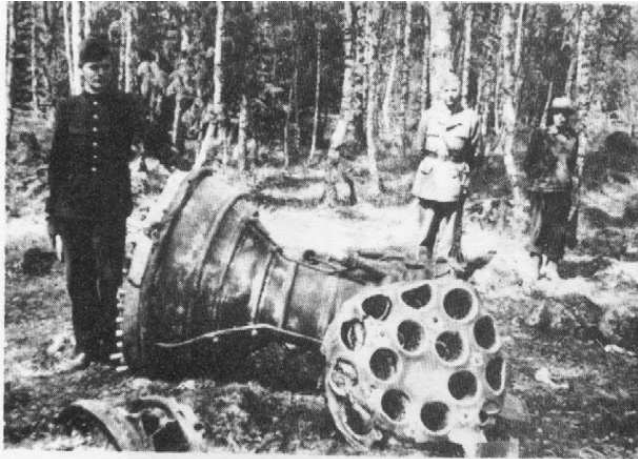
Fig. 4. Rocket engine at the site of impact.
Source: Kjellson, Ref. [9].

Fig. 8. Reaktionsaggr., huvudbrännaren

The rocket engine was of “huge” dimensions with a mass of 450 kg and with the exhaust nozzle opening of 735 mm and a length of 1.7 m (Figs. 4 and 5b). The engine was equipped with 18 injectors for the oxidiser and the fuel, and some fuel was fed into the lower end of the nozzle for regenerative cooling. The estimated chamber pressure was 16–20 atm and the thrust 28 t. With a constant thrust the propellant consumption would be about 11 t for a total launch mass of 15 t. According to Prof. Boestad this would result in a max altitude of 120 km and a max speed of 1400 m/s and is also in accordance with the actual range of some 350 km. However with a regulated thrust for better propellant efficiency the consumption would be only 4.8 t for an overall mass of 8 t, but the altitude and range would not correspond to the actual values for an engine operating time of some 60 s.

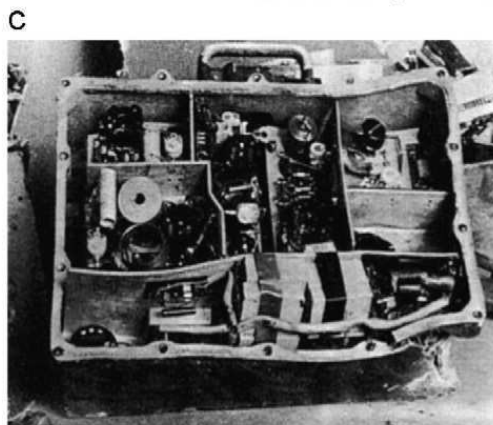
Fig. 5. (a) Reconstruction at FFA, (b) Rocket engine reconstruction at FFA and (c) Reconstruction at FFA. Receiver and transmitter.
Source: Kjellson, Ref. [9].

Fig. 33. Huvudbrännaren

Modtagare (tv); sändare (t/h) och likriktare (nedre)

and reconstruction (Fig. 5) of what was now defined as an “aerial torpedo” (*Lufttorped* and thus the final Swedish name “*Bäckebo-torpeden*”) started on July 4, 1944 at Flygtekniska Försöksanstalten, FFA (Military Aeronautical Research Institute) in Stockholm. Head of the investigation team

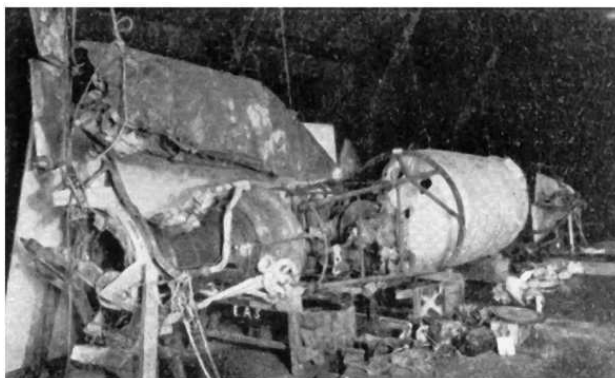
Fig. 13. Reconstruction of the A4/V-2 No V89 from Sweden at Farnborough. Source: Ref. [15].

When this test V-2 fell in Sweden, the parts were flown to England and reconstructed at Farnborough. By this means, we knew a great deal about V-2 before the first one was fired against London.

The debris were investigated and assembled in a classic fashion known from reconstruction methods after an aircraft accident (Fig. 13). This final reconstruction at RAE revealed the missing major elements of the upper (alcohol) fuel tank which would explain the shorter length and lower mass in the Swedish report.

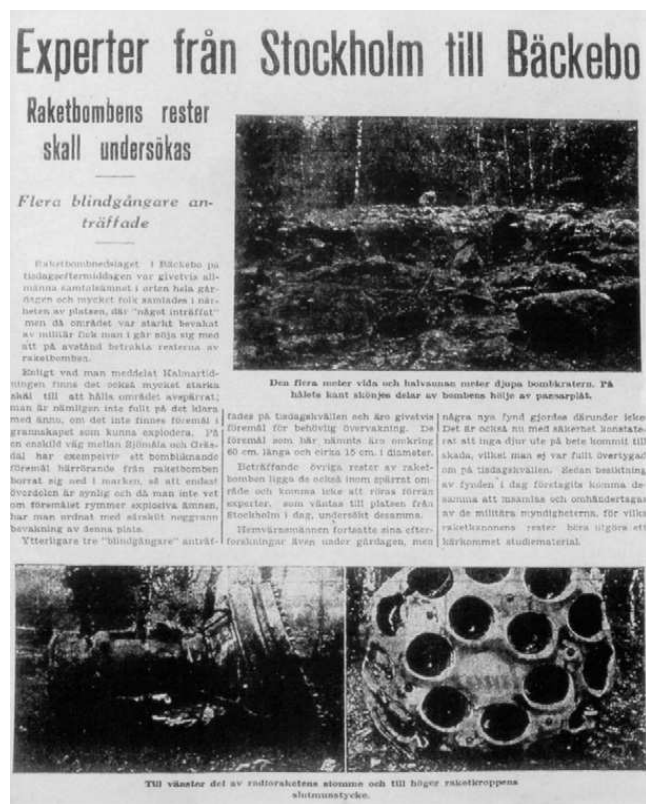
Fig. 16. Kalmar Läns Tidning June 15, 1944. Source: Ref. [17] via Royal Library, Sweden.

That the press were not yet familiar with rockets is evident from the text of the lower two photos in Fig. 16. The left one, the rocket engine, is titled the “Rocket Structure” and the right one, the rocket engine fuel injector head, “Rocket Body End Nozzle”. These photos

The reports made by Swedish [9,10] and British [12,13] investigation teams were all to be classified as top secret. But despite this, information and some pictures of the rocket (rocket engine) were published in the local and national Swedish press in the day's right after the incident. Only one article, on June 15, 1944, contained photos (3) from the crash site (Fig. 16) [17].
