HOVERCRAFT TRIALS ON SONG-HUA RIVER (ESSAI D'UN AÉROGLISSEUR SUR LA RIVIÈRE SONG-HUA)

Zhao Jian and Gu Xiong, Marine Design and Research Institute of China

ABSTRACT

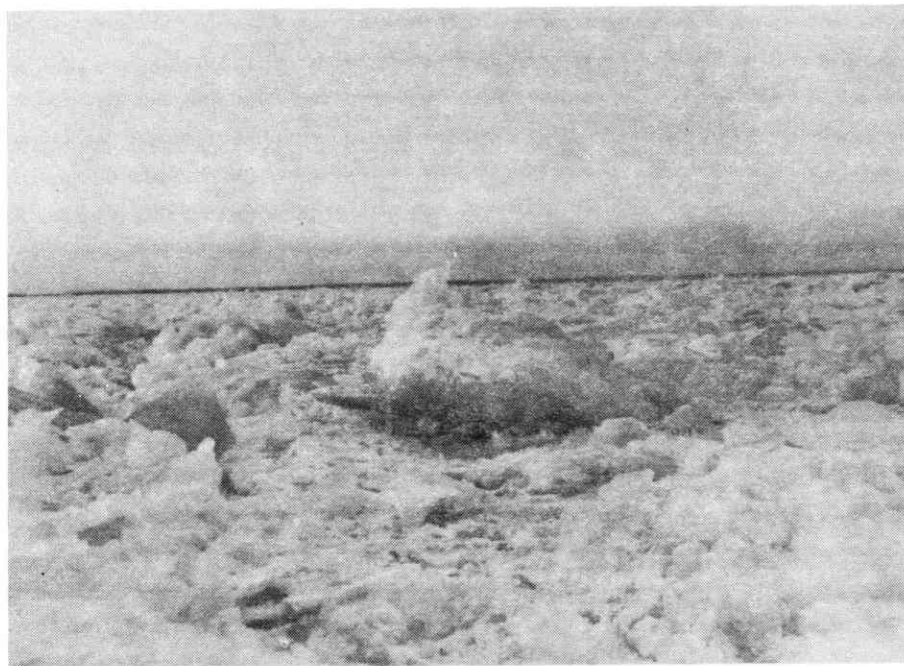
Figure 1. View of Ice Surface on the River

The rivers in the higher latitudes of northeast China remain frozen from October to May each year. Horses, persons and vehicles may cross when the rivers are fully frozen. During May and October, the thawing and freezing periods, the temperature differences between day and night are very large. This results in the ice surface fracturing during the day, with ice pans floating away. The surface is thus very unstable making it dangerous for crossing. At night, the frigid wind causes the floating ice to accumulate into ice rafts with individual floes overriding each other resulting into sharp crests pointing downwind (figure 1).

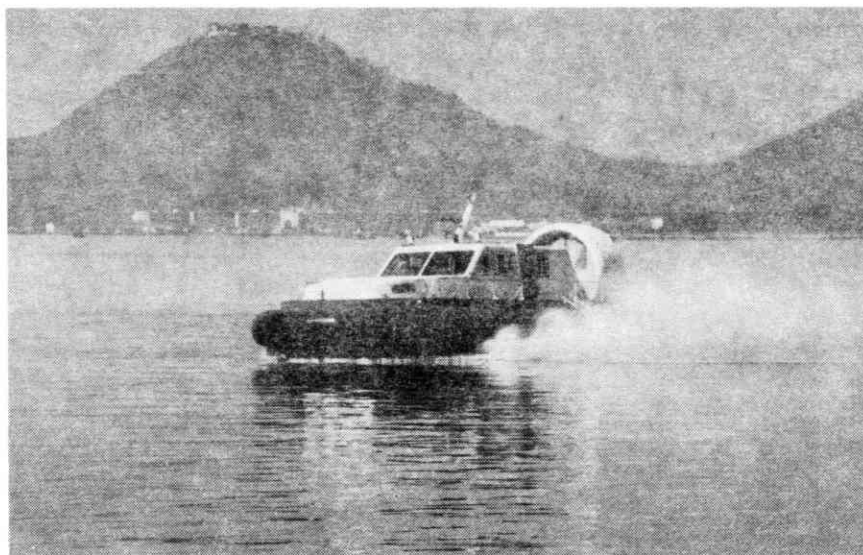
Figure 2 MARIC 7210 Hovercraft

The leading particulars of the test hovercraft MARIC 7210, shown in figures 2 and 3, are as follows:

A Deutz air cooled diesel type BF6L913 rated up to 198 hp at 2500 rpm is mounted behind the cabin to drive a five bladed fixed pitch GRP air ducted propeller with a diameter of 1.80m

A Deutz air cooled diesel type BFL913 rated up to 198 hp at 2500 rpm is mounted forward to drive an aluminium centrifugal fan with a diameter of 1.20m
