Warcop

Flood Incident Investigation Report

Warcop, Cumbria

Flood Event 5th December 2015

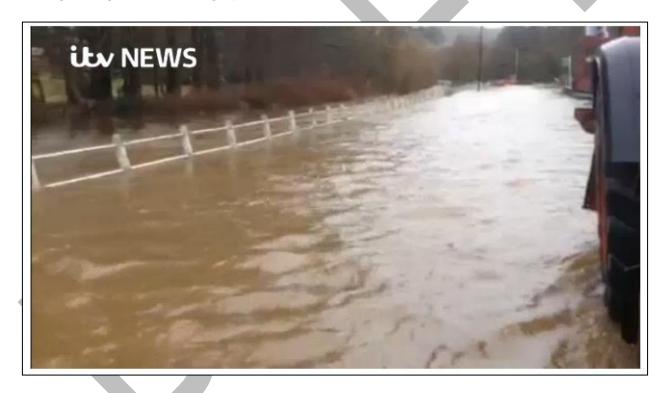
OS NGR NY 74696 15402

On the morning of the 5th December 2015 Warcop was affected by severe fluvial flooding from the Lowgill Beck and the Crook Beck (**Photograph 1** and **Photograph 2**). The first reported incidents of property flooding occurred at 04:30 hours and the flood reportedly peaked between 19:30 hours and 21:30 hours later that day. The severity and magnitude of the flood flows on the Lowgill Beck resulted in flood damage to the coping and parapet of Warcop Bridge (**Photograph 3** and **Photograph 4**).

Photograph 1: Fluvial flooding on Brookside during the 5th December 2015 Flood Event Source: ITV [http://www.itv.com/news/border/update/2016-01-08/watch-flooding-in-warcop/]

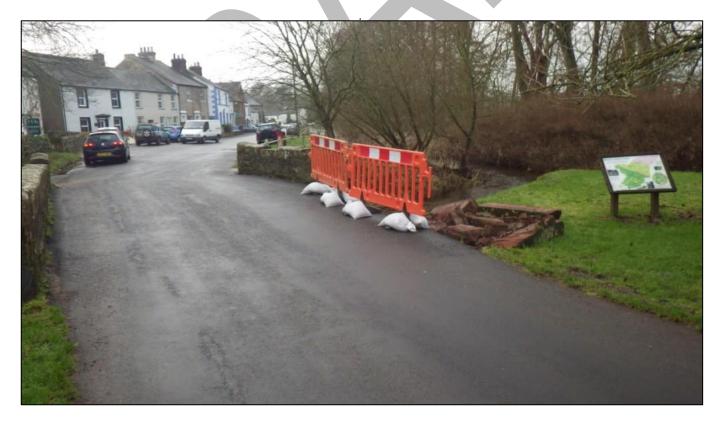
OS NGR NY 74800 15456

Photograph 3: Extent of damage on Warcop Bridge looking downstream 5th December 2015, no timestamp

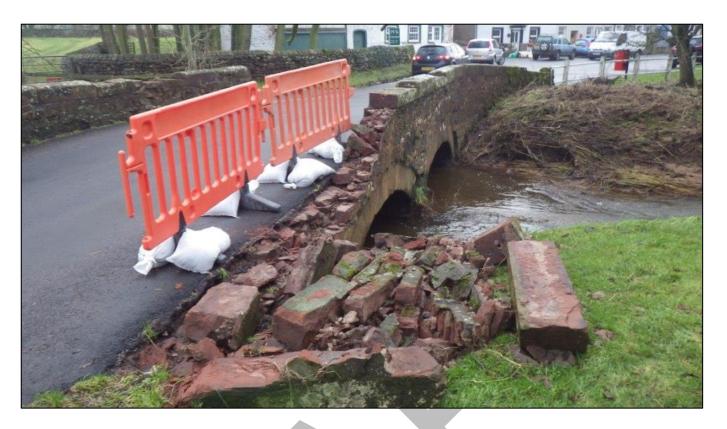
OS NGR NY 74800 15456

Photograph 4: Flood Damage on Warcop Bridge over the Lowgill Beck, looking south 15th December 2015, no timestamp

Brookside Road passes over the Lowgill Beck via a small twin arch bridge ('Warcop Bridge' as shown in **Photograph 9**). This structure has a very limited flow capacity due to low soffit levels relative to river bed levels. The limited capacity of this structure resulted in floodwater bypassing the structure and damaging the coping and parapet due to the magnitude of the flood flows (as shown previously in **Photograph 4**). At the time of the site visit the flood damage had been repaired and the structure restored to its original condition.

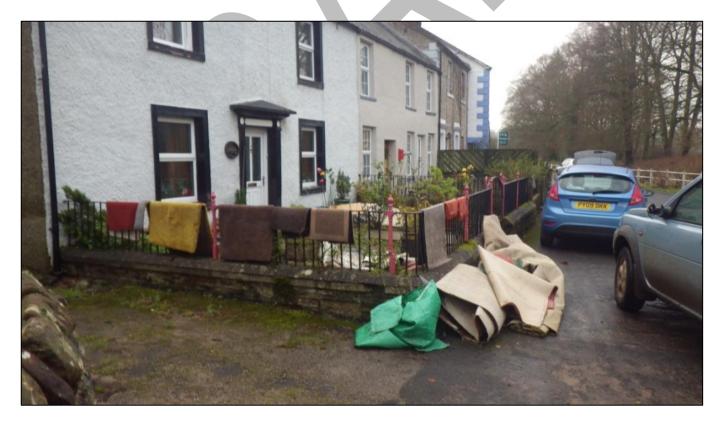
OS NGR NY 74765 15419

The flooding in Warcop was made worse by a combination of surface water runoff from the hillside to the south of Warcop and the local sewerage system reaching capacity. The flooding incident resulted in 11 reported instances of internal property flooding (**Photograph 5**) and additional external flooding of outbuildings and gardens (**Photograph 6**).

Photograph 5: Residential property flooded on Brookside 15th December 2015, no timestamp

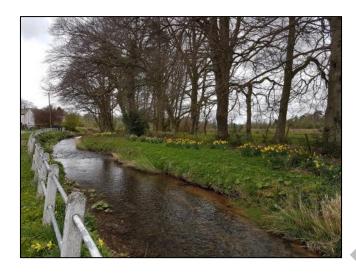
OS NGR NY 74735 15424

The Lowgill Beck is flanked by relatively flat floodplains which are not significantly elevated above the dry weather flow in the watercourse (**Photograph 7**). The floodplains were lightly vegetated and were well maintained at the time of the site visit. Property thresholds on Brookside Road were observed as being only slightly higher than road level which may result in an increased level of flood risk to these properties (**Photograph 8**).

Photograph 7: Crooks Beck looking downstream

Photograph 8: Property thresholds on Brookside Road

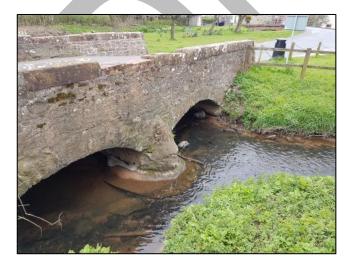
OS NGR NY 74823 15493

A larger arch bridge spans the Crooks Beck immediately north of Warcop Bridge ('New Warcop Bridge'). This structure has a much greater capacity than Warcop Bridge, although evidence of coping loss was observed on site (**Photograph 10**).

Photograph 9: Warcop Bridge over the Lowgill Beck

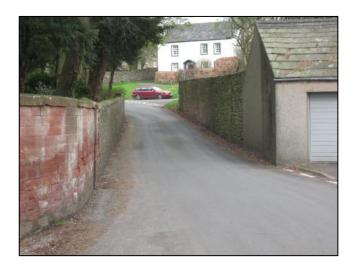
OS NGR NY 74814 15517

There are a number of surface water flowpaths leading into the centre of Warcop due to the topography of the wider river valley (as shown in **Photograph 11**, **Photograph 12** and **Photograph 13**). A significant surface water flowpath was observed by local residents on Shoregill during the 5th December 2015 flooding incident (not pictured) as surface water exceeded the capacity of the local drainage system during the event. This surface water flooding was compounded by blocked drains and gullies in this area and combined with the fluvial flooding on Brookside.

Photograph 11: Potential surface water flowpath on the B9259

Photograph 12: Potential surface water flowpath on the B9259

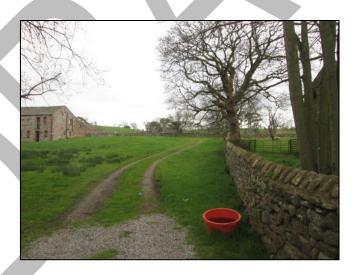
OS NGR NY 74769 15403

Photograph 13: Potential surface water flowpath near Lane Cottage
