Accessibility Audit

Kingsway Primary School
Valley Gardens
Gloucester
GL2 2ZZ

Date 13/11/2013

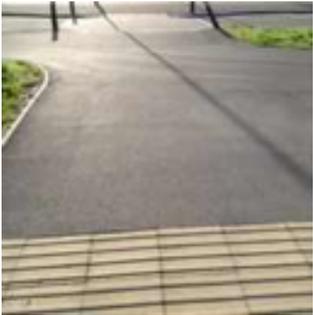
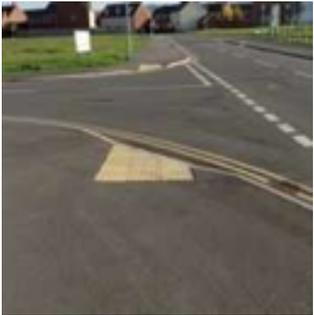
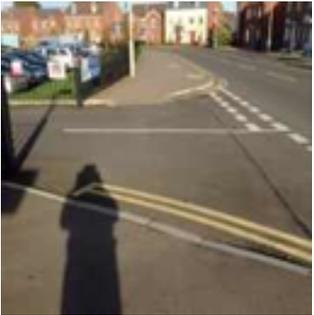
Question	Response	Details
<p>1.2 - Route free of kerbs? Do crossings on approach have tactile paving? If there are pedestrian crossings, do these have turn cones to aid people who are DeafBlind?</p>	<p>No</p>	<p>There is no tactile warning paving on approach to the car park to aid people with impaired vision.</p> <p>There are dropped kerbs provided around the site and they are clearly defined for wheelchair users.</p>
<div style="display: flex; justify-content: space-around;"> <div style="text-align: center;">

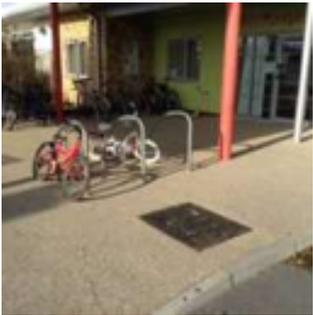
<p>Appendix 13</p>

Question	Response	Details			
<p>1.6 - Free from hazards such as bollards, litter bins? Are planting features kept to a minimum and are they colour contrasted?</p>	<p>No</p>	<p>All door barriers and bike racks are not suitably colour contrasted against the background to aid people with impaired vision.</p> <p>The low level planting boxes and small seats needs to be made more visible by e.g. back rest/high level plantings as they could cause a stumbling/trip hazard and they are not suitably colour contrasted against the background.</p> <p>There are numerous trip hazards such as bikes, toy equipment and net poles.</p>

PRIORITY B				
1.6	All door barriers and bike racks are not suitably colour contrasted against the background to aid people with impaired vision.	Add colour contrast to the door barriers and bike racks.	M	
	The low level planting boxes and small seats needs to be made more visible by e.g., back rest/high level plantings as they could cause a stumbling/trip hazard and they are not suitably colour contrasted against the background.	Remedial works should be implemented to remove the trip hazards. In the short term the low level planting boxes and small seats should be highlighted/contrasted. In the long term these needs to be protected to avoid a potential hazard.		
	There are numerous trip hazards such as bikes, toy equipment and net poles.

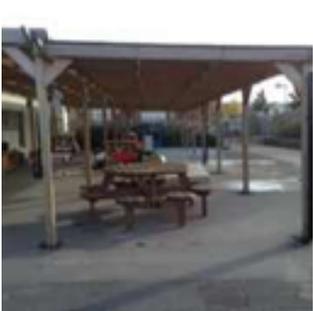
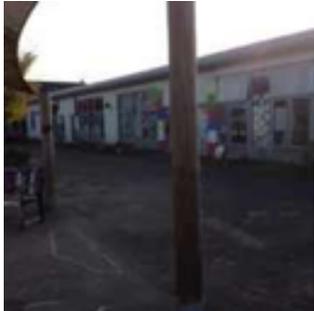
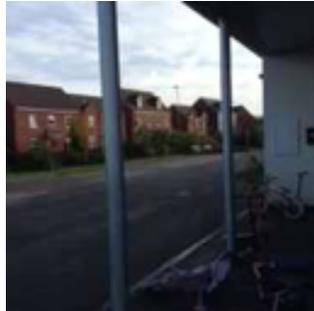
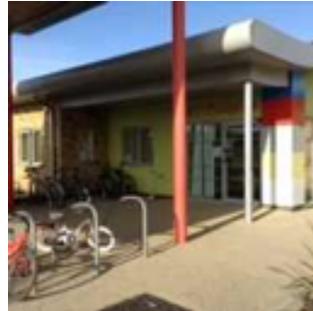
Question	Response	Details
1.7 - Free from hazardous building features such as outward-opening doors, windows or overhangs? Do columns or structural posts have markings at two heights?	No	Numerous structural posts supporting the canopy do not have colour contrast or have markings at two heights in accordance with BS8300.
<div style="display: flex; justify-content: space-around;"> <div style="text-align: center;">

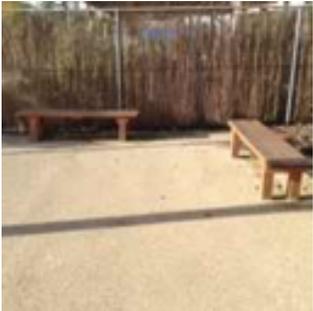
<p>Appendix 18</p> </div>

1.8 - Adequate seating provided along routes? Is there seating where parents wait to pick up / drop off their children?	No	There are seats provided between the main site entrance and the main reception entrance to provide people with ambulant disabilities a short rest before entering the school however they do not feature armrests.
<div style="text-align: center;">

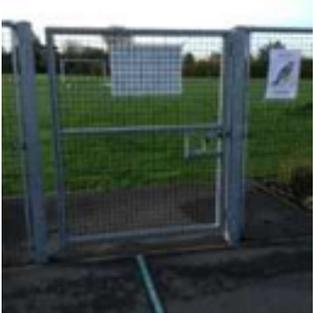
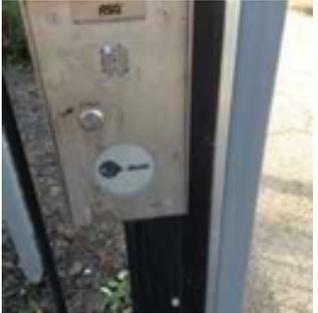
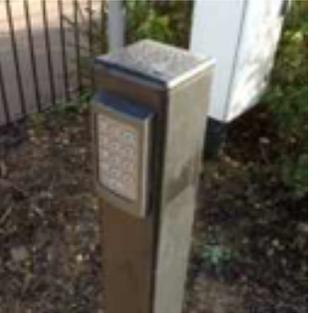
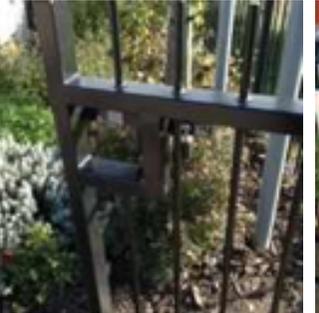
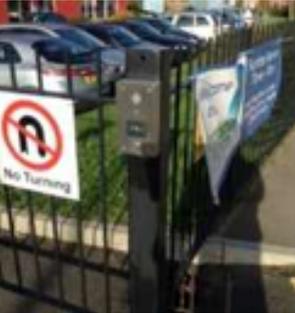
Question	Response	Details		
<p>1.9 - Are entrance gates appropriately colour contrasted and do intercoms have accessible features?</p>	<p>No</p>	<p>All gates do not have suitable colour contrast to the controls and surround to aid people with impaired vision.</p> <p>Two site entrances - There is no LED display provided to aid people with impaired hearing. The buttons lack colour contrast against the background to aid people with impaired vision. The buttons are not positioned too high off the ground level making them easy to reach for wheelchair users and people of small stature.</p>

1.9	All gates do not have suitable colour contrast to the controls and surround to aid people with impaired vision. Two site entrances - There is no LED display provided to aid people with impaired hearing. The buttons lack colour contrast against the background to aid people with impaired vision.	Add colour contrast to the controls and surround. Replace intercom which has tactile definition to the buttons and an LED display. Ensure all operating parts are within 1050mm off the landing level and ensure no obstruction below. Ensure that it is well contrasted against the background upon which it is seen. Note AD M is not descriptive on intercoms and BS8300, best practice should be referred to. In all cases when installing intercoms specialist advice should be sought.	OG

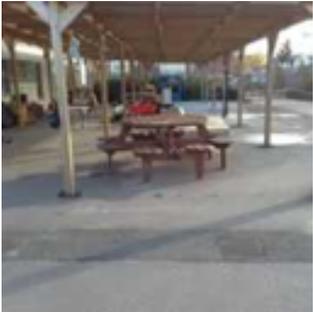
<p>Appendix 24</p>

<p>Appendix 23</p>
<p>1.10 - Is there appropriate seating within the playing areas? Is there space to the side of seating to allow a wheelchair user to park alongside a seated companion?</p>	<p>No</p>	<p>The seating has lack of colour contrast against the surroundings and there are no armrests to aid people with ambulant disabilities.</p>

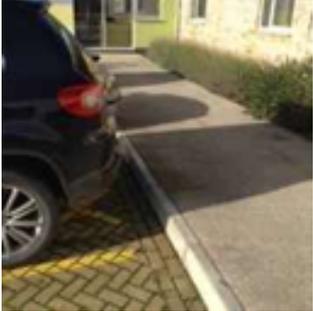
<p data-bbox="248 1102 367 1126">Appendix 25</p>

2.2 - Accessible bays clearly sign-posted from the school's car park entrance? Is there signage to the front of the bays?	No	<p>There is no signage indicating where the accessible bays are located when entering the car park.</p> <p>There is no signage to the front of any accessible bays.</p>

2.2	<p>There is no signage indicating where the accessible bays are located when entering the car park.</p> <p>There is no signage to the front of any accessible bays.</p>	<p>Refer to 15.1, it is recommended that a way finding review be undertaken for the school.</p> <p>Install signage to the front of the accessible parking spaces as per BS8300.</p> <p>Implement a management procedure to ensure the use of the accessible bays is monitored regularly to limit misuse by non-disabled motorists.</p>	M

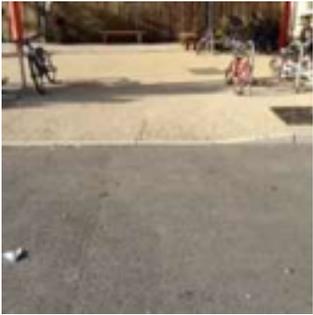
<p data-bbox="248 1264 367 1287">Appendix 27</p>

<p data-bbox="248 675 367 699">Appendix 26</p>		
2.4 - Close enough to facilities the car park serves?	Yes	
2.5 - Routes from parking area to school entrance accessible, with dropped kerbs and appropriate tactile warnings? Car park surface smooth, even and free from loose stones?	No	There is no tactile warning paving on approach to the main reception entrance to aid people with impaired vision.

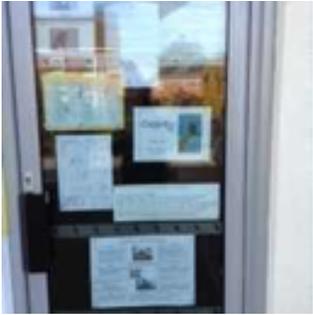
<p data-bbox="248 675 367 699">Appendix 32</p>

Question	Response	Details
5.5 - Can people each side of the door, either standing or seated, see each other and be seen? If the entrance is solid, is this due to security concerns?	No	Many doors have notices stuck over vision panels.

5.5	Many doors have notices stuck over vision panels.	Remove notices from the vision panels.	N	
5.10	There is a weather mat at the main reception which is a potential trip hazard.	Remove the door mat.	N

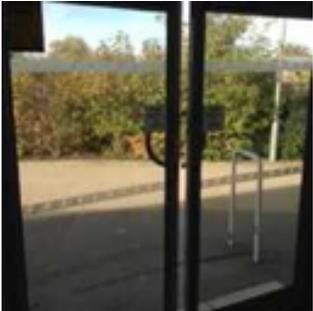
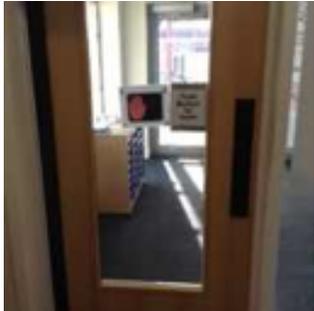
Question	Response	Details
5.11 - Are automatic doors provided? If so, do these remain open long enough for a slow-moving person to pass through? Are visual and tactile warnings provided?	No	There are power assisted doors provided to Main Reception and Rear Entrance however there are no visual and tactile warnings provided.
<div style="display: flex; justify-content: space-around;"> <div style="text-align: center;">

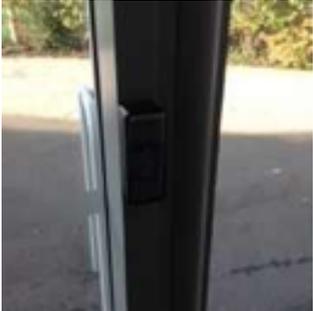
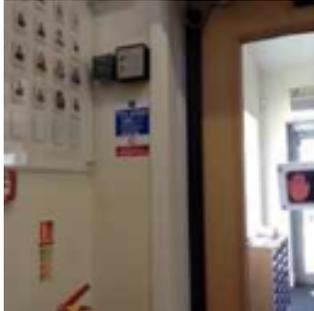
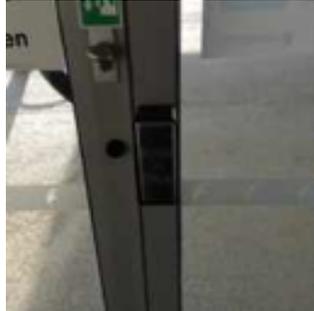
5.12 - If automatic doors are operated via a push pad rather than a sensor, are these clearly seen on approach? (internally and externally)	No	<p>All push pad buttons have no suitable colour contrast against the backgrounds to aid people with impaired vision.</p> <p>Main Reception Entrance - The push pad button is positioned too high off the floor level causing difficulties reaching for wheelchair users and people of small stature.</p>
<div style="display: flex; justify-content: space-around;"> <div style="text-align: center;">

5.12A	Main Reception Entrance - The push pad button is positioned too high off the floor level causing difficulties reaching for wheelchair users and people of small stature.	<p>Lower the push pad button to 1100mm off the finished floor level.</p> <p>Replace key pads with swipe card system.</p> <p>Implement a management procedure to ensure there is someone at the reception available to assist visitor wheelchair user to get in and out.</p> <p>According to BS8300 - Disabled people with a weak hand grip or poor co-ordination, find that using a card to open a door lock is easier.</p>	M

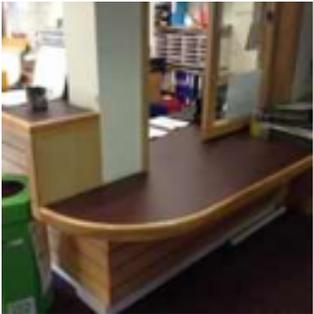
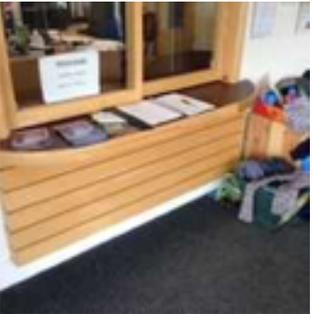
Appendix 42	Appendix 43

6.2 - Transitional lighting? Is the entrance lobby and reception area well illuminated?	Yes	
6.3 - Reception/desk/counter/ checkout suitable for approach and use from both sides by people either standing and seated?	No	Main Reception - The desk is at approx 760mm high, this has a lower section plus sufficient knee space both sides for people sitting or wheelchair users. This desk also has a 1100mm level to accommodate people standing however there is a fitted glazed panel provided.

6.3	Main Reception - This desk also has a 1100mm level to accommodate people standing however there is a fitted glazed panel provided.	The fitted glazed should be replaced with sliding glazed panels.	OG

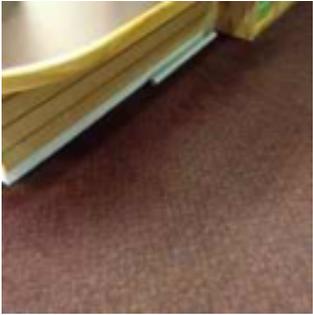
Question	Response	Details
6.4 - Surfaces suitable? Is there colour contrast to the flooring in front of the reception desk and are edges highlighted?	No	There is no contrast to the flooring to aid orientation for people with impaired vision when attempting to locate the reception desk.

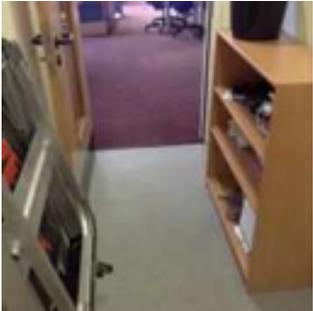
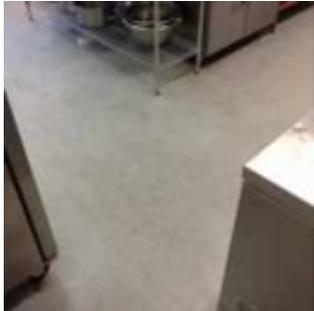
Question	Response	Details
7.1 - Corridor wide enough for a wheel chair user to manoeuvre and for other people to pass? Turning space for wheel chair users?	No	Canteen Kitchen and outside Site Manager Office - There is some furniture and kitchen units in the corridor causing potential difficulties accessing for wheelchair users.
<div style="display: flex; justify-content: space-around;"> <div style="text-align: center;">

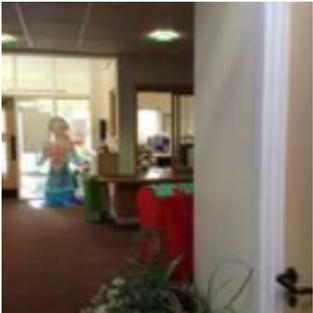
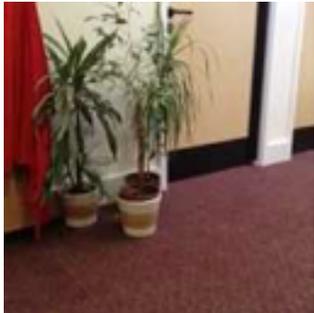
7.2 - Free from obstruction to wheel chair users and from hazards to people with impaired sight? Are there any internal columns that have a lack of colour contrast?	No	<p>There is a model aeroplane hanging from the ceiling near Main Reception which could cause a potential impact injury for people with impaired vision because they may not be able to detect the hazard with their assistance cane.</p> <p>Main Reception - The plant pots positioned within the corridor are a potential trip hazard for people with impaired vision.</p>
<div style="display: flex; justify-content: space-around;"> <div style="text-align: center;">

7.2	There is a model aeroplane hanging from the ceiling near Main Reception which could cause a potential impact injury for people with impaired vision because they may not be able to detect the hazard with their assistance cane.	A management procedure should be implemented to remove the hazards.	N	
	Main Reception - The plant pots positioned within the corridor are a potential trip hazard for people with impaired vision.

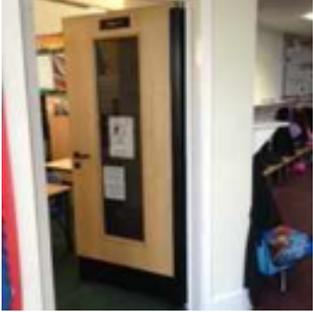
<p data-bbox="248 639 365 663">Appendix 51</p>		
8.2 - Glass door: clearly visible when closed? Are manifestations suitably colour contrasted against the background?	N/A

Question	Response	Details
8.1 - Distinguishable from surroundings?	Yes	The wooden doors against white walls are suitably contrasted to aid people with impaired vision.

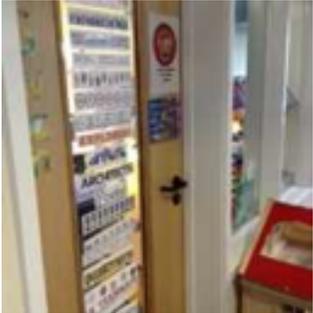
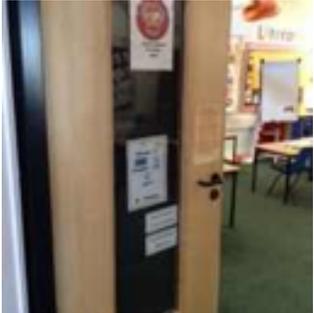
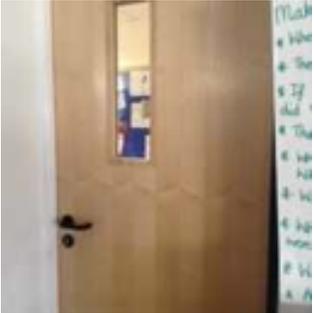
Question	Response	Details
<p>8.3 - Can people each side of the door, either standing or seated, see each other and be seen? Are vision panels kept clear of temporary notices? (for an example classroom entrances)</p>	<p>No</p>	<p>Medical Room door has a vision panel that is too high off the floor level.</p> <p>Many vision panels have notices stuck over them.</p> <p>Vision panels need to be included in frequently used doors where privacy (toilets etc) is not required, with a minimum visibility zone between 500mm and 1500mm from floor level and located at the side of the leading edge. Glass should comply with BS6206.</p>
<div style="display: flex; justify-content: space-around; align-items: center;"> <div style="text-align: center;">

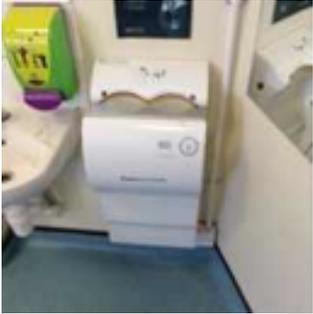
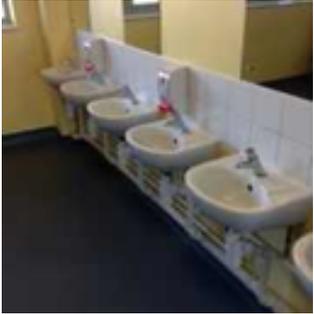
Question	Response	Details
12.1 - Lobby door light enough to open easily? Lobby of sufficient size for easy access?	Yes	
12.2 - Slip-resistant floors throughout?	Yes	Slip resistant flooring is provided throughout the toilets.
12.3 - Fittings all easily distinguishable from background? Are hand dryers and sanitary ware easily seen against their surroundings?	No	<p>Throughout WCs numerous sanitary ware and hand dryers were not sufficiently colour contrasted against the surroundings to aid people with impaired vision.</p> <p>There are air blade hand dryers provided however this may be difficult to use for those with limited manual dexterity.</p>
<div style="display: flex; justify-content: space-around;"> <div style="text-align: center;">

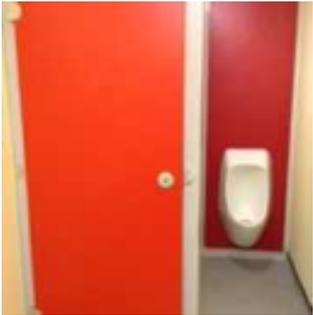
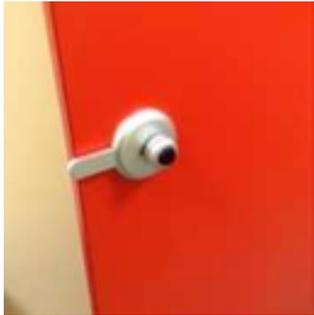
Question	Response	Details
<p>12.4 - Compartment door controls all easily gripped and operated? Are cubicle doors suitably colour contrasted against the panels?</p>	<p>Yes</p>	<p>All cubicle doors are suitably colour contrasted against the surroundings to aid people with impaired vision.</p> <p>All door controls are easy to use for those with dexterity impairments.</p>
<div style="display: flex; justify-content: space-around;"> <div style="text-align: center;">

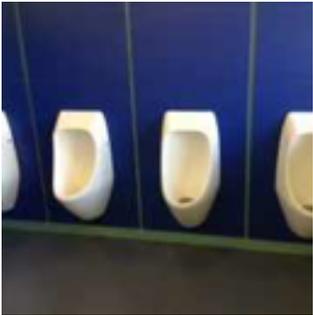
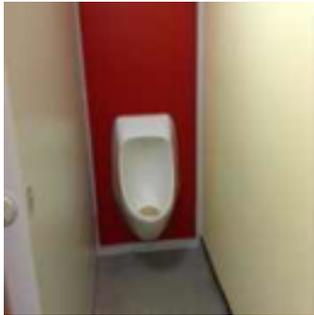
<p>Appendix 59</p> </div> </div>		
<p>12.5 - Are urinals well contrasted and do they have grab rails to assist people with ambulant disabilities?</p>	<p>No</p>	<p>There are no grab rails to any of the urinals to assist people with ambulant disabilities.</p> <p>All urinals are suitably colour contrasted against the background to aid people with impaired vision.</p>
<div style="display: flex; justify-content: space-around;"> <div style="text-align: center;">

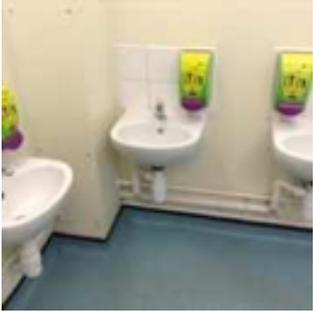
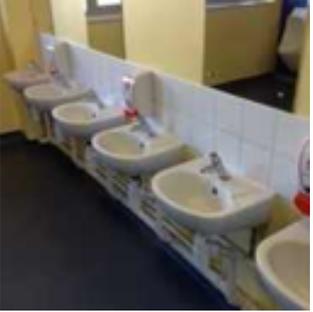
Question	Response	Details
12.6 - Are lever style taps provided within the WCs to aid people with dexterity impairments?	No	Throughout the WCs, standard and push taps are provided which are not easy to use for people with dexterity impairments.
<div style="display: flex; justify-content: space-around;"> <div style="text-align: center;">

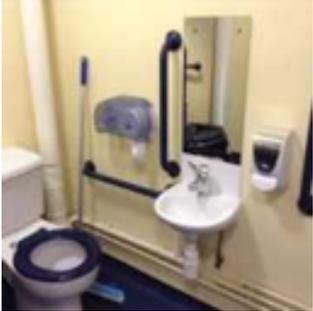
<p data-bbox="248 815 367 839">Appendix 64</p>

13.4 - Hand washing and dry facilities within easy reach of someone seated on WC? Is the hand basin suitably positioned in accordance to BS8300?	No	The hand wash basin is within easy reach whilst seated on the toilet pan. There is no hand dryer provided to aid people who may struggle to use hand towels.

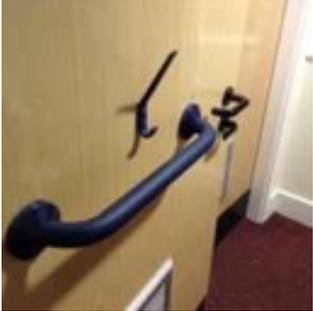
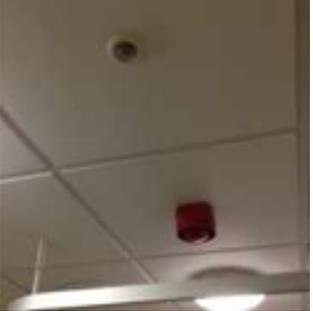
13.5 - Door controls, lock and light switch easily reached and operated? Is there a grab rail to the inner face of the entrance?	Yes	Grab rail on the door is provided. There is a lever lock that is easy to use for those with dexterity impairments. Sensor lighting is provided.

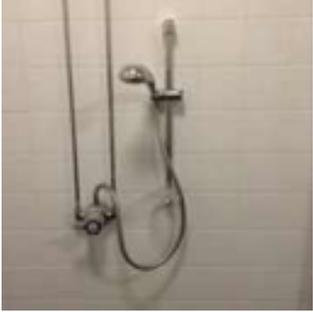
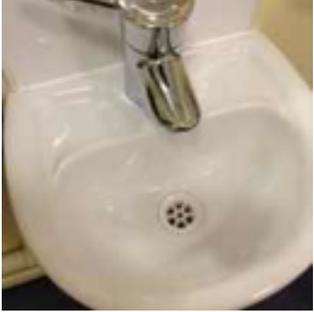
Question	Response	Details
13.6 - Tap appropriate for use by a person with limited dexterity, grip of strength?	Yes	Wash hand basin and shower control have lever taps to aid people with dexterity impairments.
<div style="display: flex; justify-content: space-around;"> <div data-bbox="152 320 465 632">

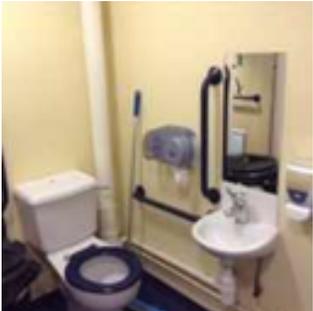
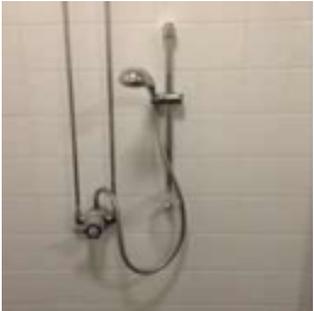
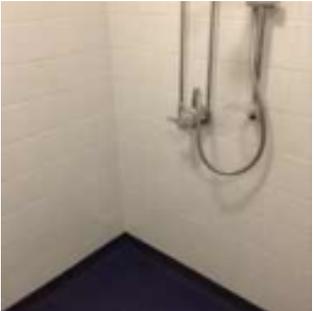
13.7 - Suitably designed grab rails fitted in all positions necessary to assist manoeuvring? Are grab rails suitably colour contrasted to aid people with impaired vision?	No	<p data-bbox="1272 703 2063 767">There are blue grab rails in the toilet pan areas and these have a suitable colour contrast against the background.</p> <p data-bbox="1272 807 2063 871">There are no grab rails provided in the shower areas and there is no tip-up seat for people with ambulant disabilities.</p>
<div style="display: flex; justify-content: space-around;"> <div data-bbox="152 906 465 1217">

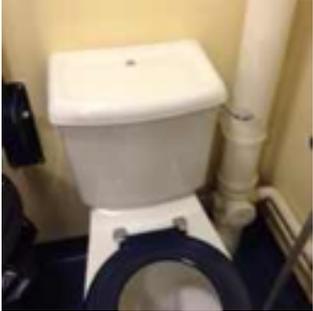
Question	Response	Details
13.8 - Is there a back rest provided to the toilet pan?	No	This accessible WC has no back support.

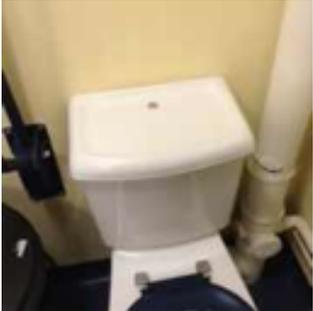
<p data-bbox="248 1086 367 1110">Appendix 73</p>

<p data-bbox="248 603 367 627">Appendix 72</p>		
13.9 - Is the flush of a suitable spatula type and is it appropriately located on the transfer side of the toilet pan?	No	This toilet pan does have a suitable spatula type flush handle but it is positioned on the wrong side of the cistern.

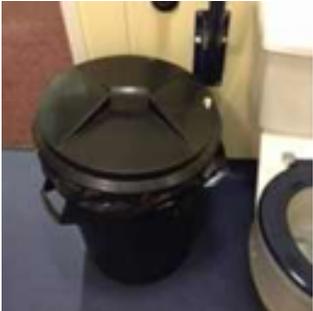
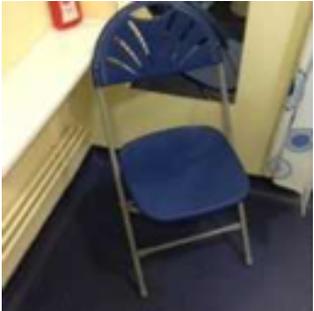
Question	Response	Details
13.10 - Is the transfer side of the toilet pan kept clear of any obstacles that may deny wheelchair users all of the transferring techniques in which an accessible WC is designed to provide?	No	On the day of the survey, a black bin and a chair were positioned within the transfer area.
<div style="display: flex; justify-content: space-around;"> <div style="text-align: center;">

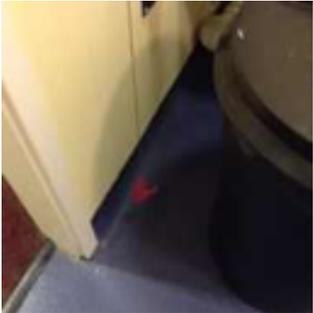
13.11 - Is there a cord alarm? Is this coloured red with two triangular bangles and easy to reach from floor level?	No	There is a pull cord alarm provided however both triangular bangles were positioned near the floor level.
<div style="text-align: center;">

13.11	There is a pull cord alarm provided however both triangular bangles were positioned near the floor level.	Reposition the bangles. According to BS8300 - An emergency assistance pull cord should be sited so that it can be operated from the WC and from an adjacent floor area. The emergency assistance pull cord, coloured red, should be provided with two red bangles of 50 mm diameter, one set at a height between 800 mm and 1000 mm and the other set at 100 mm above floor level. Implement management procedure to ensure that the alarm cord is never tied up and always hanging loose.	M

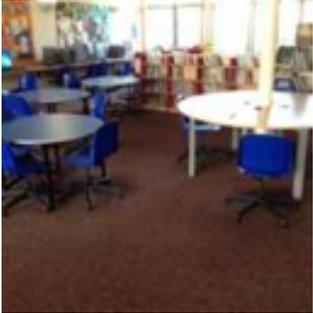
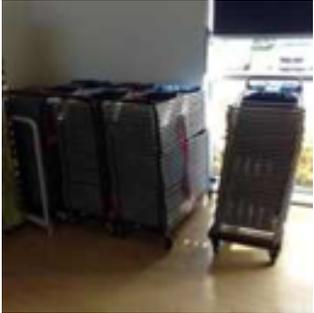
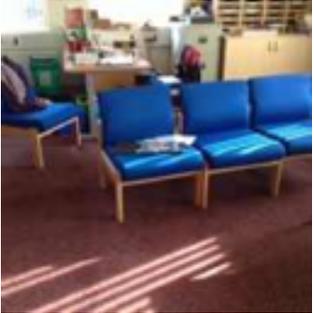
Question	Response	Details
14.1 - Are seats provided at intervals along long internal routes or where waiting likely?	Yes	
14.2 - Seats stable, with armrests and provided in a range of heights? Space for wheelchair user to pull up alongside a seated companion?	No	There are no seats with armrests provided within the Main Hall, Staff Rest Room and Library area to aid people with ambulant disabilities.
<div style="display: flex; justify-content: space-around; align-items: center;"> <div style="text-align: center;">

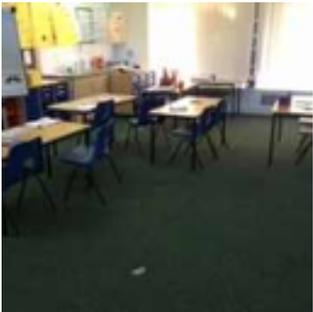
<p>Appendix 80</p> </div>

<p>Appendix 79</p> </div> </div>		
14.3 - Are a number of chairs with armrests available within each classroom?	No	There are no chairs with armrests in any classrooms.
<div style="text-align: center;">

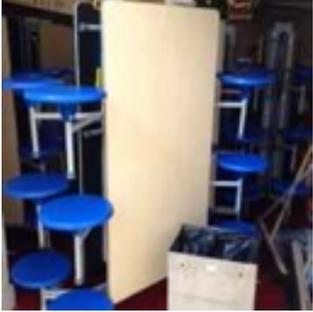
<p data-bbox="248 639 367 663">Appendix 83</p>

Question	Response	Details
14.6 - Does the dining room have appropriate seating rather than fixed seating which can be inaccessible for a range of users?	No	There is no fixed seating in the dining room however there are no seats with armrests to aid people with ambulant disabilities.

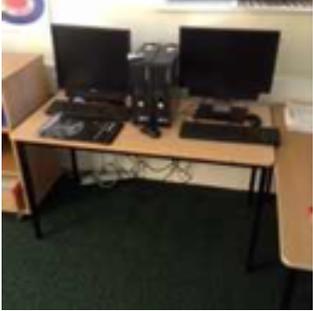
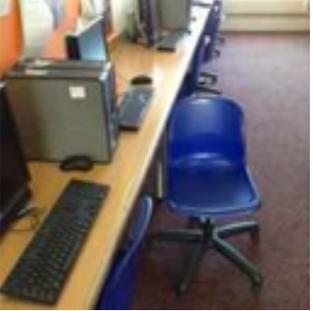
<p data-bbox="248 1265 367 1289">Appendix 84</p> <p data-bbox="568 1265 687 1289">Appendix 85</p>

14.7 - Is there a dropped counter and an induction loop available for the Library counter?	N/A	
14.8 - Where there are IT facilities i.e. within classrooms and the Library (if applicable) are height adjustable computer desks available?	No	Computer facilities are provided throughout the school. It was noticed that there are no height adjustable tables provided for wheelchair users or people of small stature.

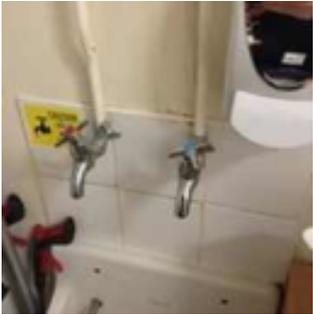
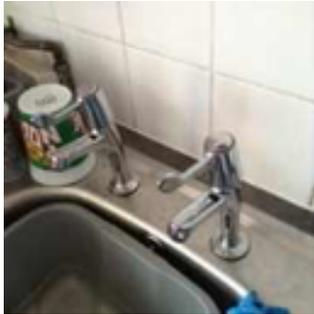
Question	Response	Details
<p>14.10 - Does the kitchen sink within the Staff Room have a lever tap to accommodate people with dexterity impairments?</p>	<p>No</p>	<p>Canteen Kitchen, classrooms and Staff Rest Room - There are lever taps provided that are easy to use for people with dexterity impairments.</p> <p>Site Manager Office - There are no lever taps provided.</p> <p>No accessible tables were identified within the employee working areas.</p>
<div style="display: flex; justify-content: space-around;"> <div data-bbox="152 528 465 842">

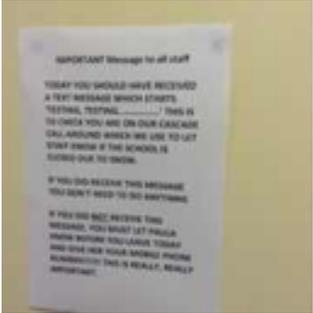
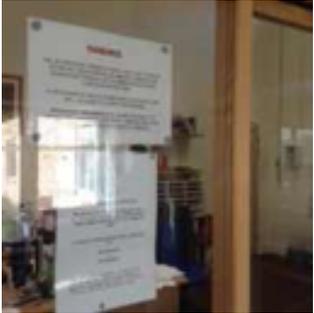
Question	Response	Details
<p>15.6 - Are notice boards well structured and the use of reflective protective covers avoided? Are temporary notices illustrated using good practice i.e. use of lower and upper case lettering?</p>	<p>No</p>	<p>Throughout the school various locations were identified where there are temporary notices typed out in capital letters.</p> <p>Temporary notices are placed behind a reflective screen making viewing difficult for those with impaired vision.</p>
<div style="display: flex; justify-content: space-around;"> <div data-bbox="152 424 465 737">

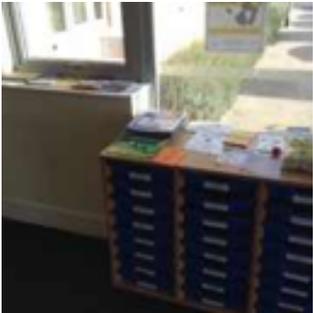
<p>Appendix 91</p> </div> </div>

<p>Appendix 90</p> </div> </div>		
<p>15.7 - Are leaflets provided at suitable heights for wheelchair users and for people of small stature? Are leaflets available in alternative accessible formats such as Braille, Moon or Large Print? Are staff aware that materials can be provided in accessible formats on request? Is facility indicated as being available?</p>	<p>Yes</p>	<p>The leaflets are positioned not more than 1200mm off the floor level make it easy to reach for wheelchair users or people of small stature.</p>

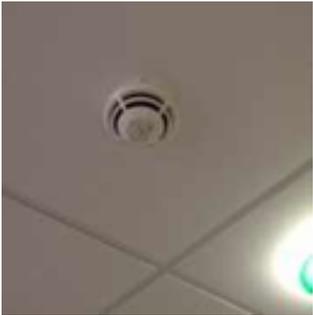
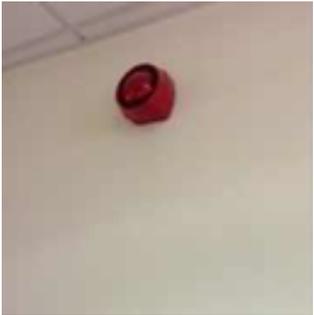
Question	Response	Details
Checklist 17 - Means of Escape		
17.1 - Audible alarm system supplemented by visual system?	Yes	There are flashing beacons provided in all Classrooms, Offices, Halls, WCs and Corridors for people with impaired hearing in the event of an emergency.
<div style="display: flex; justify-content: space-around; align-items: flex-start;"> <div style="text-align: center;">

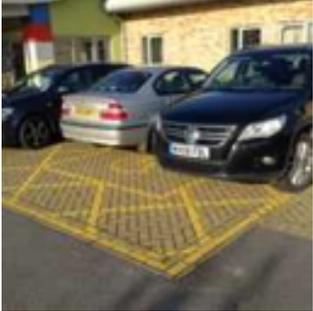
<p data-bbox="248 1102 367 1126">Appendix 97</p>

18.1 - External Routes; Including steps and ramps, kept clean, unobstructed and free from surface water, snow and ice?	Yes	
18.2 - Accessible parking; Designated spaces not used by non-disabled drivers and kept free from obstructions?	No	On the day of the survey, all accessible bays were used by non-Blue Badge Holders.
