IEA Wind Task 46
Erosion of wind turbine blades

**Leading Edge Erosion Classification
System**

Technical report

December 2022

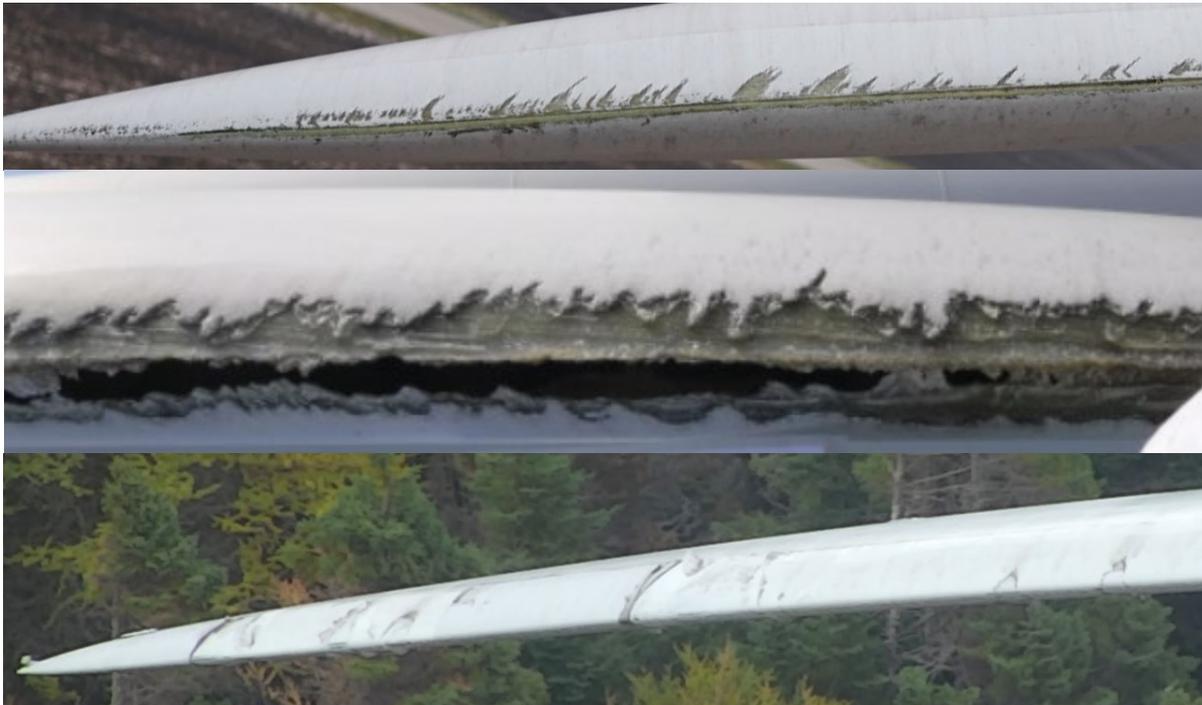
Figure 2-1 – Examples of wind turbine blade erosion damage (top - progression of leading edge erosion, middle – untreated leading edge erosion resulting in open cavity, bottom – damage to leading edge protection tape).

Despite the potential for the varying kinds of damage shown in Figure 1, the main type of damage that is classified here as leading edge erosion is caused by multiple, high-velocity impacts from hydrometeors impacting the area ($\pm 5-10\%$) around the blade leading-edge and focused on the outer one-third of the leading edge which experiences the highest relative velocities (Letson, et al. 2020).

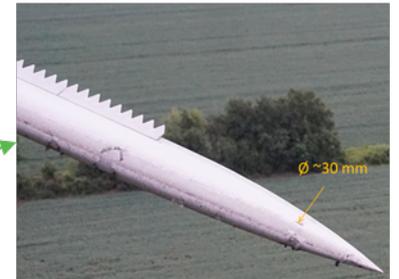
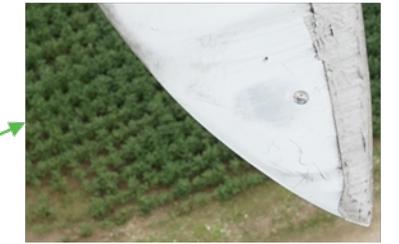
Figure 3-2 – Results of the draft erosion classification system test.

The resulting scores from the assessments of each participant are shown in Figure 3-2, where the participants have been anonymized by their type of organization and the median and variance of the scores has been tallied. The images with low variance between the participants theoretically means the system was straight-forward to apply in a standard way, whereas the results with high variance indicate that further improvements in the system are needed. The feedback and observations from this test were again incorporated into the revised system presented in the next section.

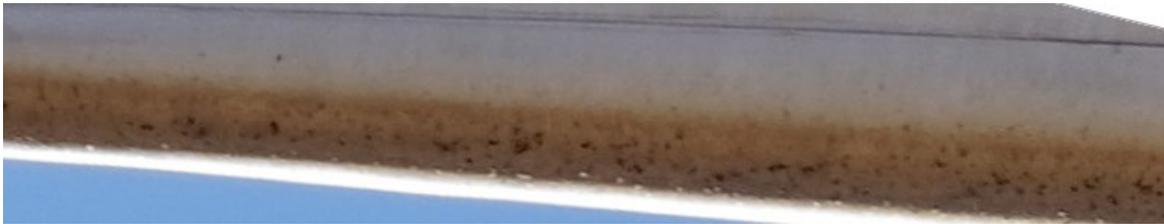
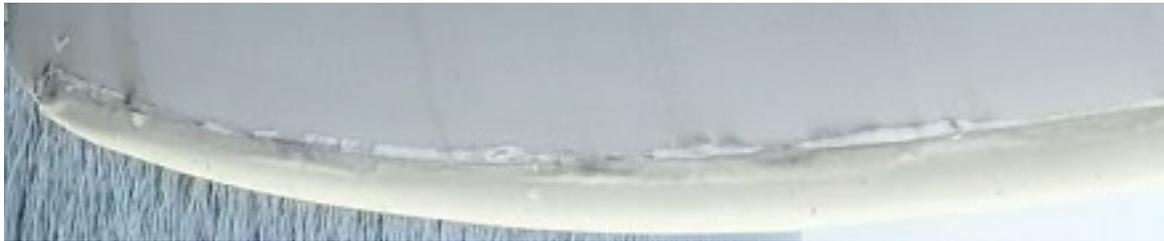
Level 1 (LEP) – “Lightly worn external coating/LEP” or “Instances of reduced LEP adhesion”

Damage threshold: individual instances $\geq 1\text{cm}^2$ & individual instances $\leq 10\text{cm}^2$

- The expectation is that the LEP is still intact and providing protection to the underlying layers.
- However, the incubation period of the LEP has ended and there are noticeable instances of localized damage on the LEP that are greater than 1cm^2 but less than 10cm^2 in area.
- Discernable peeling/reduced adhesion noted on edges of leading edge protection.

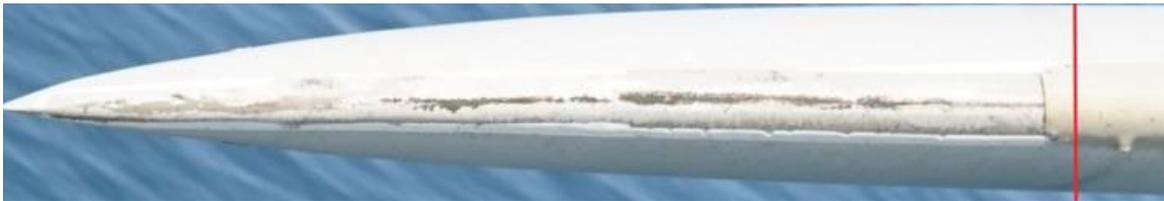
Damage threshold: destruction of LEP $\geq 1\text{m}^2$

- Destruction of the LEP is obvious over a considerable length of the leading edge.
- Adhesion failure has resulted in a considerable length of the leading edge being unprotected.

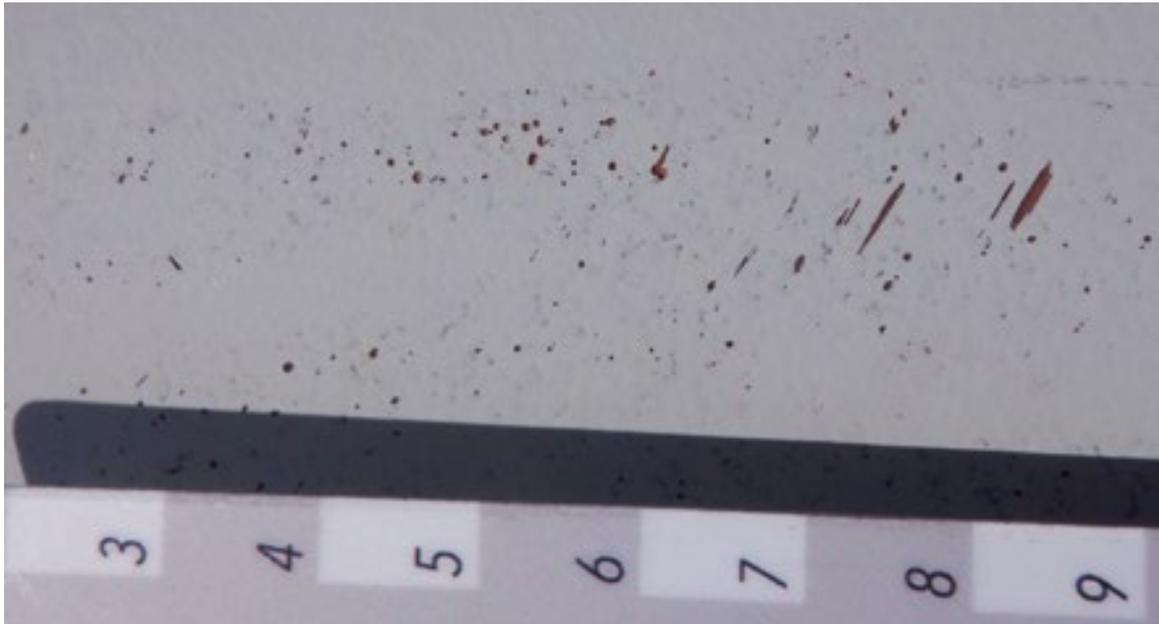
Level 1 (No LEP) – “Erosion barely visible or pinholes”

Damage threshold: individual instances $\leq 1\text{cm}^2$

- Erosion is observable from inspection imagery but is small/minor enough, such that it is not immediately discernable.

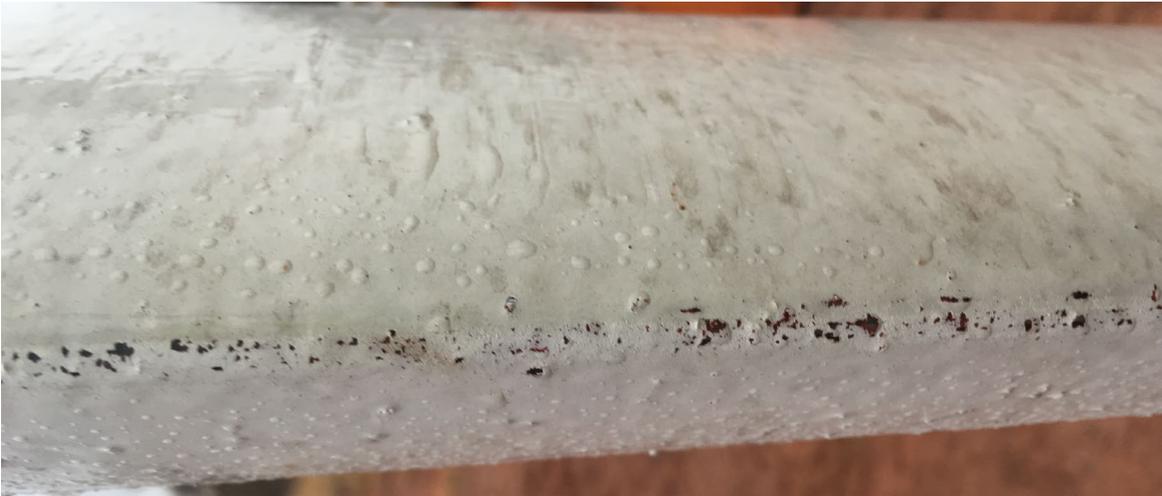
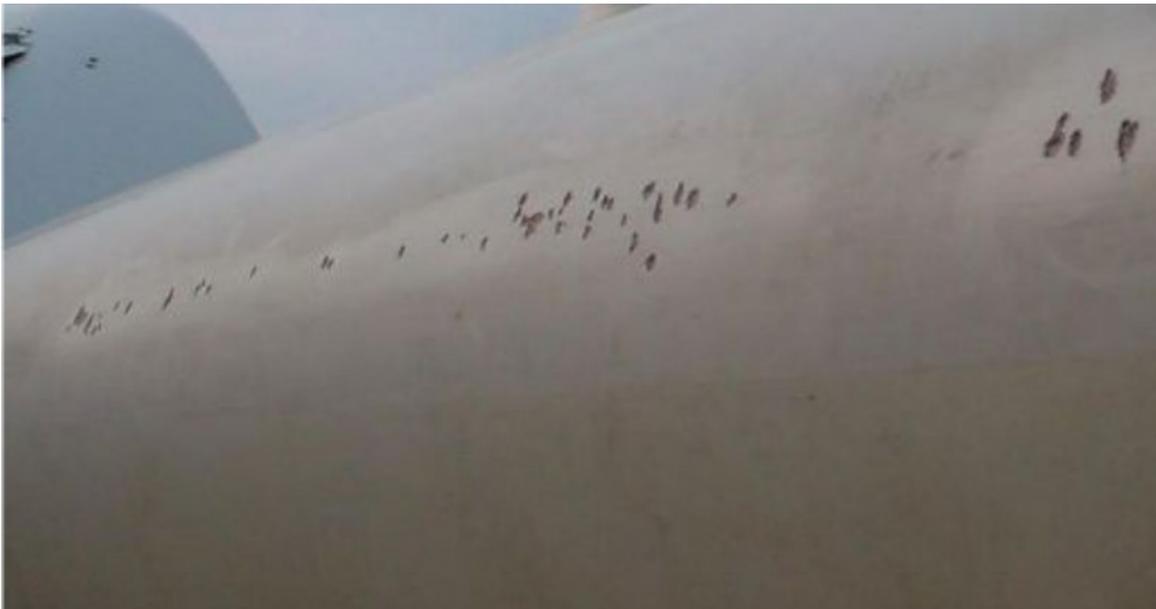
Level 2 (No LEP) – “Localized Pitting”

Damage threshold: individual instances $\geq 1\text{cm}^2$

- Multiple individual pits are noted

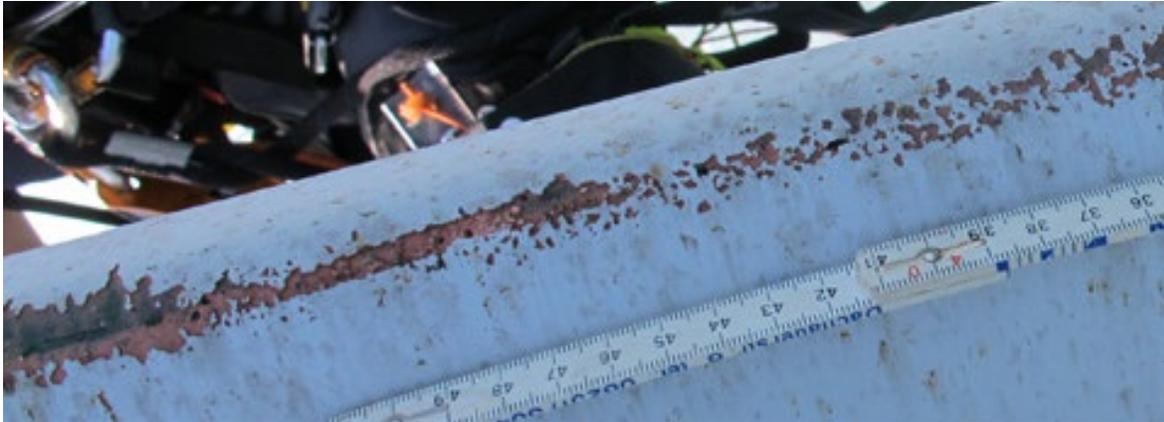
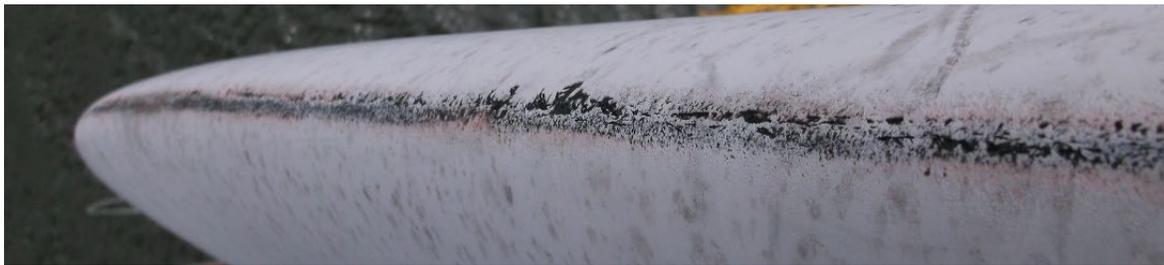
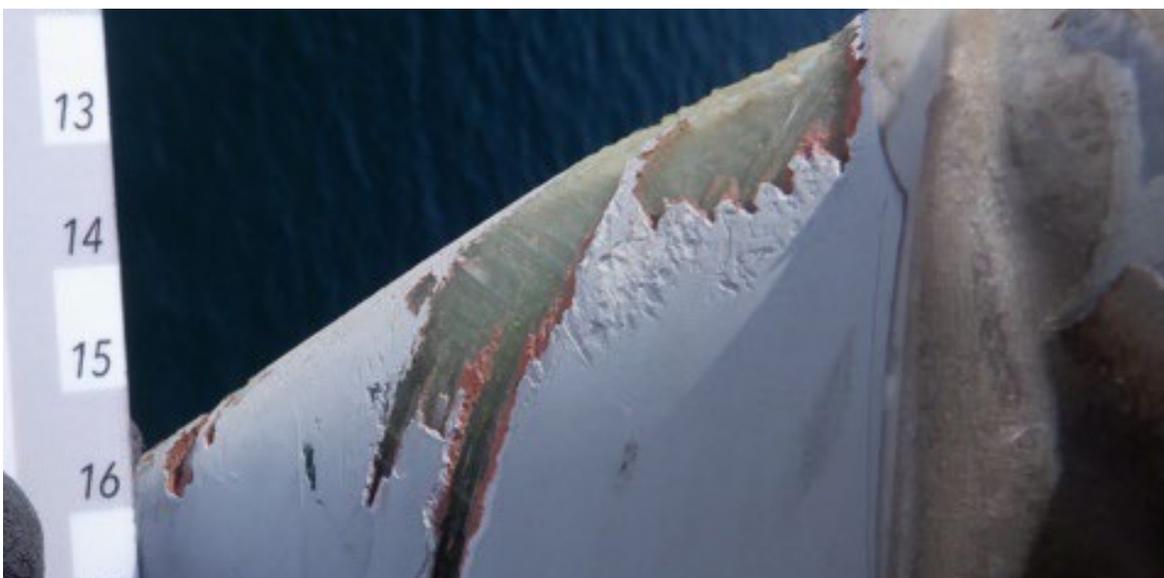
Level 3 (No LEP) – “Widespread or coherent pits, some gouges”

Damage threshold: erosion of topcoat $\leq 10\text{cm}^2$

- Pits are widespread and cohesive over a significant continuous length of the blade.
- Underlying composite layers may be clearly visible but not over a large overall area.

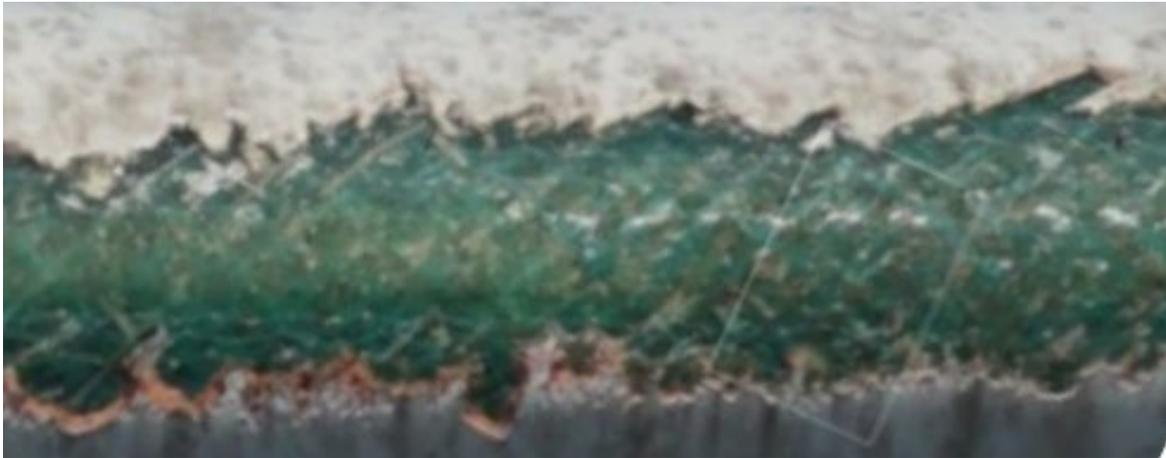
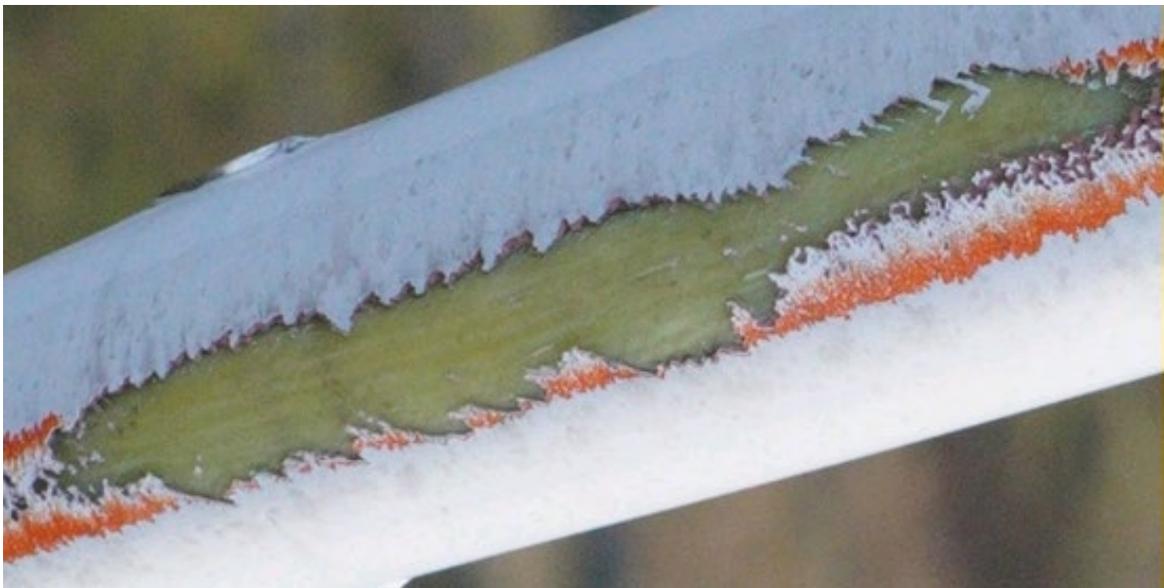
Level 4 – “Erosion of topcoat with immediate layer underneath visible and exposed”

Damage threshold: erosion of topcoat $\geq 10\text{cm}^2$; erosion of laminate $\leq 1\text{cm}^2$

- Erosion has worn away to the laminate such that the filler layer or immediate laminate is observable over an area greater than 10cm^2
- Damage to the substrate is either not entirely obvious or sufficiently small/minor.

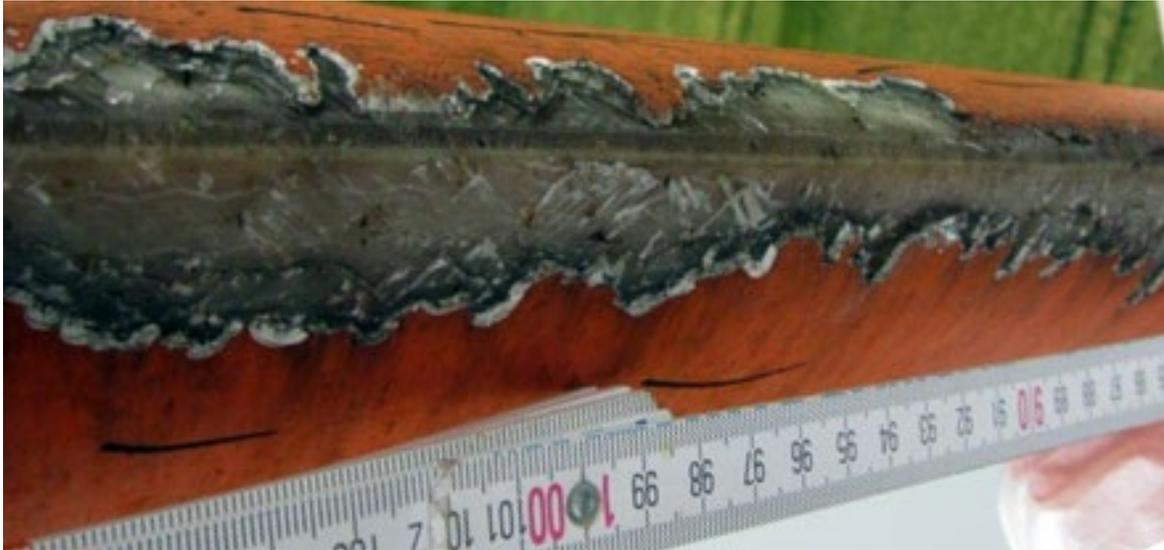
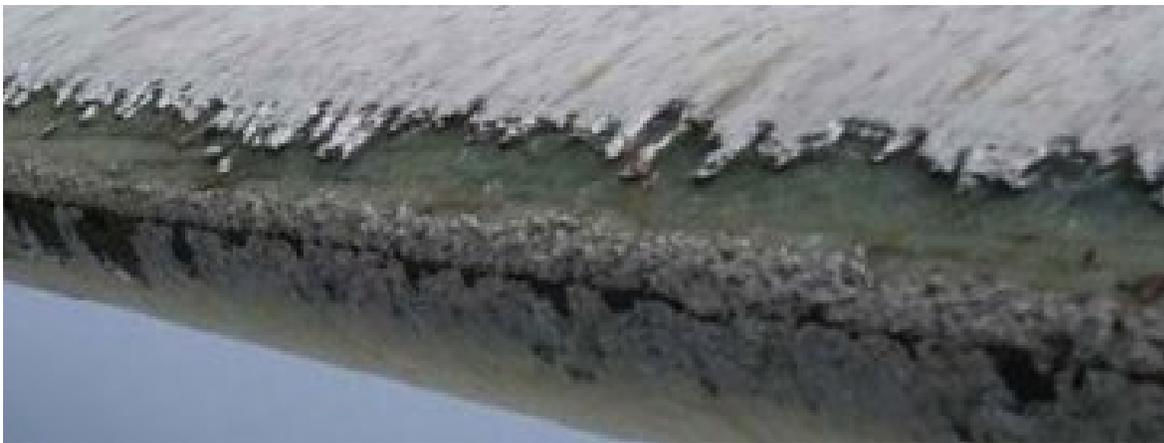
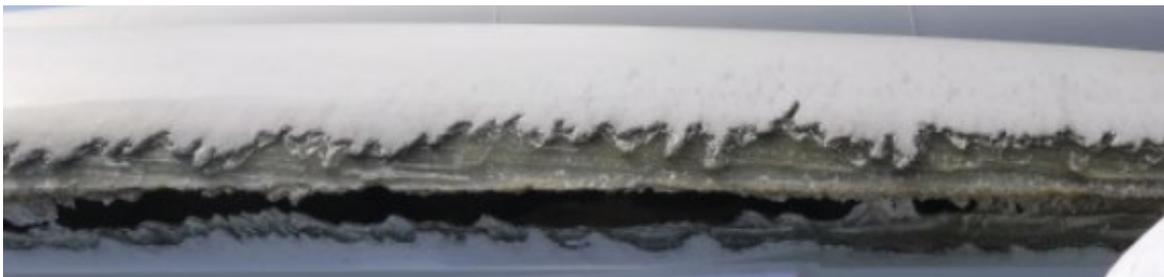
Level 5 – “Notable damage to substrate”

Damage threshold: erosion of laminate $\geq 1\text{cm}^2$

- Obvious damage to the laminate layers.
- Any damage beyond the threshold will still be classed as Level 5.

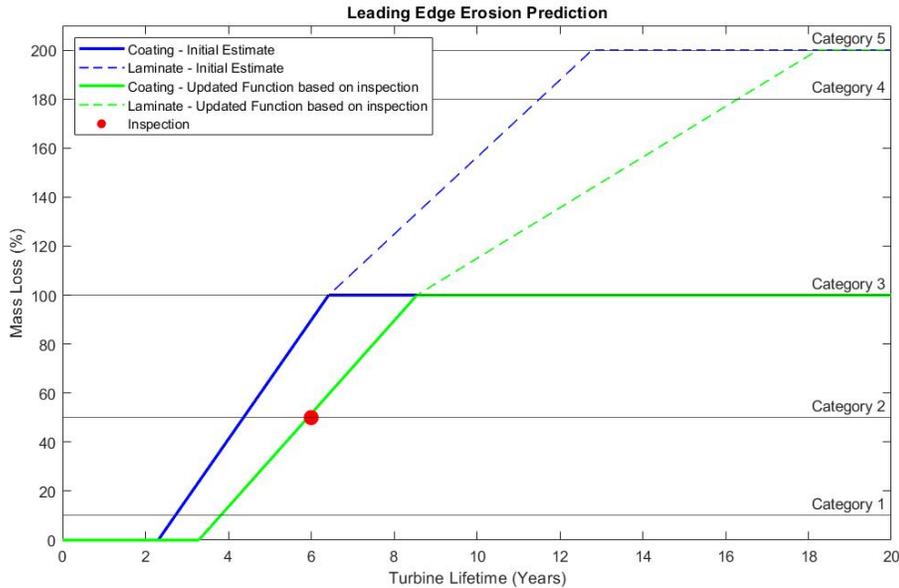
Figure 4-1 – Example plot of leading-edge erosion prediction of a wind blade airfoil section where initial model estimates are updated to better fit inspection data from the field.

One approach is to use percent eroded area of an airfoil leading edge section as a proxy for percent mass loss at that blade section e.g., if 20% of the leading-edge topcoat area is eroded away, that would correspond to a 20% mass loss of the topcoat. After leading edge erosion is detected and categorized on a blade, a function involving a combination of the Springer model weighted by rain and wind statistics can be curve fit to the inspection data, see figure below (Verma, et al., 2021) Additionally, Eisenberg observed that erosion damage is proportional to the local incoming blade velocity ($\propto V^{6.7}$); if blade radius is used as an analog for velocity than this relationship along with inspection data and the probability weighted Springer model can be used to determine either the rate of erosion loss along the entire blade and/or incubation time if erosion has not started to occur in certain areas (Eisenberg, et al., 2018). The incubation time and mass loss rate are a function of the blade laminate and the environmental conditions. Assuming that the environmental conditions in the past are relatively similar to those in the future, an estimate can be made of the future erosion state. This estimate can be further refined with subsequent inspections and the

uncertainty of the model can also be reduced with better measurements of either the actual mass loss, the blade construction, and the real environmental conditions. A prototypical definition of the relationship between mass loss and erosion class was given in Table 5. The model assumes different mass loss rates for coated and uncoated composites after the erosion progresses through the coated. This model is currently under development and will need to be validated against wind plant inspection and operational data, a process that is currently underway.

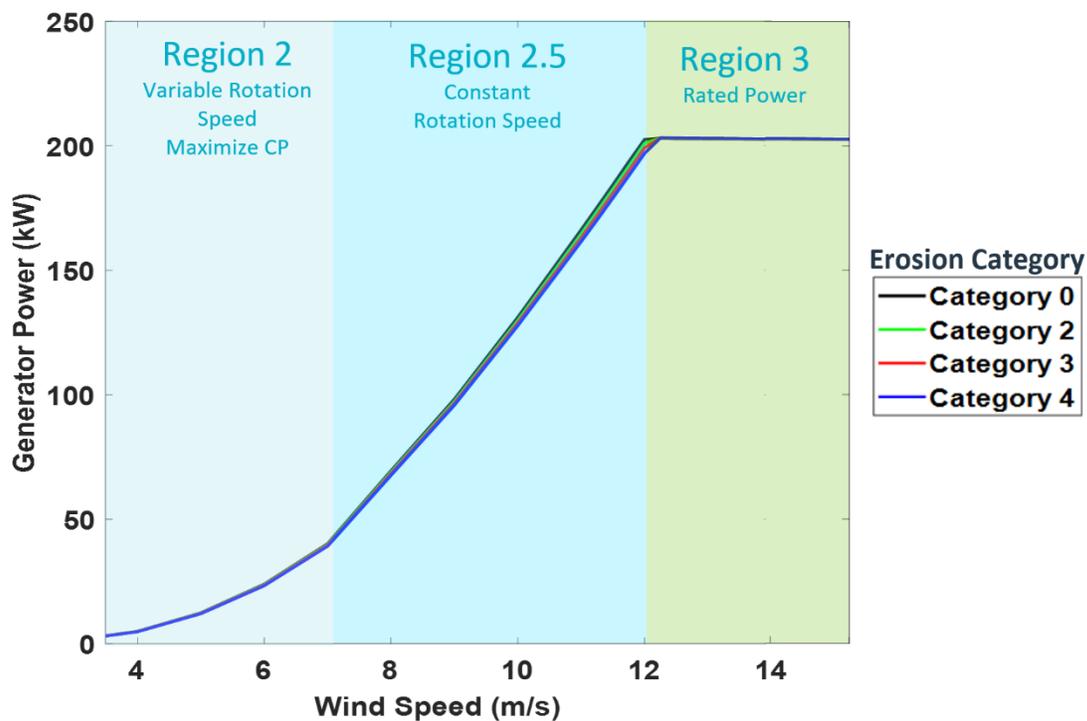
Figure 4-2 – Nominal power curve with several erosion categories. Power loss in the classification system is defined in region 2 of the power curve. Power curve from Ref. (Maniaci, et al., 2020).

The effect of aerodynamic performance changes due to leading edge erosion can be quantified in terms of power loss for a given wind speed range or for the annual energy production, which integrates the effect of leading edge erosion on power loss across the entire wind speed range. Investigations have been made to quantify this (Maniaci, et al., 2020; Bak, et al., 2020). The erosion categories in the classification system are related to the power loss in normal region 2 operation for a variable speed, variable pitch horizontal axis wind turbine, when the turbine is operating at or near the design tip speed ratio, typically 6-8 m/s, as illustrated in Figure 4-2.

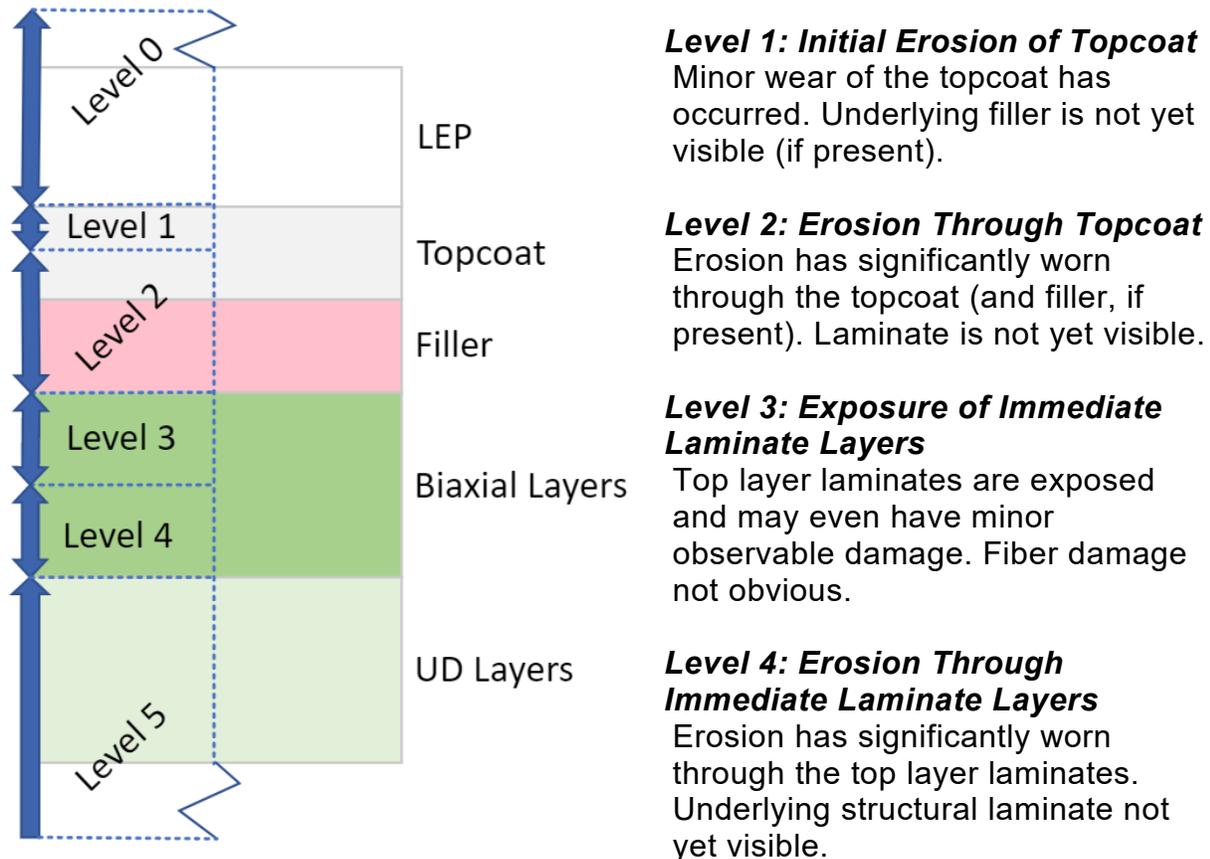
Figure 4-3 – Reference layers of wind turbine blade composition.

The severity levels for blade integrity criterion have been considered with regards to the blade composite structure displayed in Figure 4-3. If an LEP is present, initial erosion/degradation of this is still considered to be Level 0.

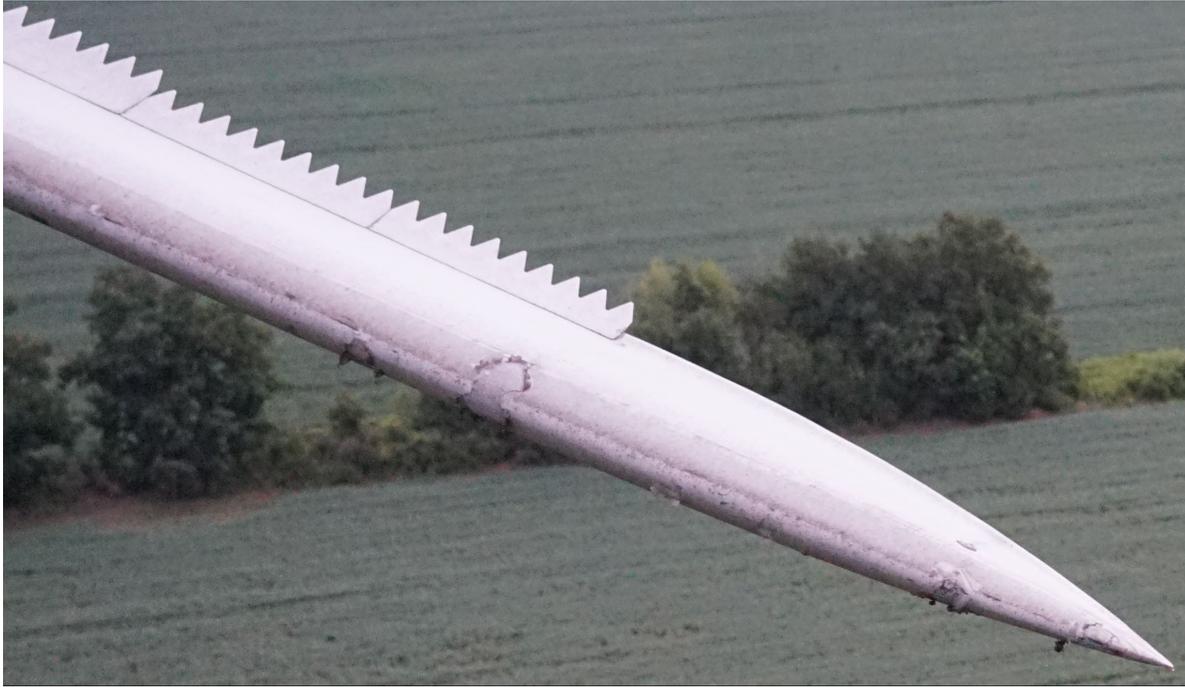
Parameter (Specified by Service Provider)	Value
Material	Tape
Tape Width (Total PS & SS)	250mm
Tape Thickness	300 mm (Film)
	60 mm (Adhesive)
Blade Length	49 m

Criteria	Severity Level	Note
Visual Condition	2	2 where tape is peeling, 1 overall
Mass-loss or Depth	1	
Aerodynamics/Performance	2	2 where tape is peeling, 1 overall
Structural	1

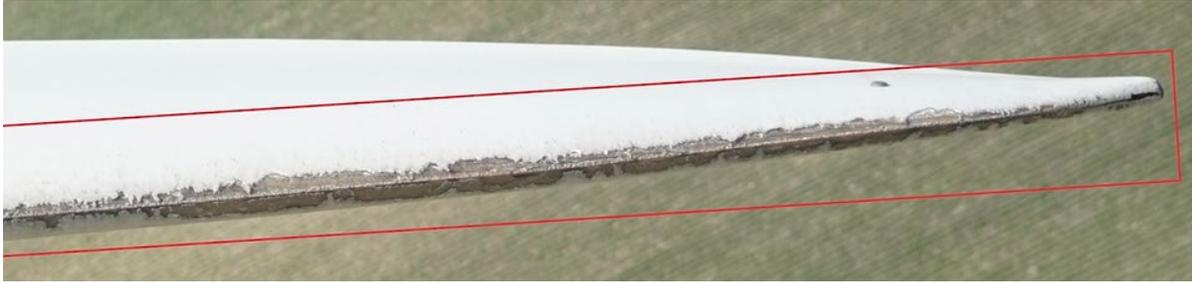
Parameter (Specified by Service Provider)	Value
Material	Laminate
Blade Length	37 m
Distance from Root	37.3 m
Length of damage	4.1 m
Width of damage	0.15 m

Criteria	Severity Level	Note
Visual Condition	4	Large, exposed surfaces of fiberglass. Signs of damage to the underlying fiberglass
Mass-loss or Depth	4	
Aerodynamics/Performance	4	
Structural	3

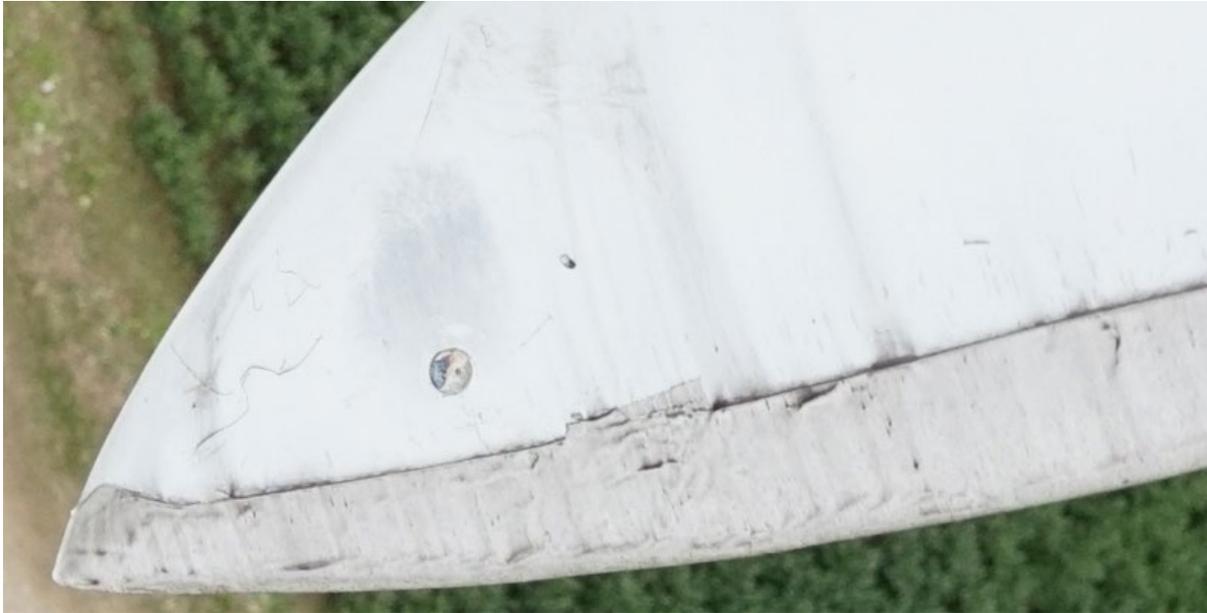
Parameter (Specified by Service Provider)	Value
Material	PU Coating
LEP Width (Total PS & SS)	200 mm
Blade Length	49 m

Criteria	Severity Level	Note
Visual Condition	2	Tape is in poor condition but attached.
Mass-loss or Depth	1	
Aerodynamics/Performance	2	Tape is in poor condition, cat. 2-3 perf. loss
Structural	1

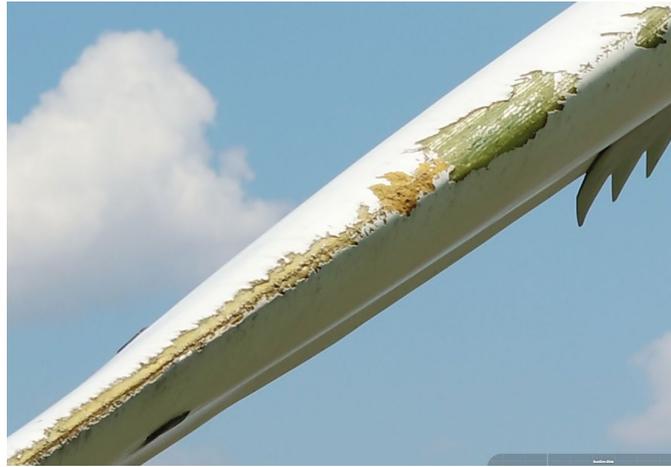
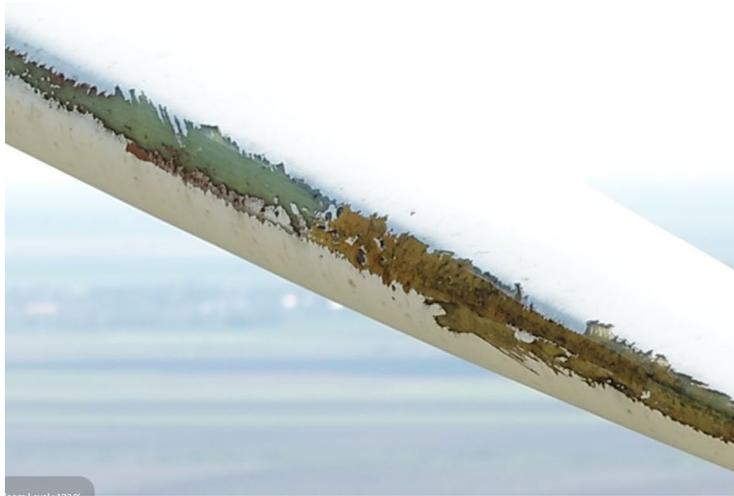
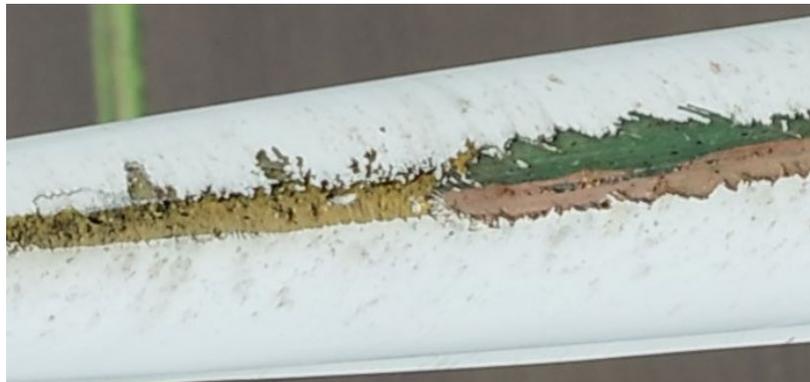
The above three images are examples of category 4 erosion via visual identification. The outer layers of coating and material are completely removed along the leading edge and the underlying layers of material are now eroding. The aerodynamic loss of these areas of the blade likely falls into standard category 4 as well.

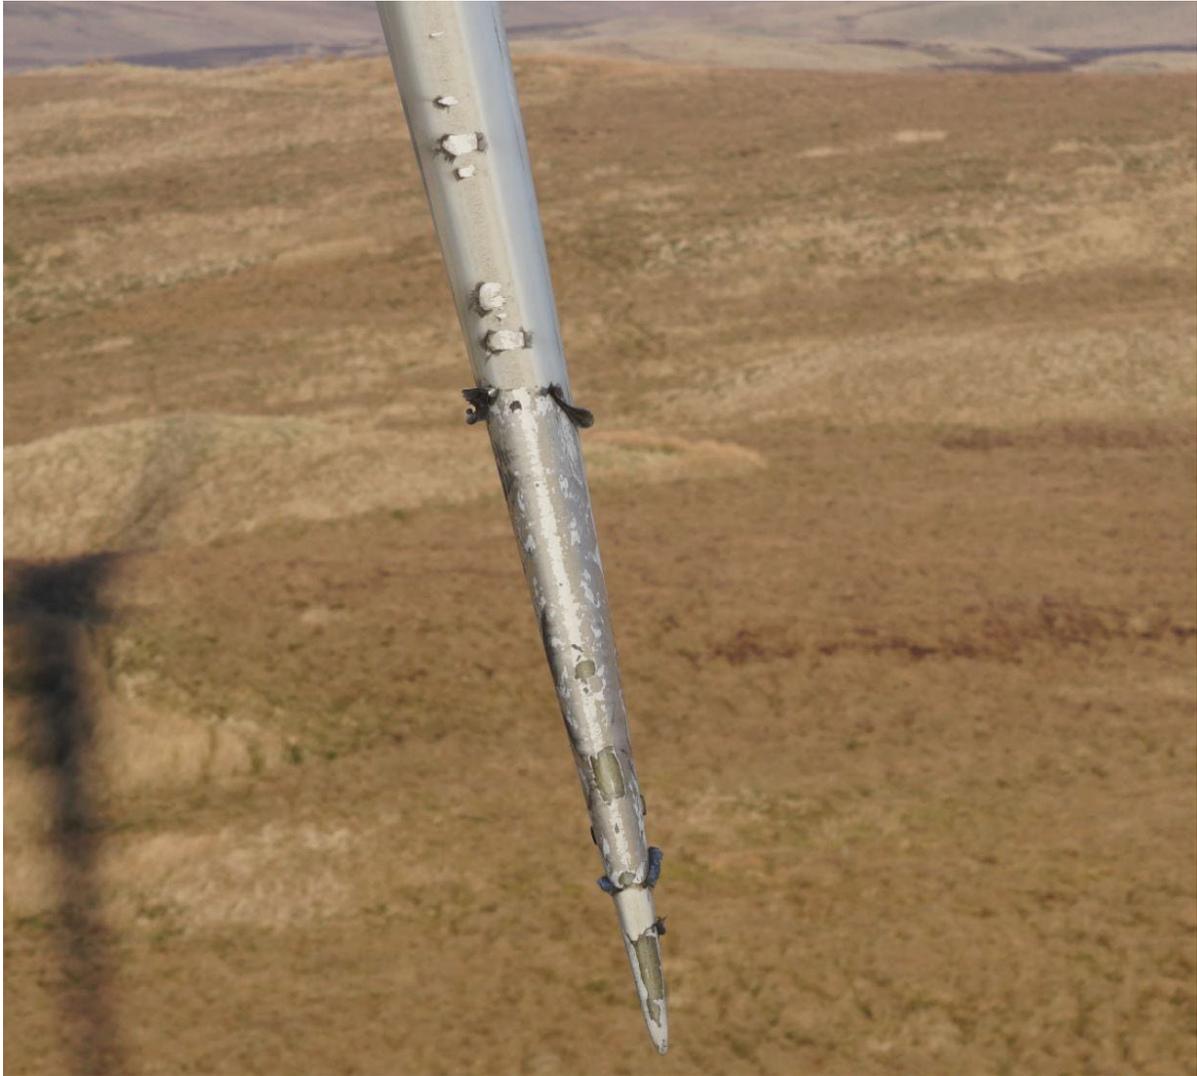
This blade shows leading edge protection delamination and peeling. The underlying blade does not appear to yet have severe erosion, category 1 with some category 2 areas; however, the areas of peeled leading edge protection material could cause aerodynamic flow transition and possibly separation over local areas, increasing the drag to equivalent of a higher blade erosion category, likely category 3 and possible even category 4 in some local areas.

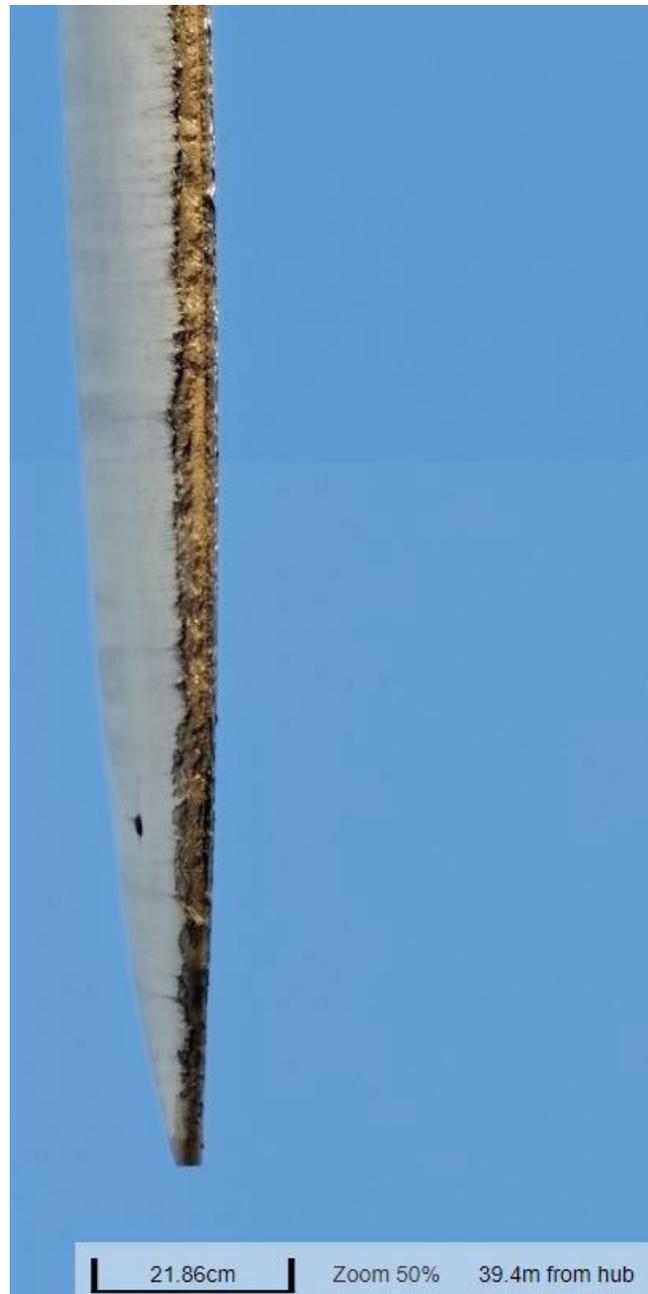
This blade has experienced severe erosion. It is at the high end of category 4, with the underlying structural material exposed and eroding, and will move to category 5 if it hasn't already in local areas.

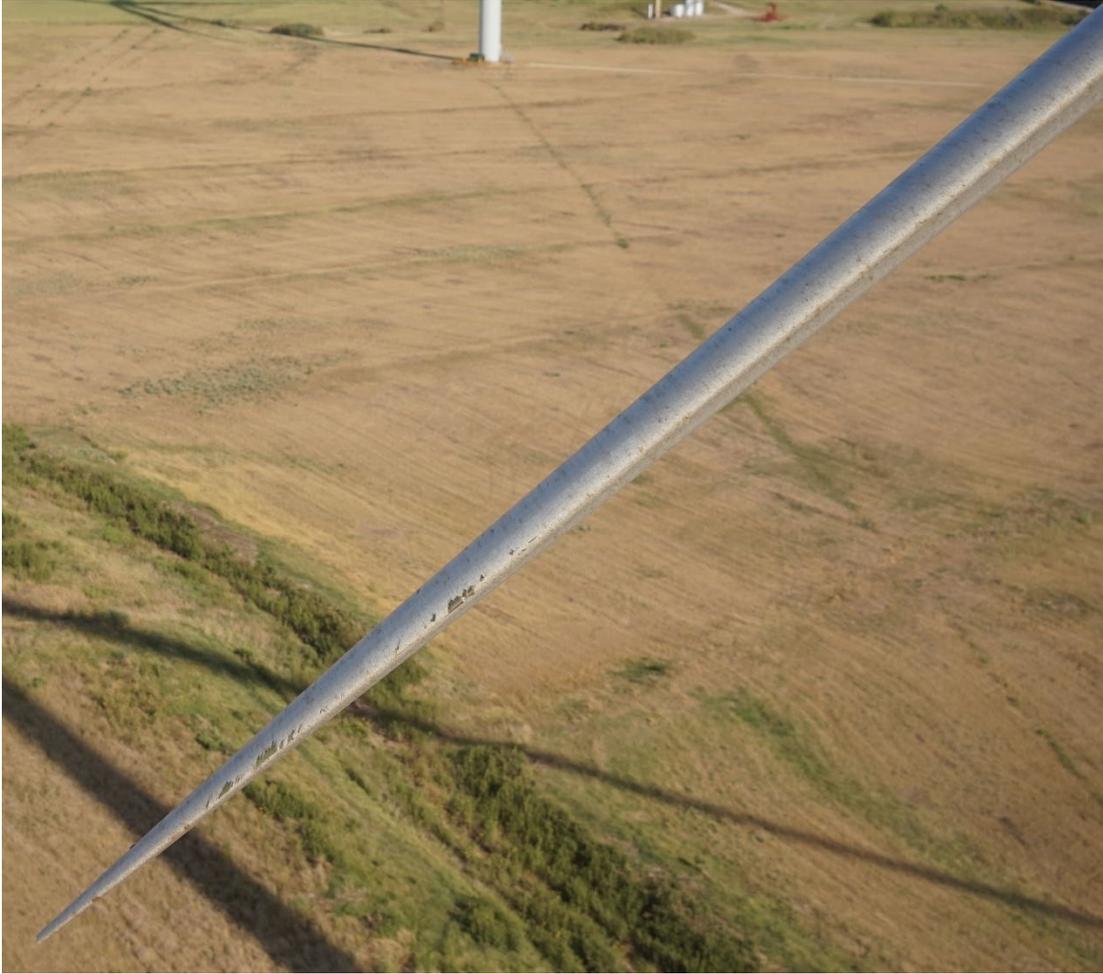
This blade shows lighter erosion and no leading edge protection. The blade would fall into category 2 due to local pitting and some areas of deeper erosion and delamination.

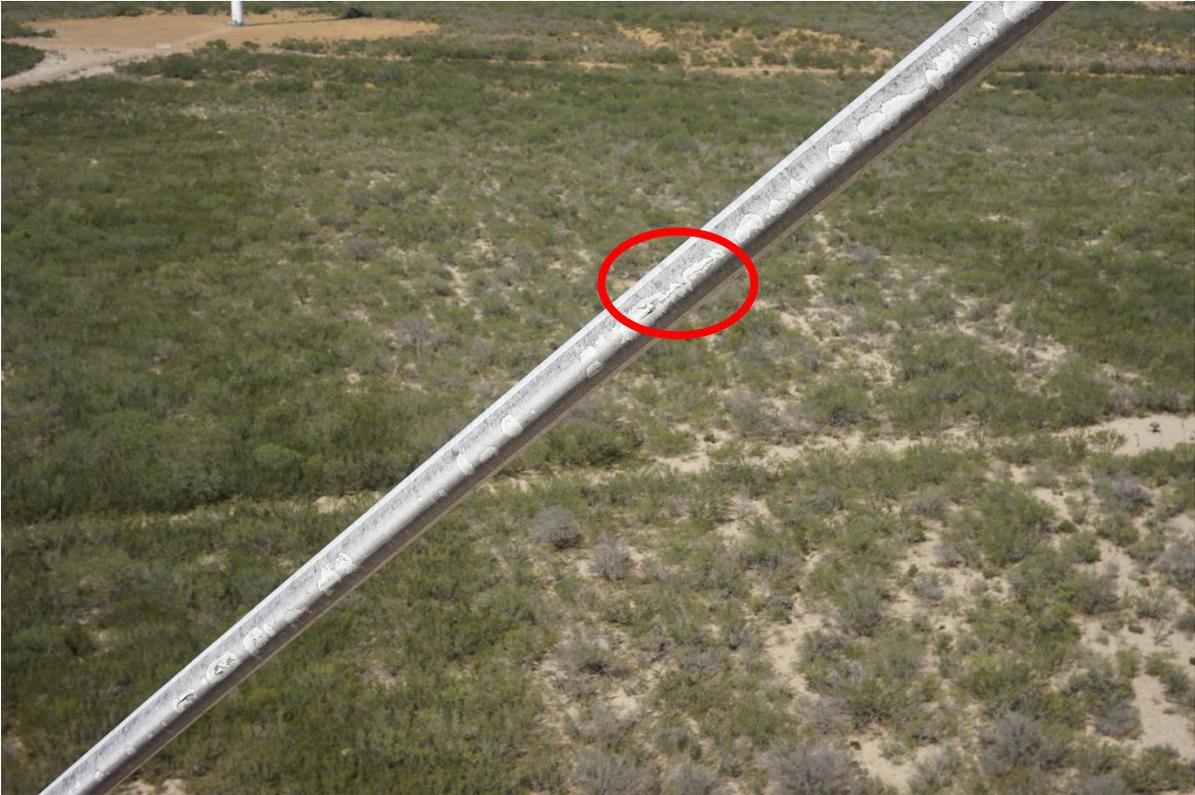
This image shows failing leading edge protection. The leading edge protection is rated category 3, as it is no longer providing protection on large areas of the blade. The underlying blade surface appears to have category 2 erosion in some small pockets where the protection has failed. This example shows the difficulty in local categorization versus categorizing the entire blade. It also shows the challenging nature of assessment with limited visual data, as the severity of the damage above the middle of the image (circled) is not clear and could be a structural crack or simply surface damage.

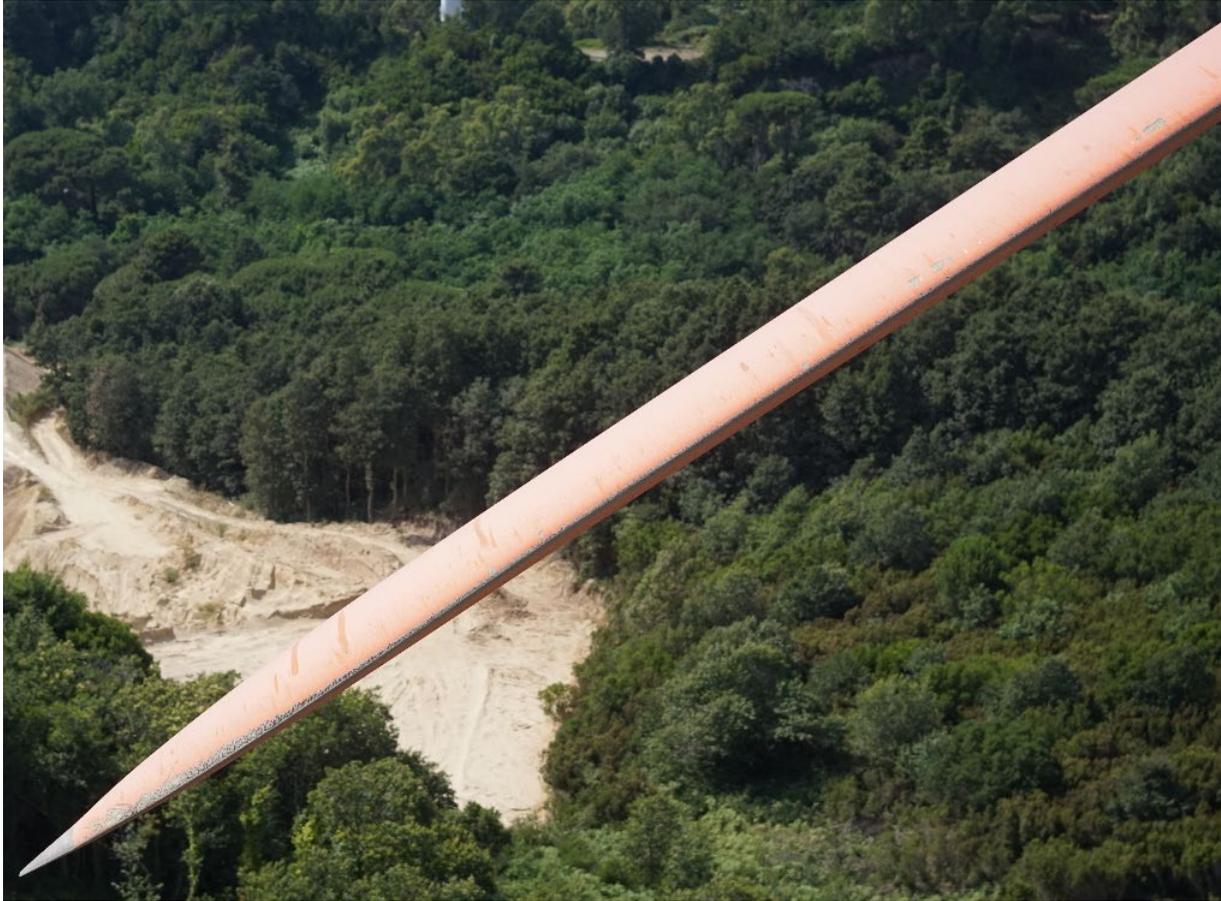
The blade in the above image appears to have category 4 erosion near the blade tip, as the fiberglass layers appear exposed and damaged. The erosion category moves to 3 further inboard and then to category 2. This is an example of classic erosion progression along the blade span. The blade could be categorized either by the maximum erosion category near the tip (4) or by the location of inboard progression using identification algorithms.

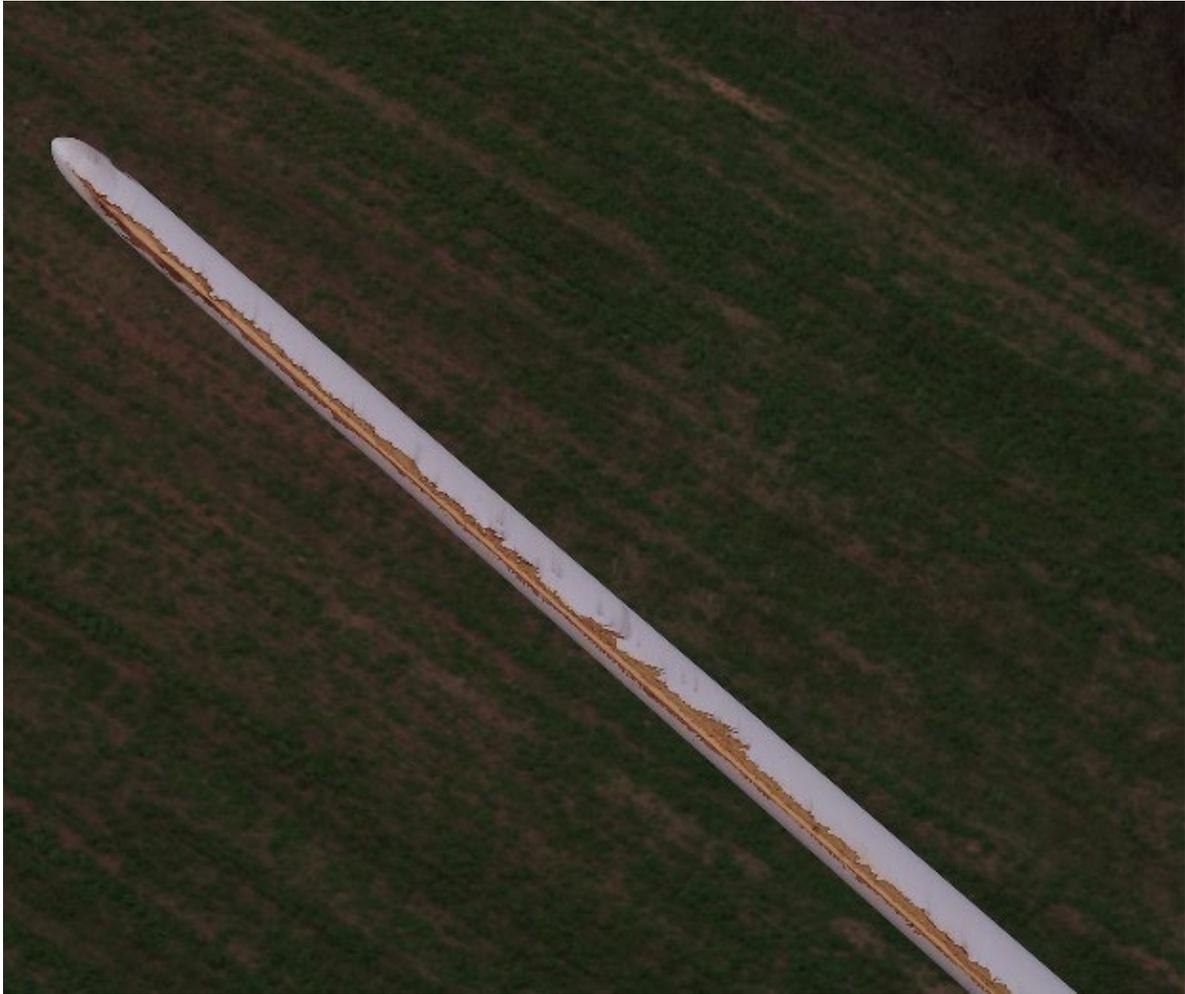
This blade appears to fall into category 4 erosion. The outer coating and layers are fully eroded at the leading edge. There is also evidence of some local peeling, which can cause even higher aerodynamic drag losses than erosion alone as the peeling can cause flow separation behind it.
