# Damage Mechanisms Affecting Fixed Equipment in the Refining Industry

API RECOMMENDED PRACTICE 571  
SECOND EDITION, APRIL 2011

**Downstream Segment**

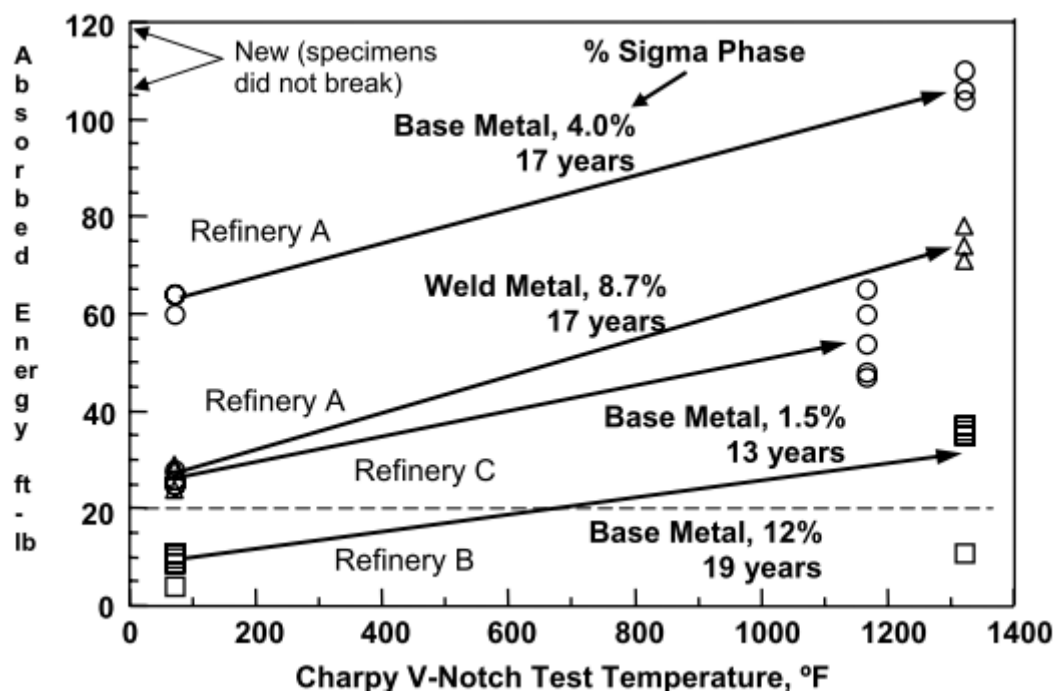
Figure 4-11 – Charpy V-Notch Impact Test Results as absorbed energy in ft-lbf, at room temperature and service temperature (Reference 6).

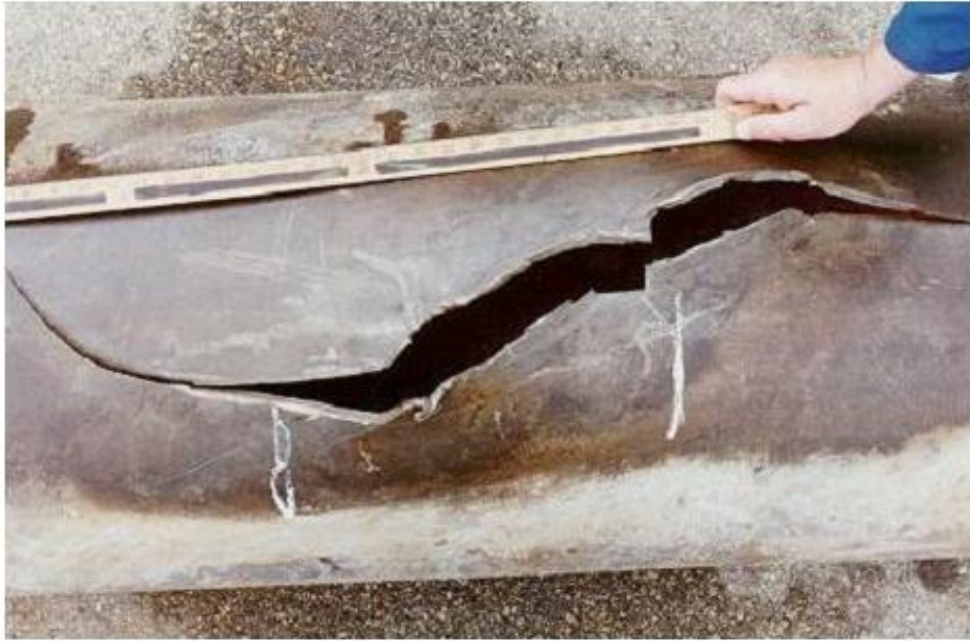
**Figure 4-12 – 20-inch carbon steel pipeline that failed during hydrotest at gouges on the O.D.**

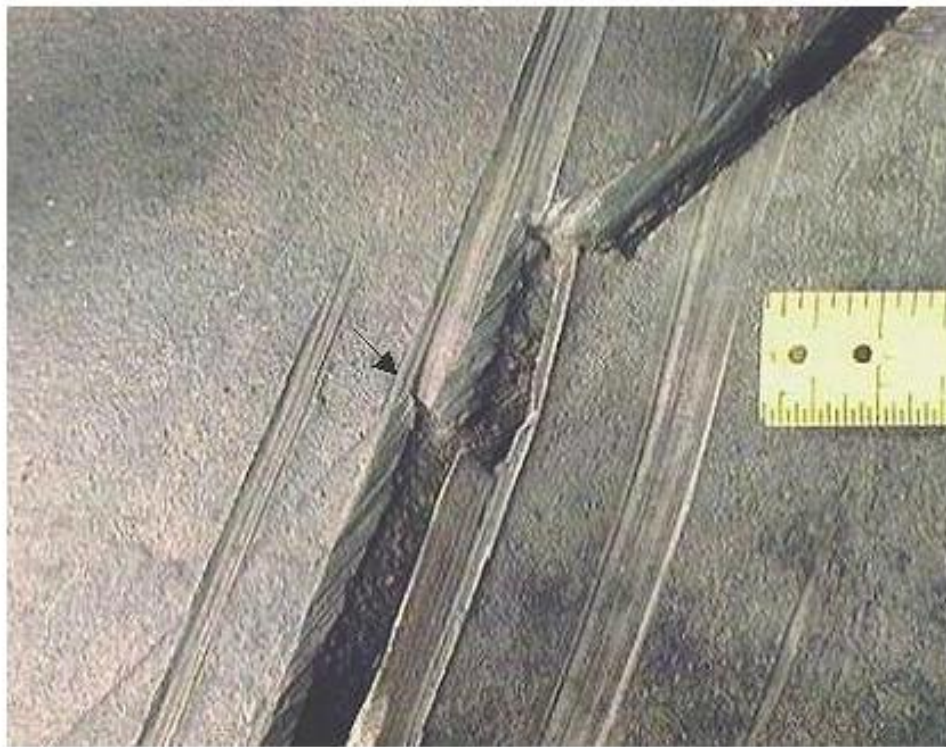
**Figure 4-13 – Close-up photograph showing the gouges and the fracture origin (arrow) in one of the gouges.**

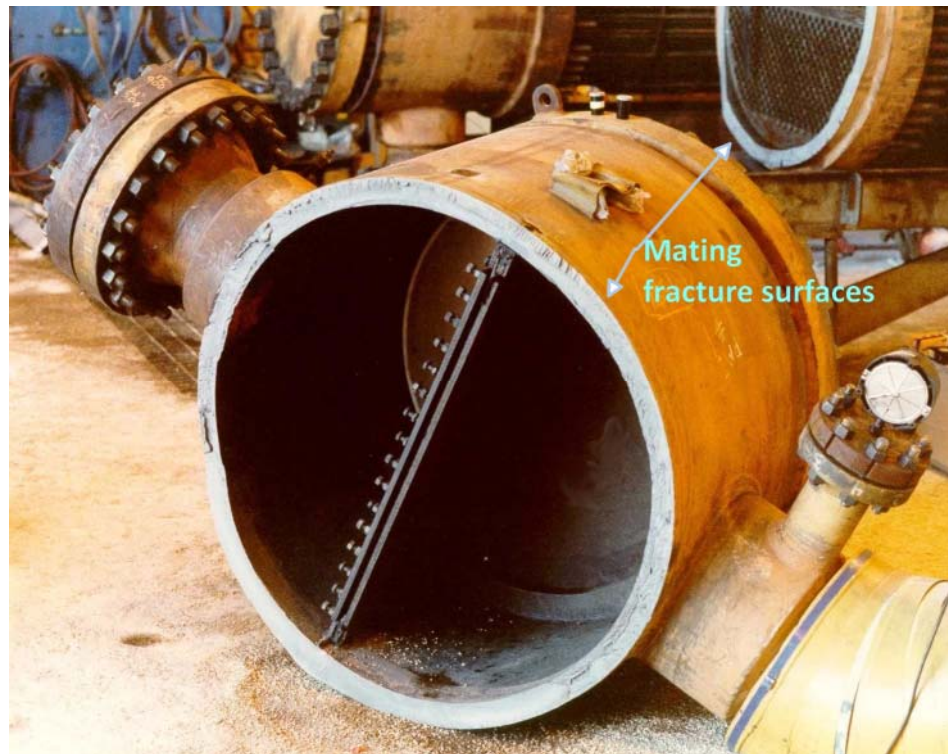
**Figure 4-14 – Brittle Fracture of 2.2 inch wall C-0.5Mo exchanger channel during hydrotest.**

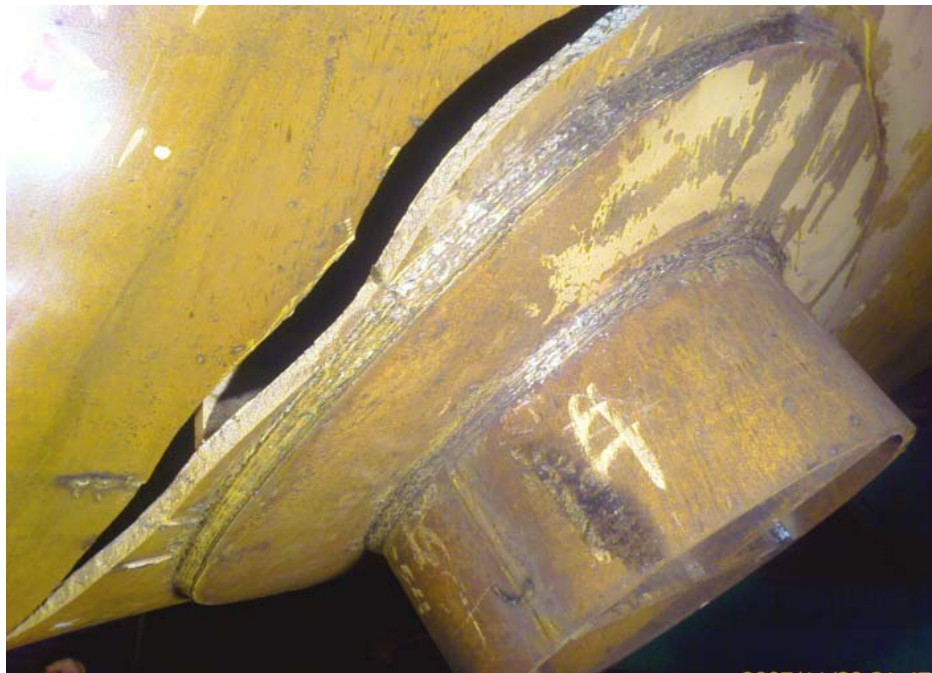
**Figure 4-15 – Brittle Fracture of vessel shell during hydrotest.**

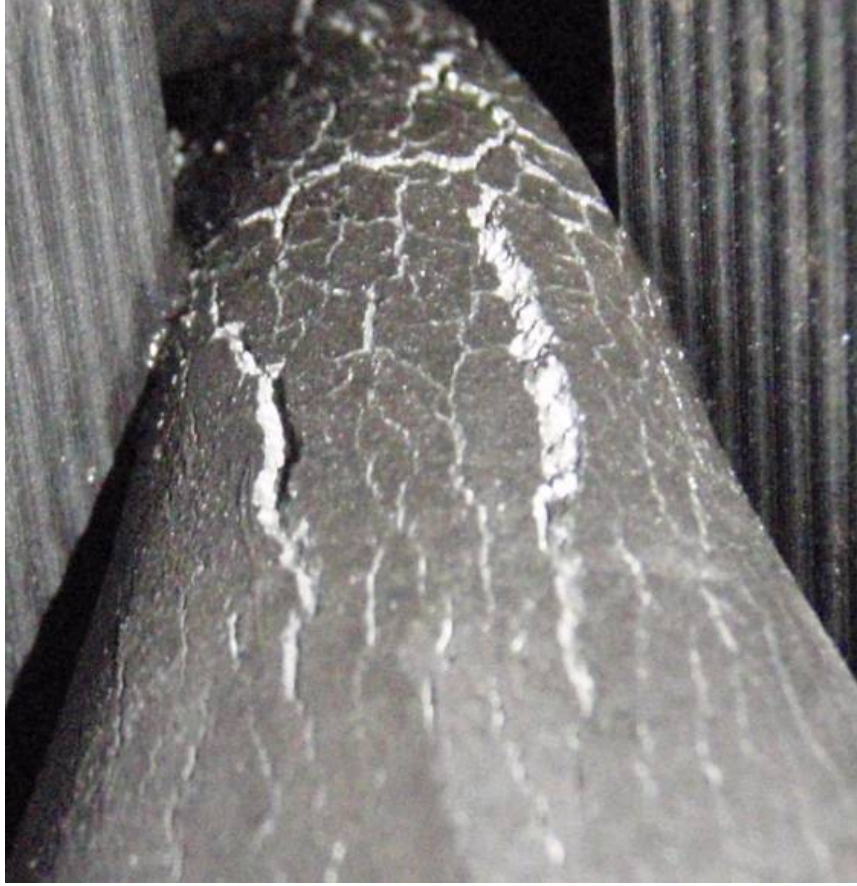
**Figure 4-17 – Pinched Alloy 800H pigtail opened up creep fissures on the surface.**

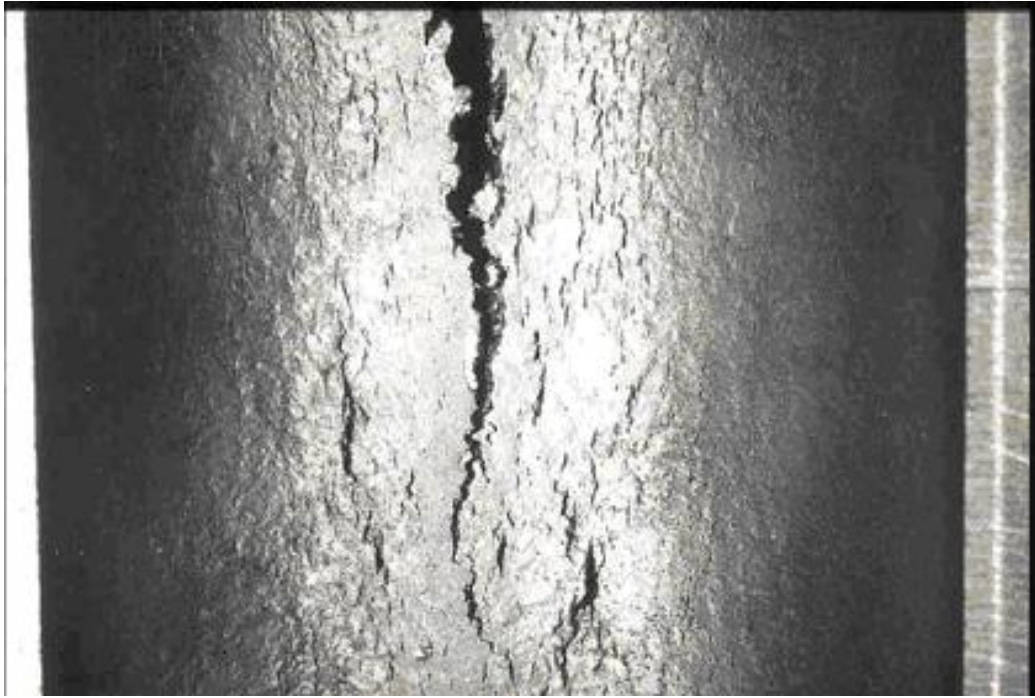
**Figure 4-18 – Creep rupture of an HK40 heater tube.**

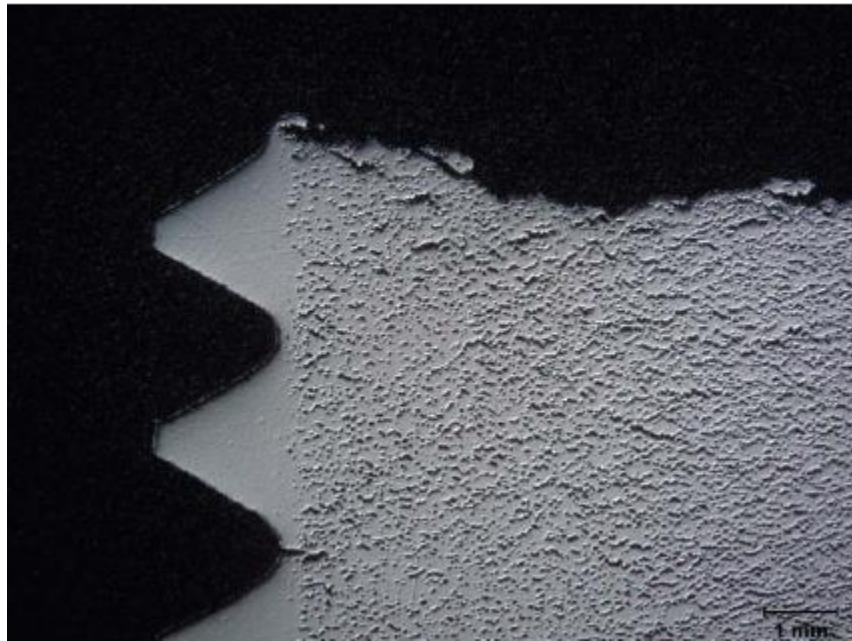
**Figure 4-19 – Creep Failure of 310 SS Heater Tube Guide Bolt after approximately 7 years service at 1400°F (760°C). a.) Cross-section at 10X, as-polished. b) Voids and intergranular separation characteristic of long term creep, 100X, etched.**

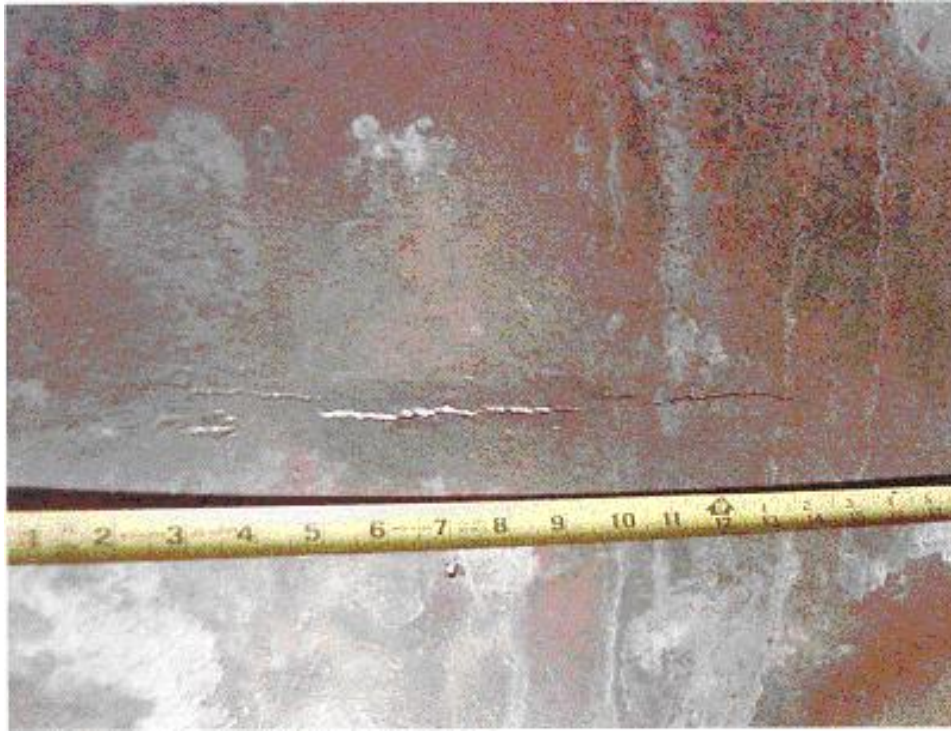
**Figure 4-22 –Thermal fatigue cracking associated with bulged skirt shown in Figure 4-21.**

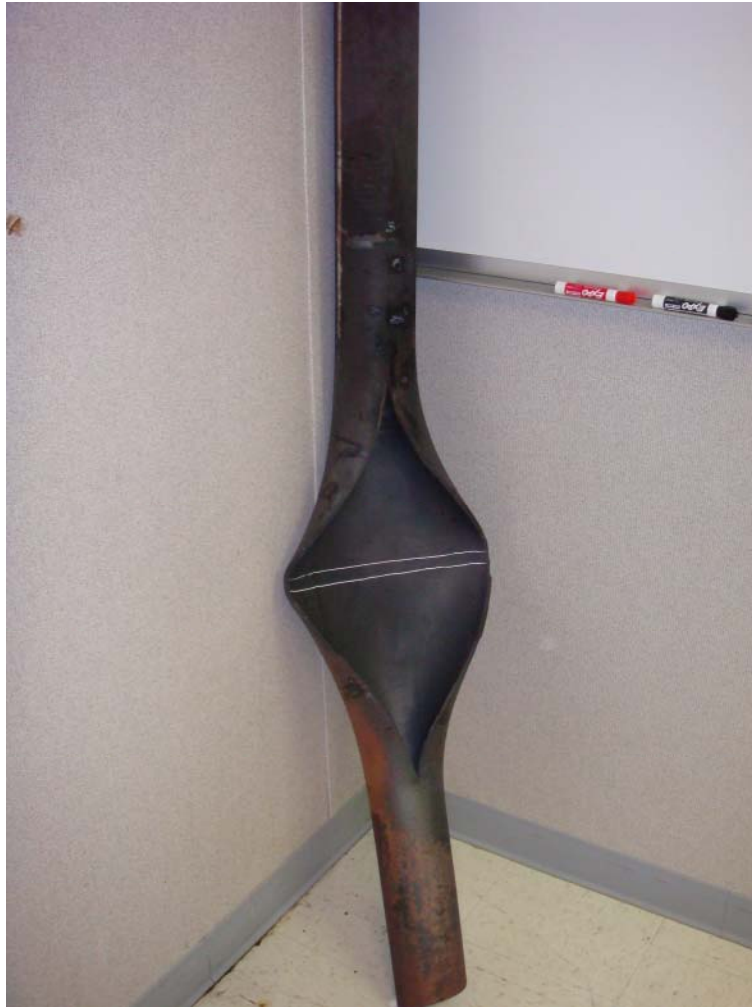
**Figure 4-28 – Short term overheating failure of a vertical 4.5-in. OD, Schedule 160 2.25Cr-1Mo (SA335-P2) hydrocracker radiant that was 21 years old. Failure occurred due process side starvation with burners running.**

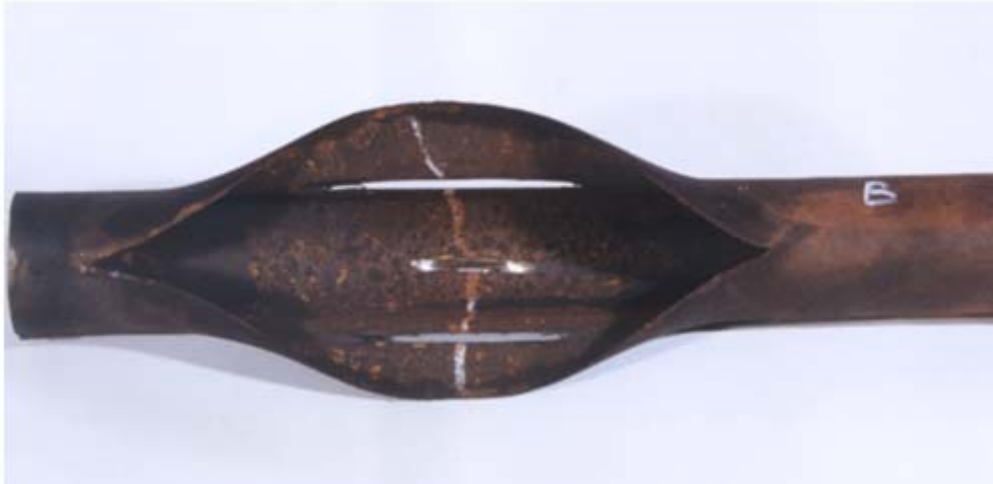
**Figure 4-29 – Short term overheating tube failed by bulging and rupture due to short term overheating at a temperature well over 1380°F (750°C).**

- a) Damage is typically characterized by localized deformation or bulging on the order of 3% to 10% or more, depending on the alloy, temperature and stress level.
- b) Ruptures are characterized by open “fishmouth” failures and are usually accompanied by thinning at the fracture surface ([Figure 4-28](#) to [4-31](#)).

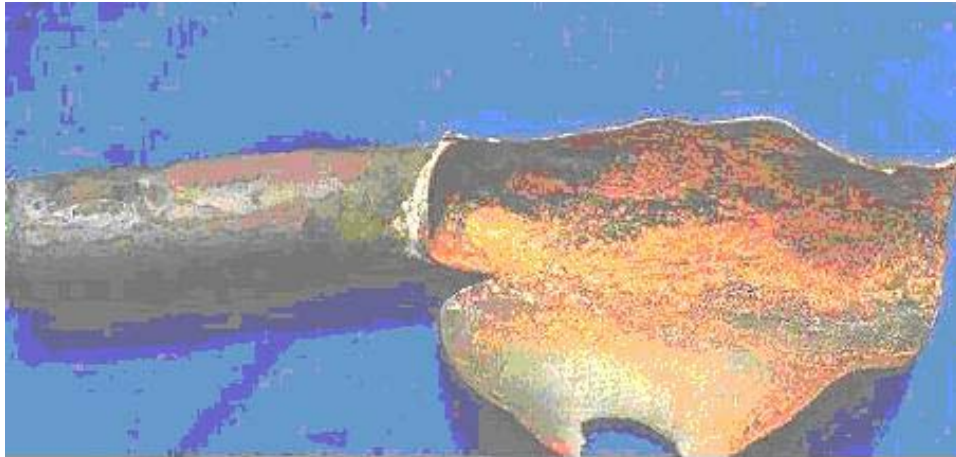
**Figure 4-30 – 1Cr-0.5Mo boiler superheater tube in 700 psig steam service that failed due to overheating.**

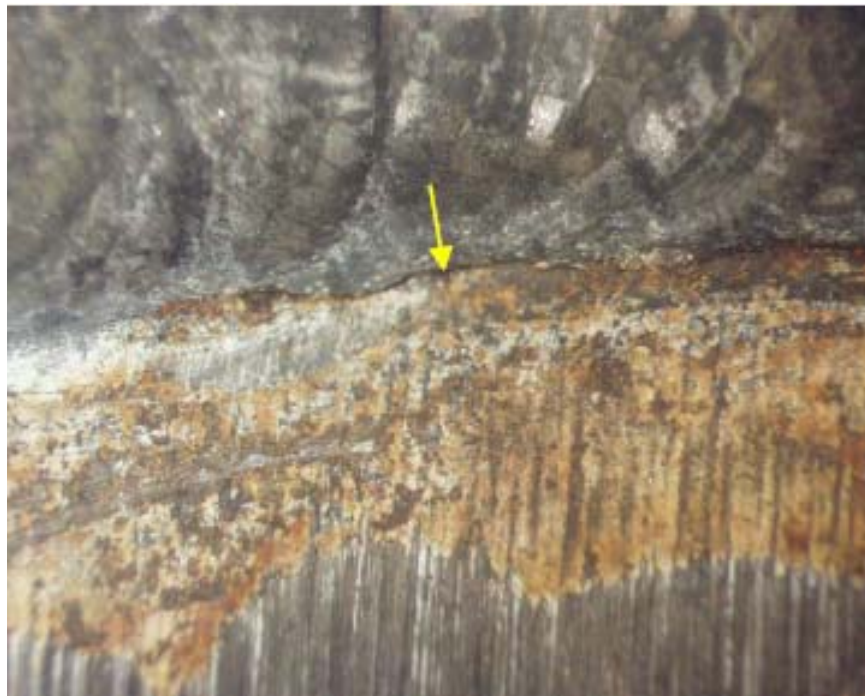
**Figure 4-36 – Weld detail used to join a carbon steel elbow (bottom) to a weld overlaid pipe section (top) in high pressure wet H<sub>2</sub>S service. Sulfide stress cracking (SSC) occurred along the toe of the weld (arrow), in a narrow zone of high hardness.**

- a) In most cases, the cracks form at the toe of the weld in the heat-affected zone of the ferritic material ([Figure 4-36](#) to [Figure 4-42](#)).
- b) Welds joining tubes are the most common problem area, but support lugs or attachments of cast or wrought 300 Series SS to 400 Series SS are also affected.

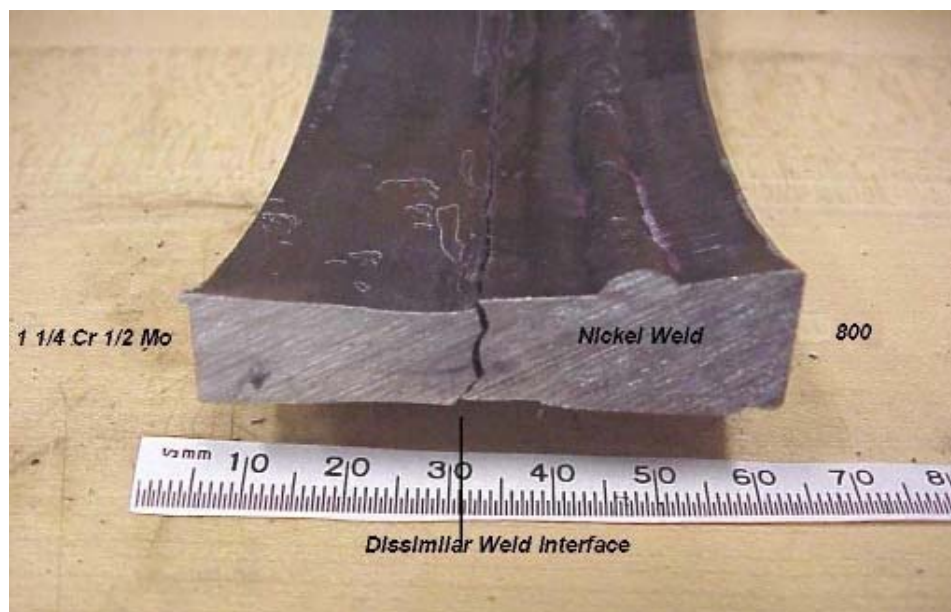
Figure 4-38 – Failure of DMW joining 1.25Cr-0.5Mo to Alloy 800H in a Hydro-dealkylation (HAD) Reactor Effluent Exchanger. Crack propagation due to stresses driven at high temperature of 875°F (468°C) and a hydrogen partial pressure of 280 psig (1.93 MPa).

- h) DMW's for high temperature service in hydrogen environments must be carefully designed and inspected to prevent hydrogen disbonding (Figures 4-38 to 4-41).

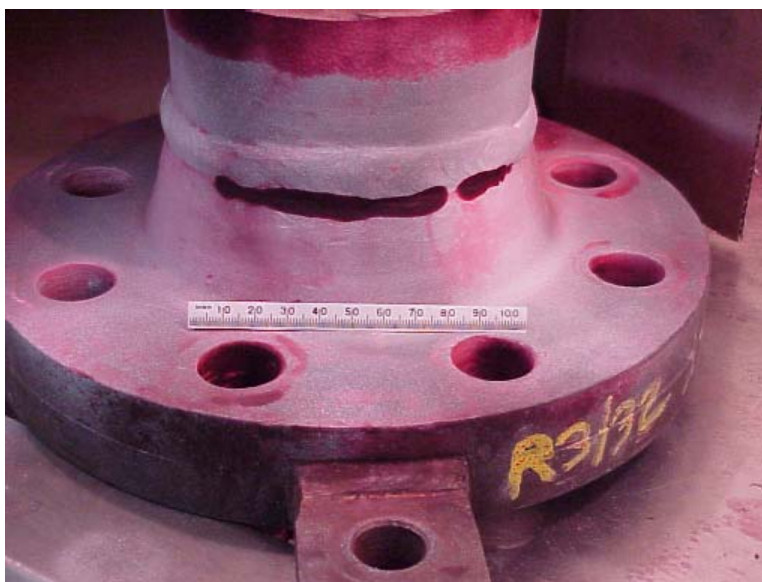
**Figure 4-41 – Failure of nickel alloy DMW joining HP40 (Nb modified) tube to 1.25Cr-0.5Mo flange in a Steam Methane Reformer due to cold hydrogen disbonding of the buttering layer. Process temperature 914°-941°F (490° to 505°C), Pressure (2.14 Mpa), H<sub>2</sub> content 10-20% (off-gas).**

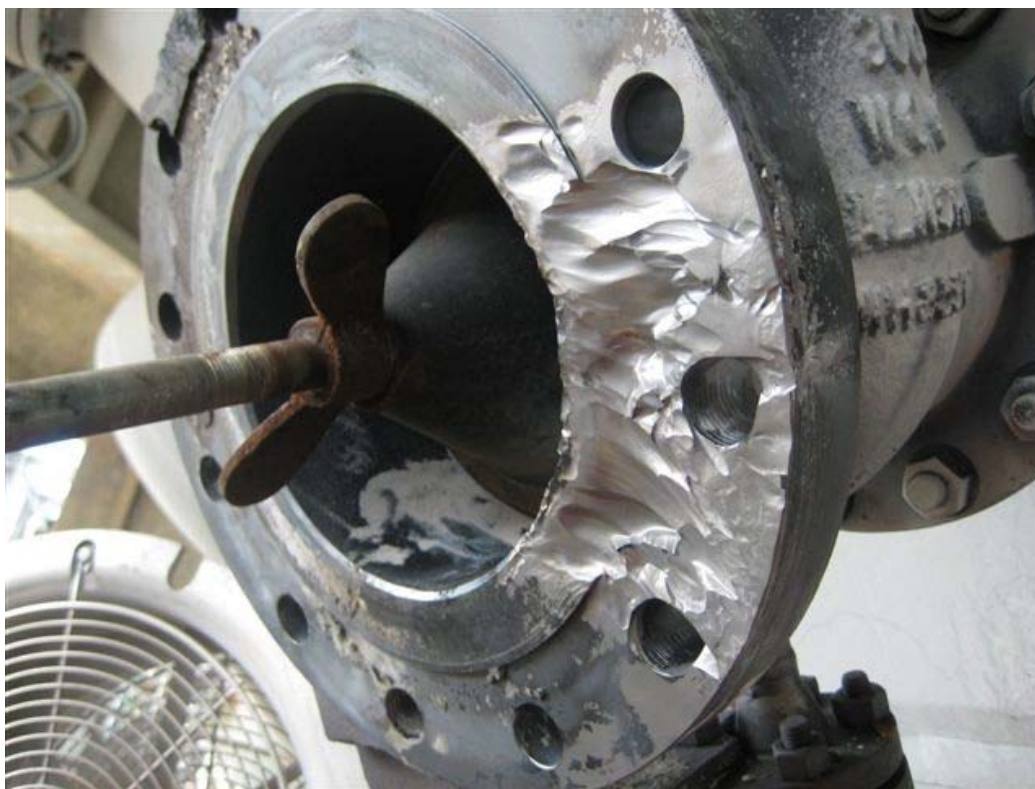
**Figure 4-43 – Erosion Corrosion of a 1.25Cr 300 # valve flange on an FCC Catalyst withdrawal line.**

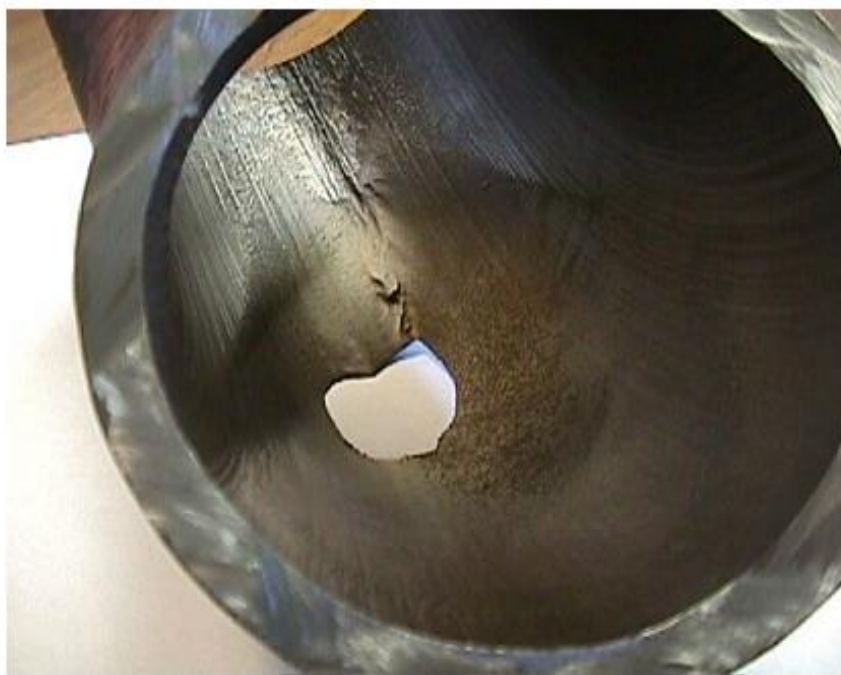
**Figure 4-44 – Erosion of a 9Cr-1Mo coker heater return bend.**

- b) Erosion can be caused by gas borne catalyst particles or by particles carried by a liquid such as a slurry. In refineries, this form of damage occurs as a result of catalyst movement in FCC reactor/regenerator systems in catalyst handling equipment (valves, cyclones, piping, reactors) and slurry piping ([Figure 4-43](#)); coke handling equipment in both delayed and fluidized bed cokers ([Figure 4-44](#)); and as wear on pumps ([Figure 4-45](#)), compressors and other rotating equipment.

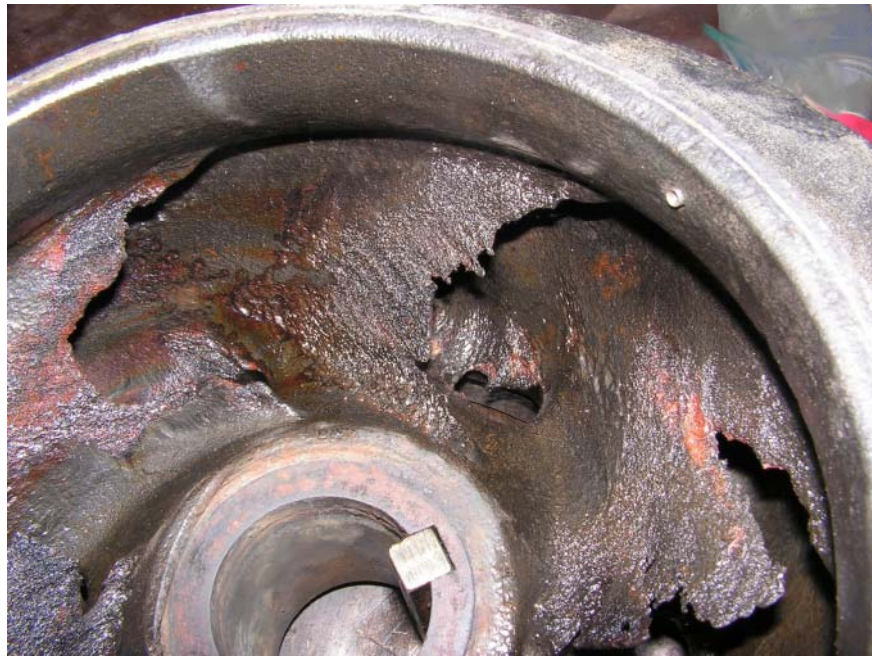
**Figure 4-45 – Erosion-Corrosion of is ASTM A48 Class 30 Cast Iron Impeller in recycle water pump.**

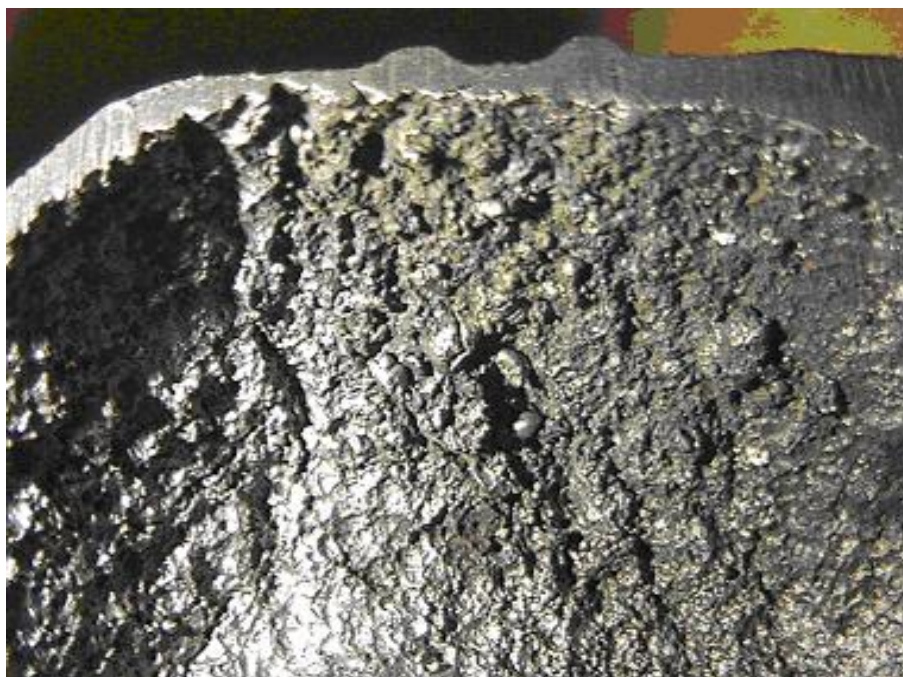
**Figure 4-47 – Closer view of damaged surface of butterfly valve.**

Cavitation damage generally looks like sharp-edged pitting but may also have a gouged appearance in rotational components. However, damage occurs only in localized low-pressure zones (see [Figure 4-46](#), [Figure 4-47](#) to [Figure 4-49](#)).

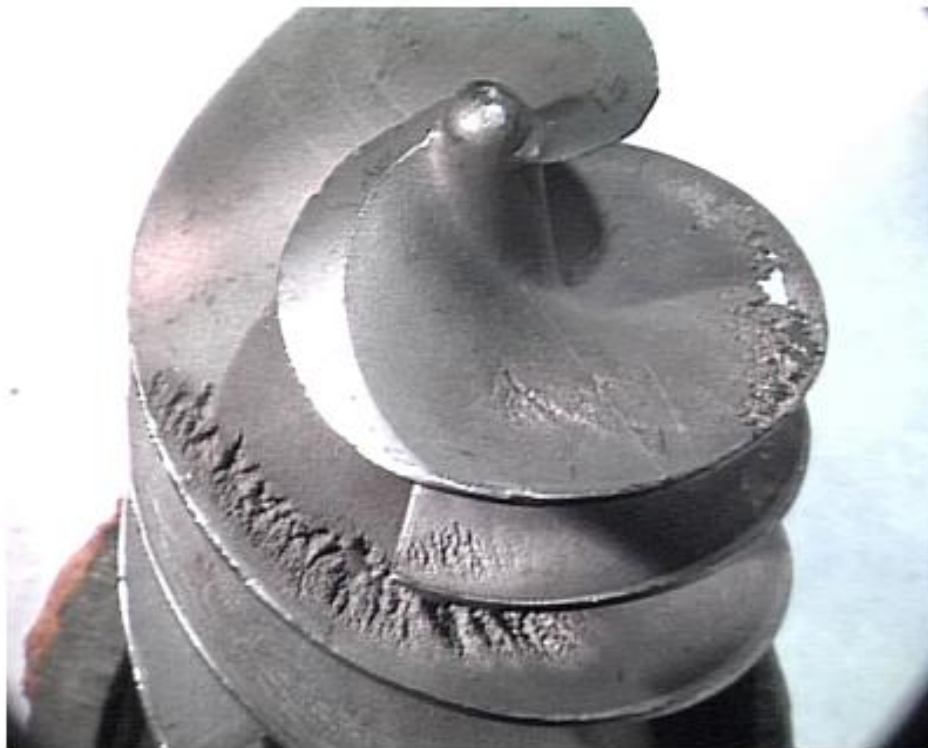
**Figure 4-48 – Cavitation pitting on the low-pressure side of a stainless steel pump impeller.**

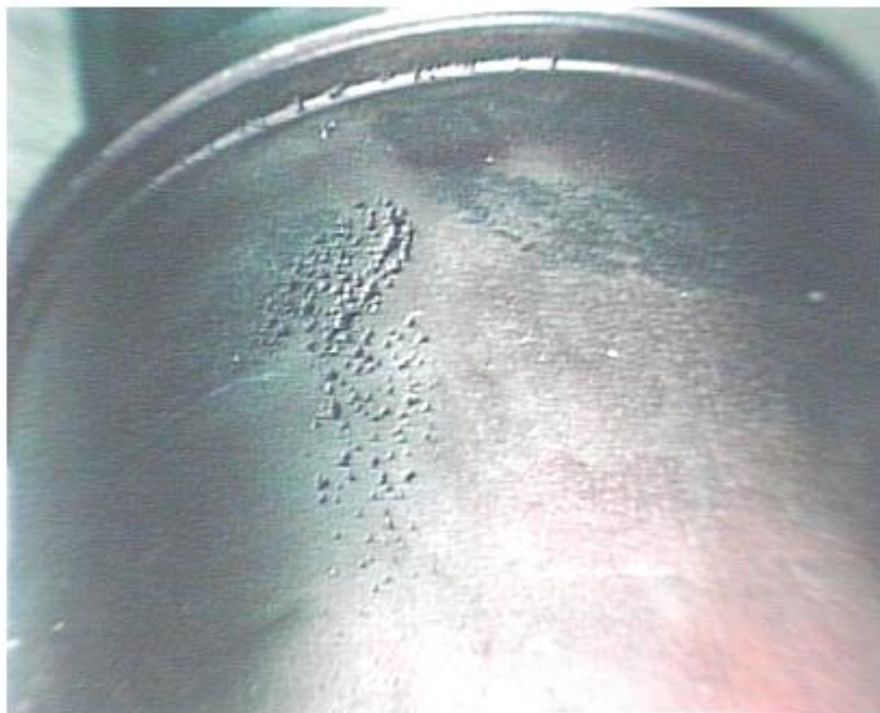
**Figure 4-49 – Cavitation pitting on the water side of a cast iron cylinder liner in a large engine.**

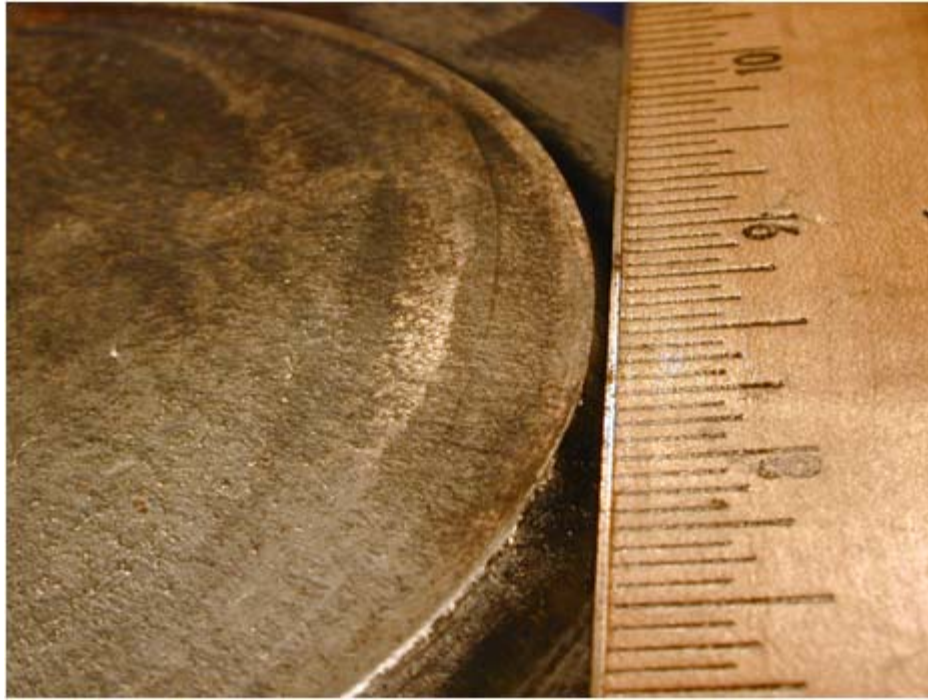
**Figure 4-52 – Higher magnification view of figure above showing “beach marks”.**

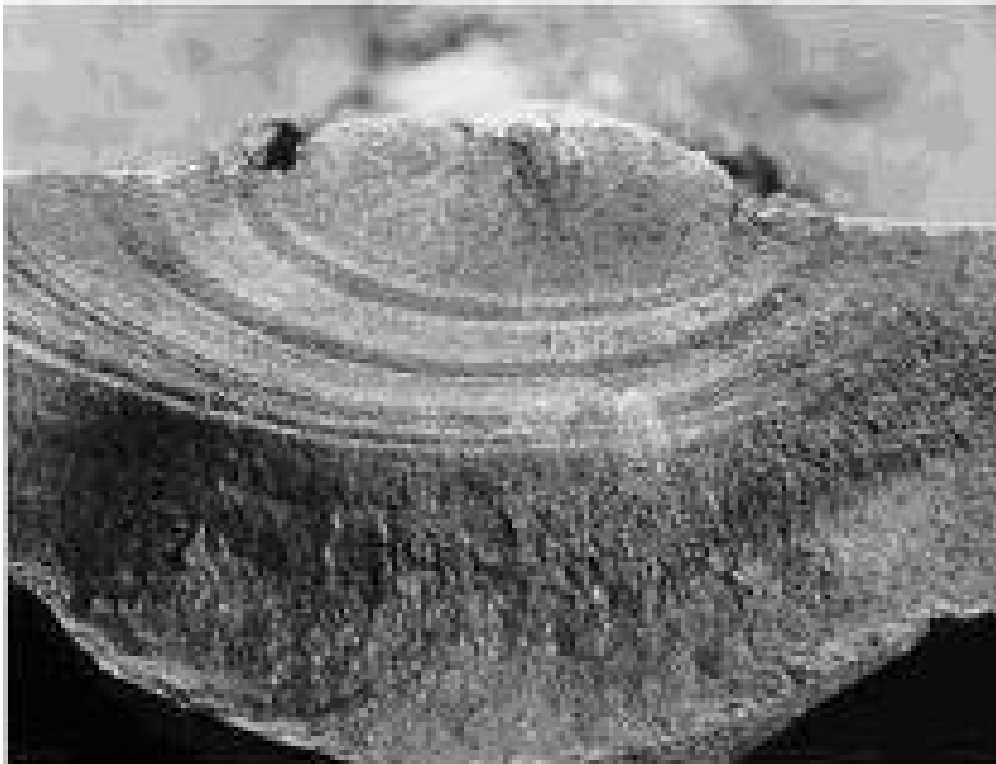
**Figure 4-53 – Fatigue fracture surface of a carbon steel pipe.**

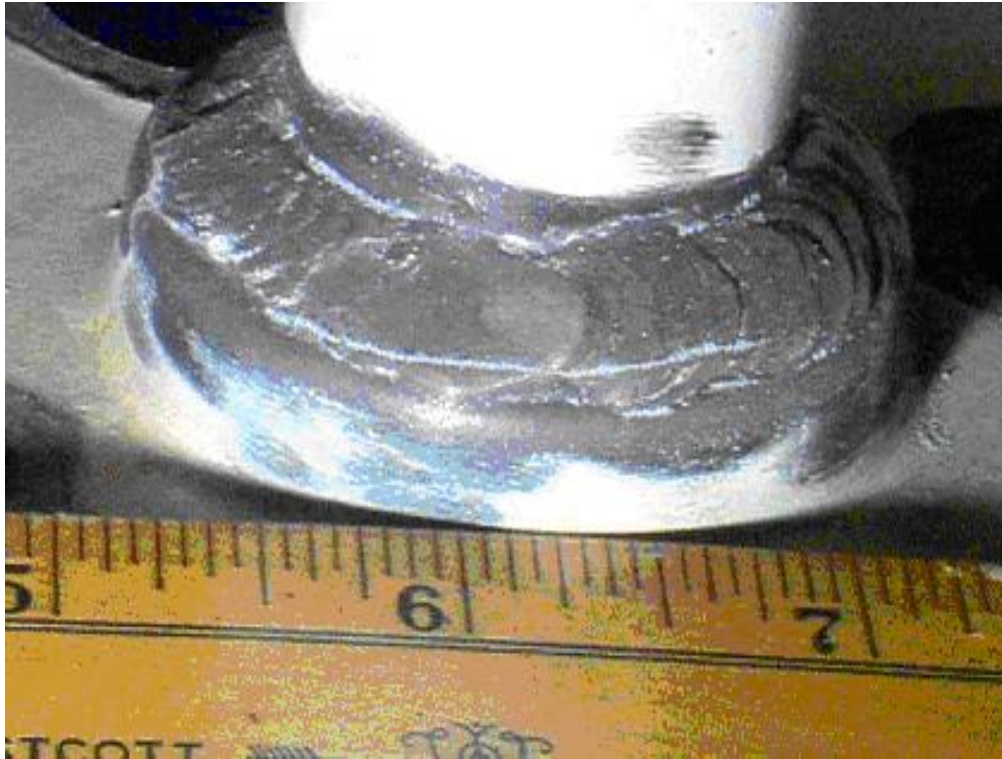
**Figure 4-57 – Vibration induced fatigue of a 1-inch socket weld flange in a thermal relief system shortly after startup.**

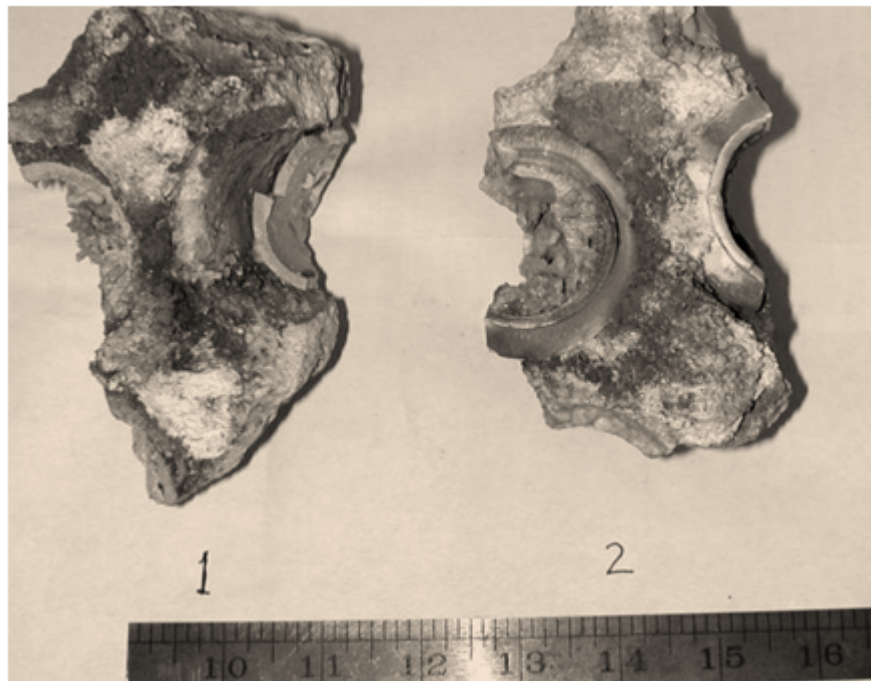
**Figure 4-59 – Damaged refractory and ferrules.**

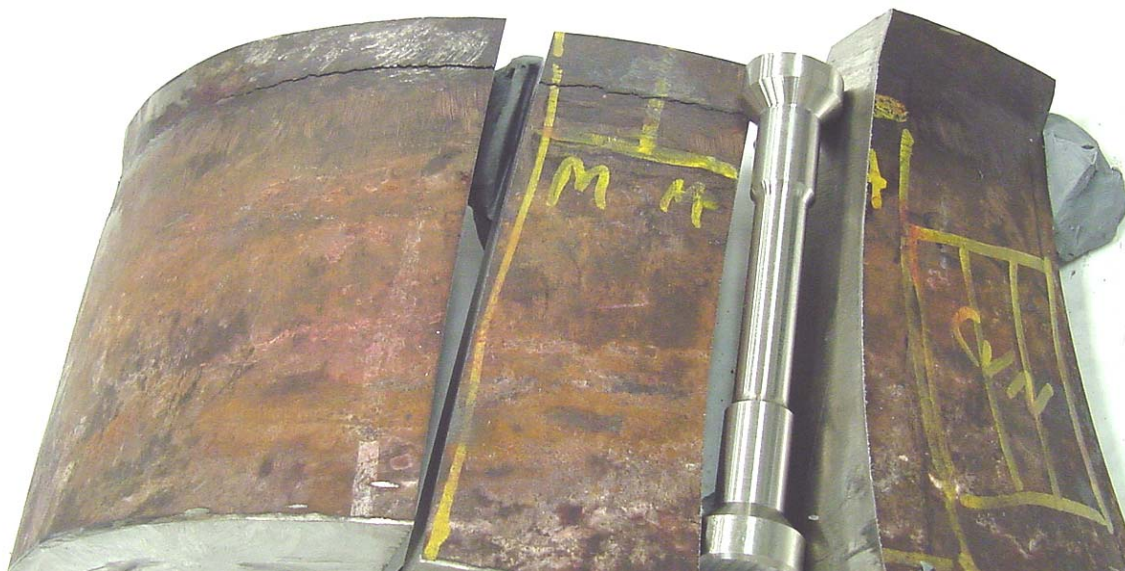
**Figure 4-60 – Samples removed from a cracked 12-inch NPS 321SS elbow in hot recycle H<sub>2</sub> line that operated at 985°F in hydrocracker.**

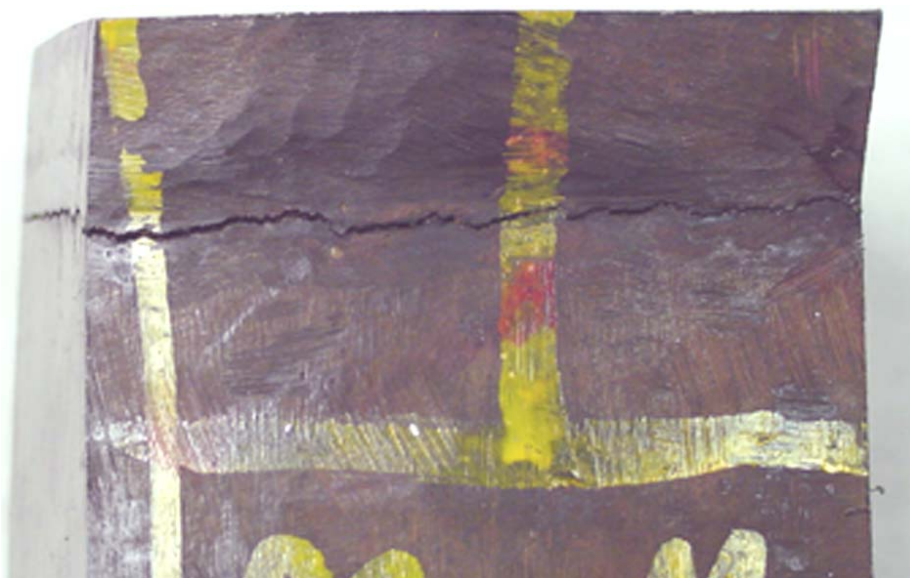
**Figure 4-61 – Crack at weld from SS321 elbow shown in the Figure 4-60.**

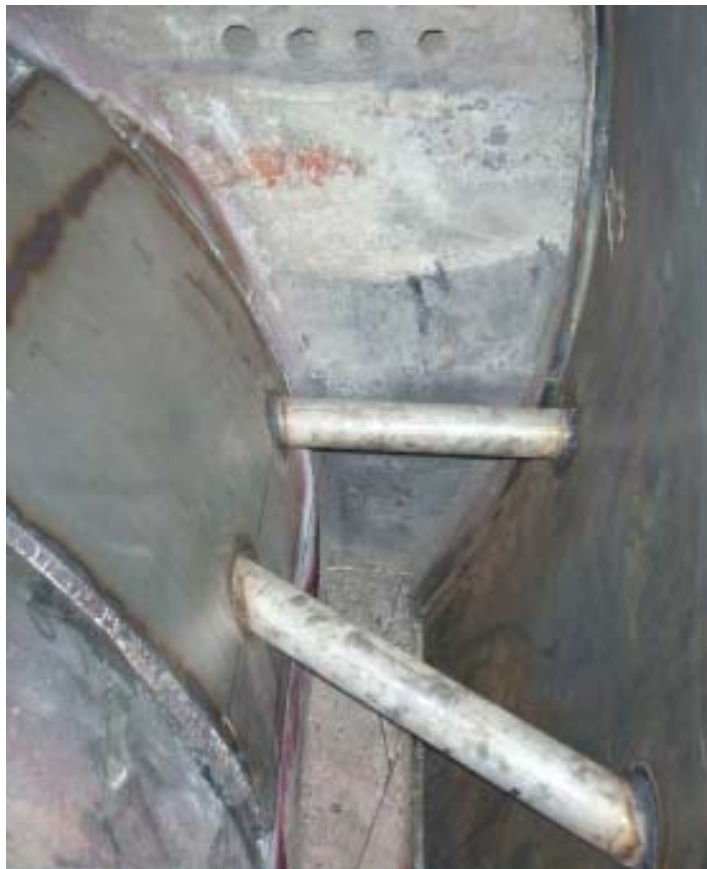
**Figure 4-64 – Thermal combustor on the front end of a reaction furnace on a sulfur recovery unit.**

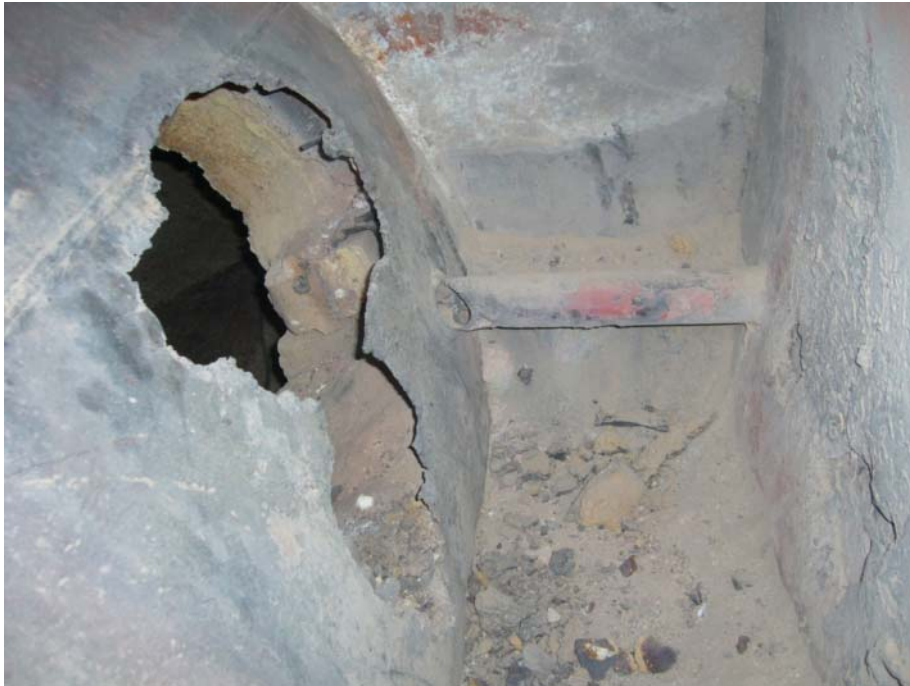
**Figure 4-65 – Same as figure above after damage due to oxygen combustion resulting from oxygen injection into the thermal combustor on the front end of the reaction furnace.**

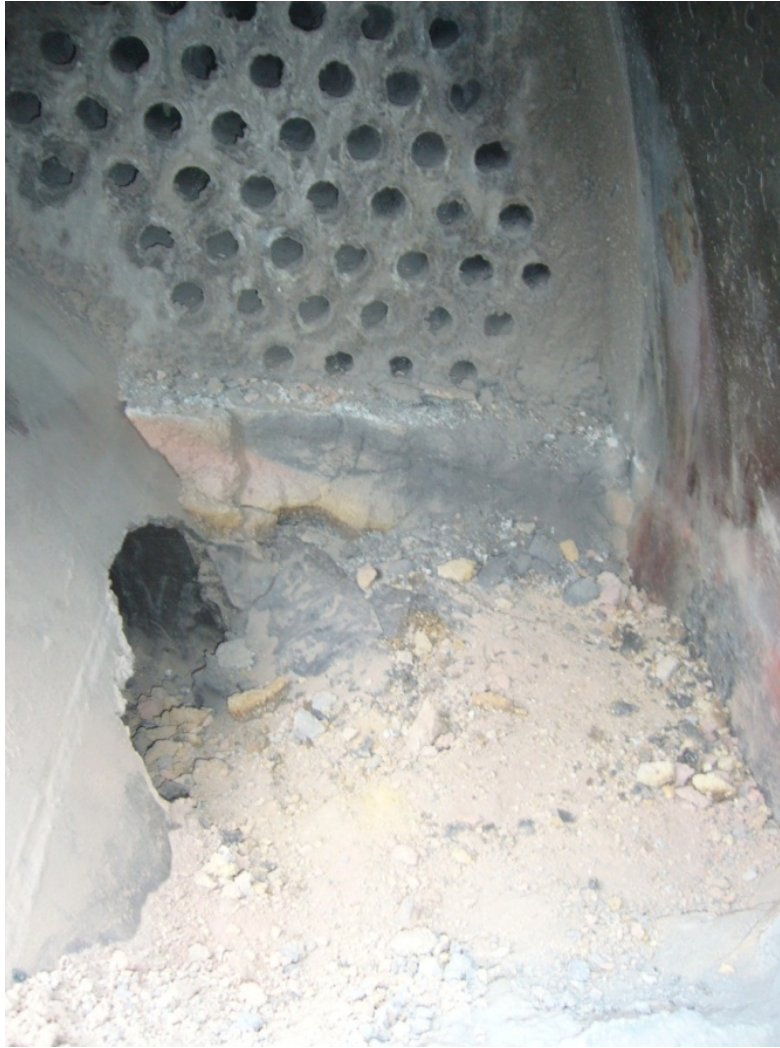
**Figure 4-66 – Same as figure above when viewed from a different angle.**

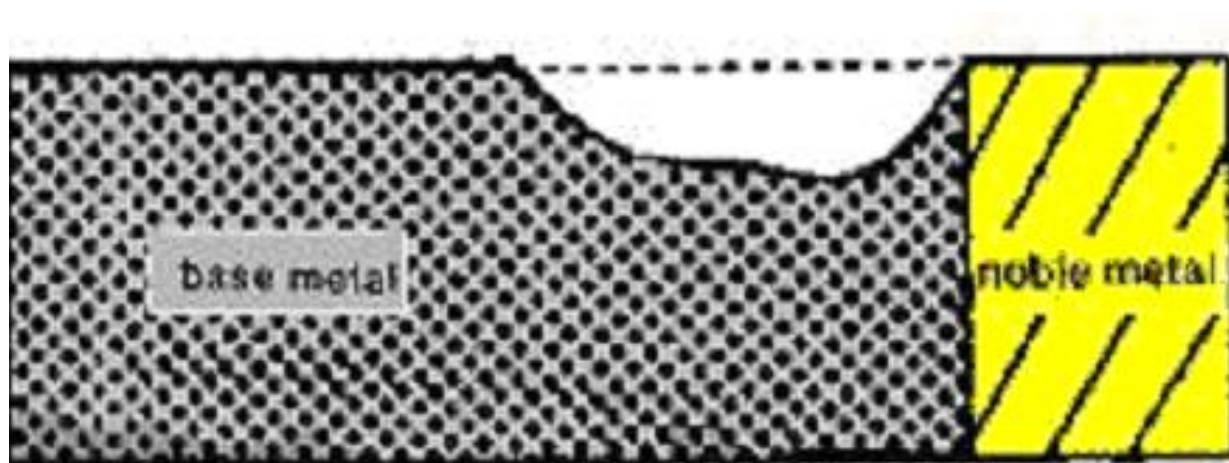
Figure 4-70 – Preferential galvanic corrosion of the more active component of the two materials.

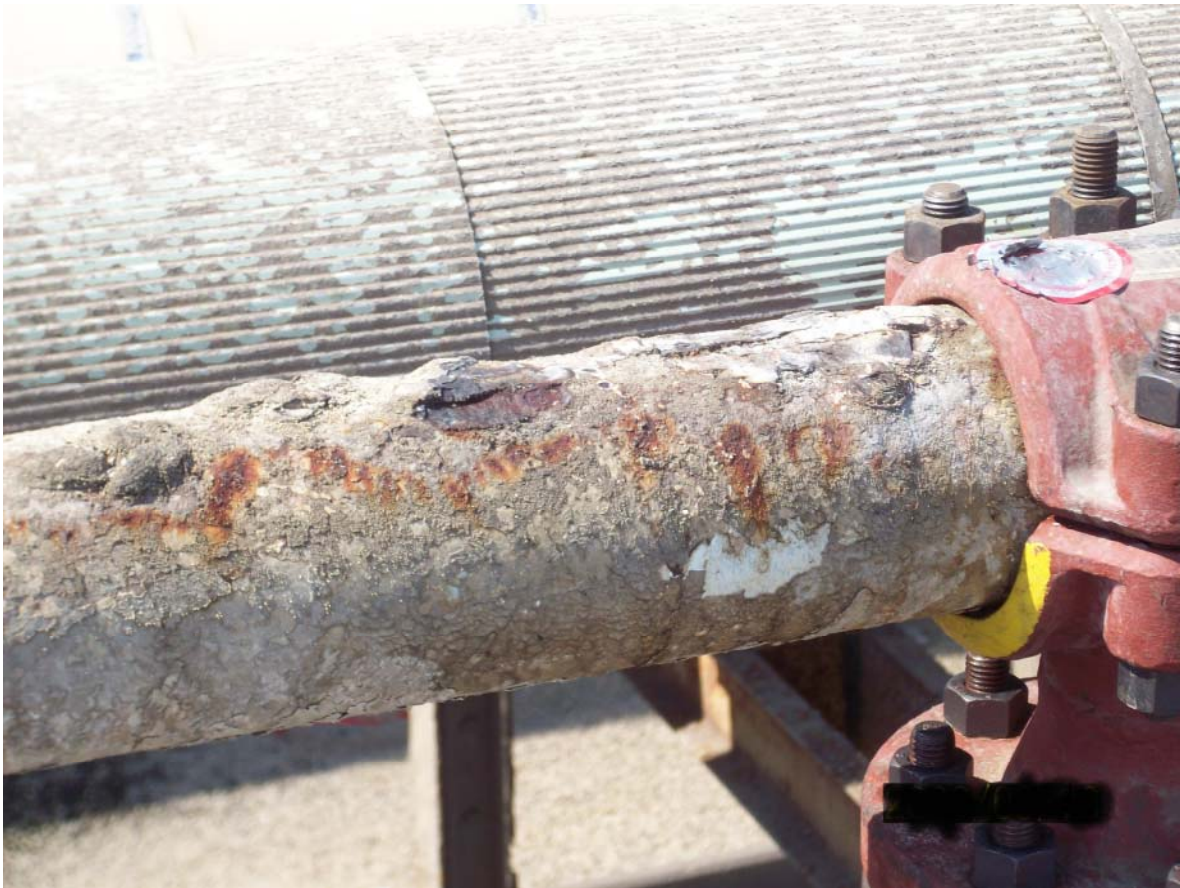
**Figure 4-72 – Atmospheric Corrosion of an LPG line in close proximity to a cooling tower.**
