# Damage Mechanisms Affecting Fixed Equipment in the Refining Industry

API RECOMMENDED PRACTICE 571  
SECOND EDITION, APRIL 2011

**Downstream Segment**

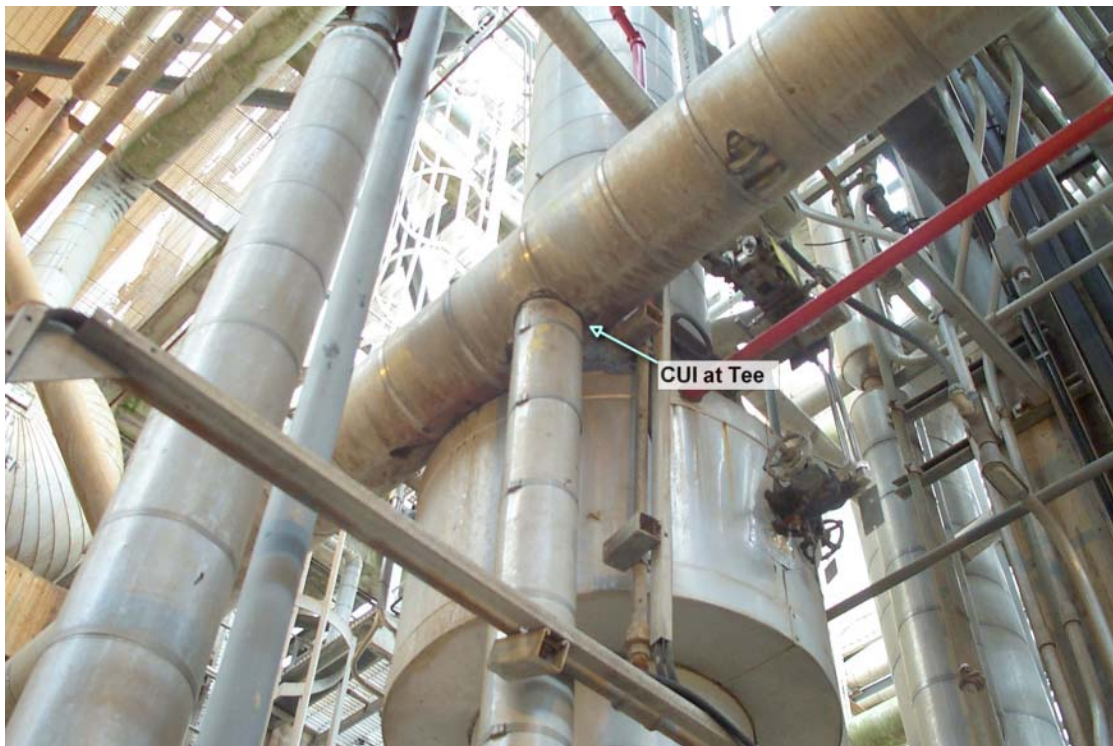
**Figure 4-73 – Tee in a 1000 psig ethylene line before insulation removal.**

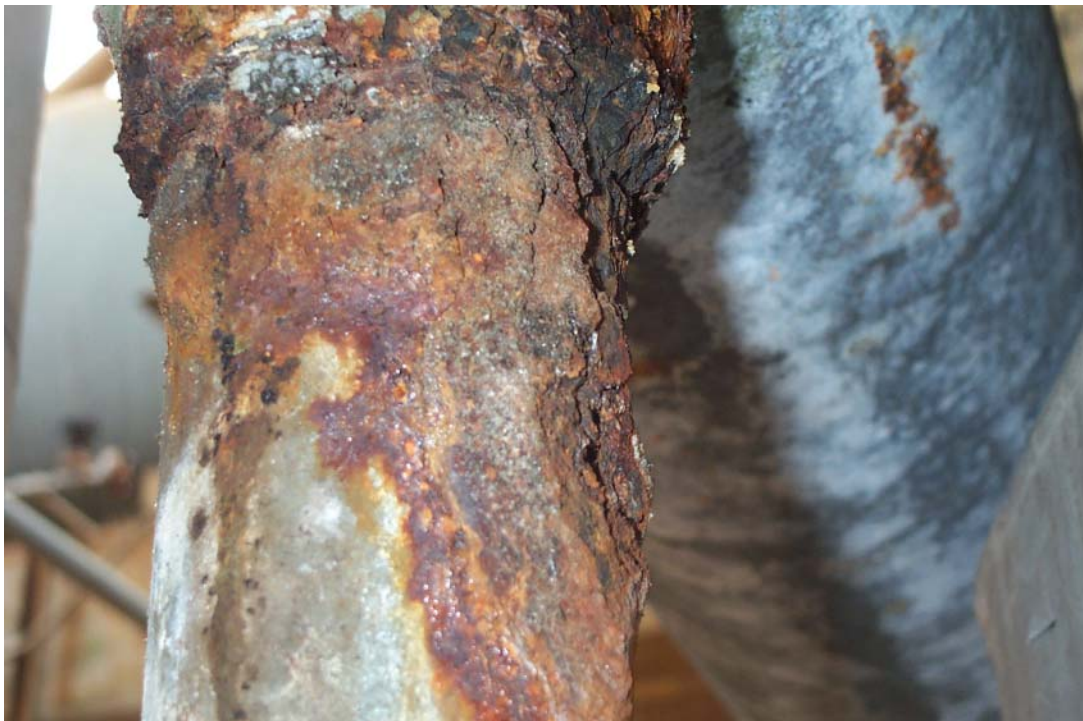
**Figure 4-74 – Close-up of Tee CUI of a Tee in Figure 4-73 after insulation removal.**

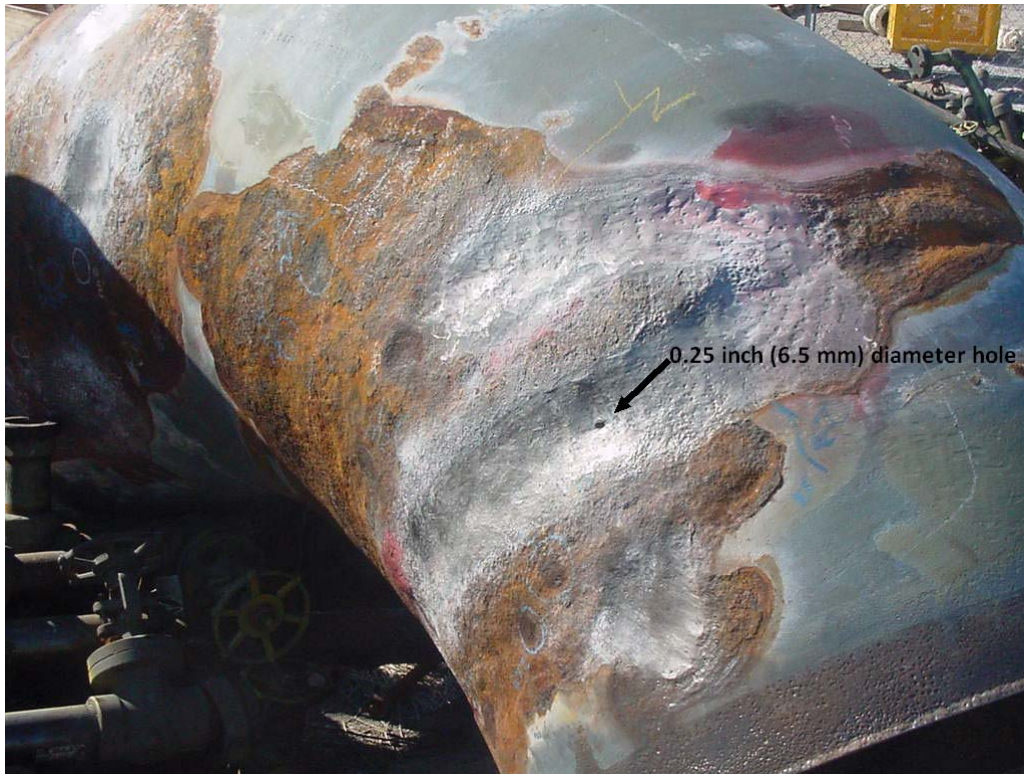
**Figure 4-75 – CUI of a 30 inch CS Butadiene line showing highly localized corrosion which could only be found by stripping the entire line. Note the 0.25 in (6.5 mm) diameter hole at arrow.**

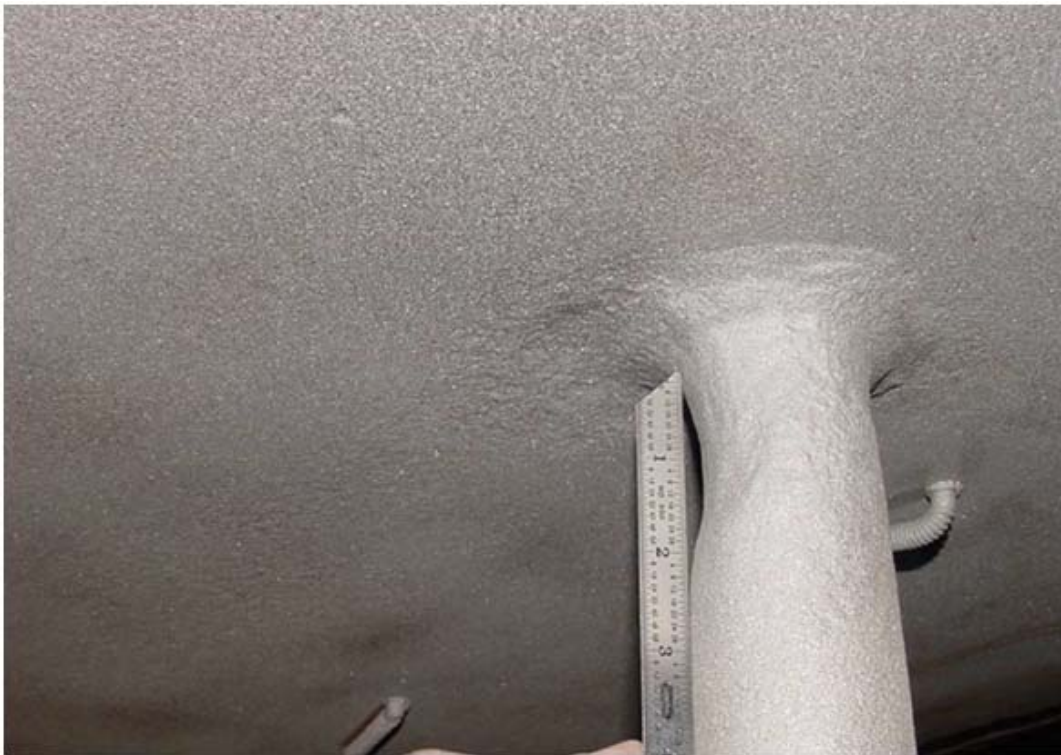
**Figure 4-76 – CUI of nozzle on a bottom head.**

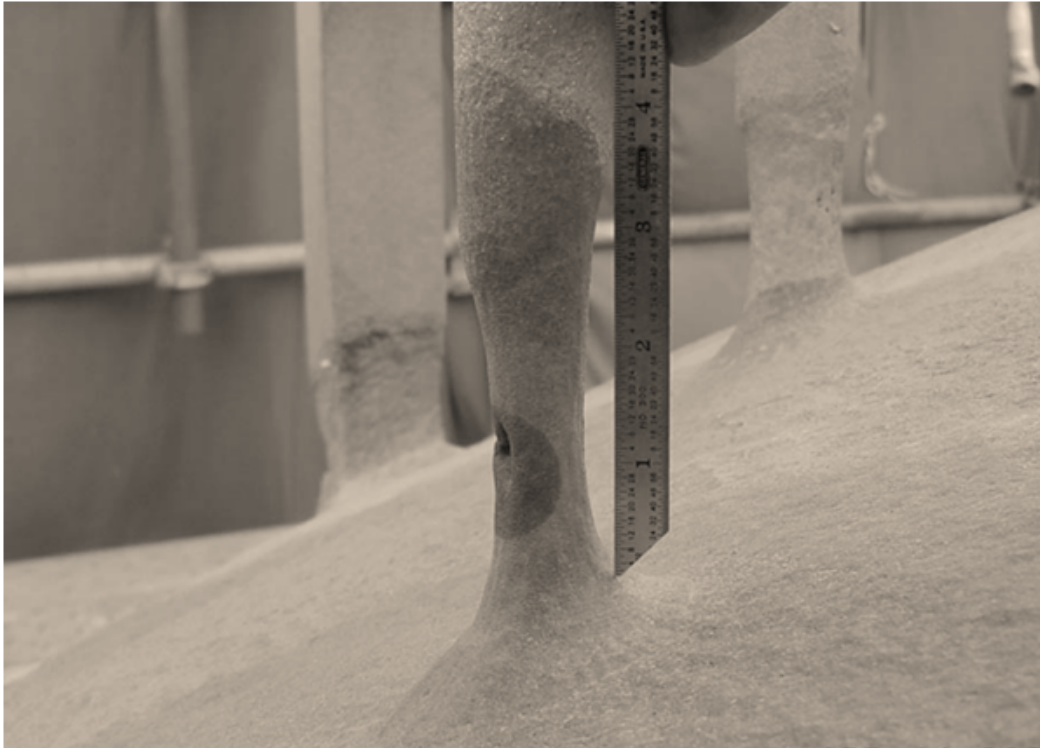
Figure 4-77 – CUI of nozzle on a top head.

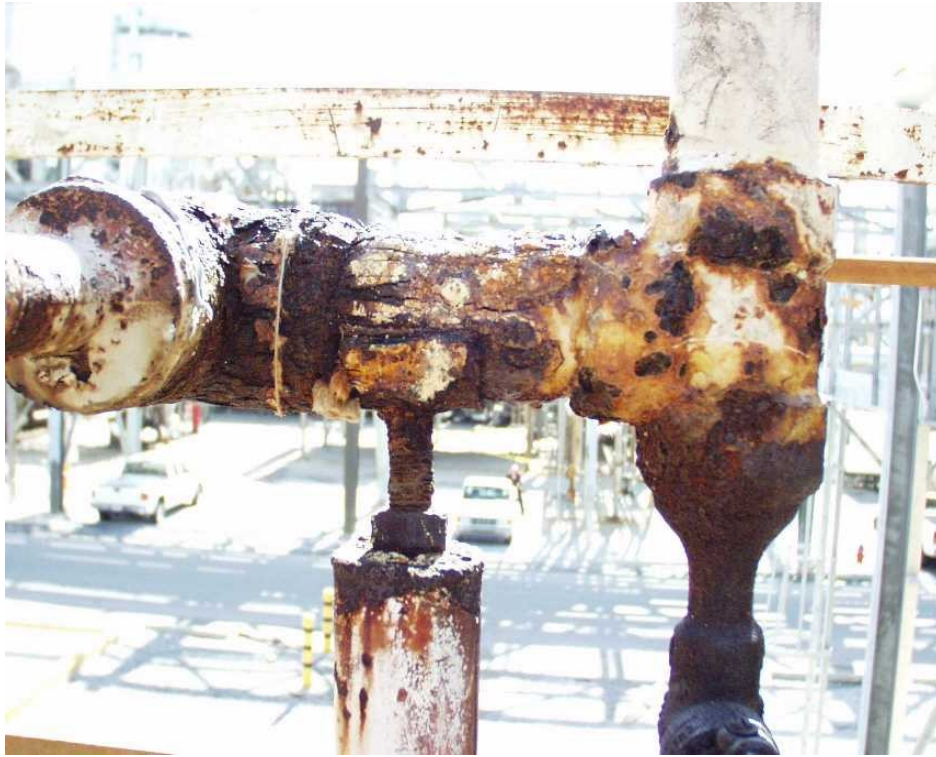
**Figure 4-80 – CUI of CS level bridge.**

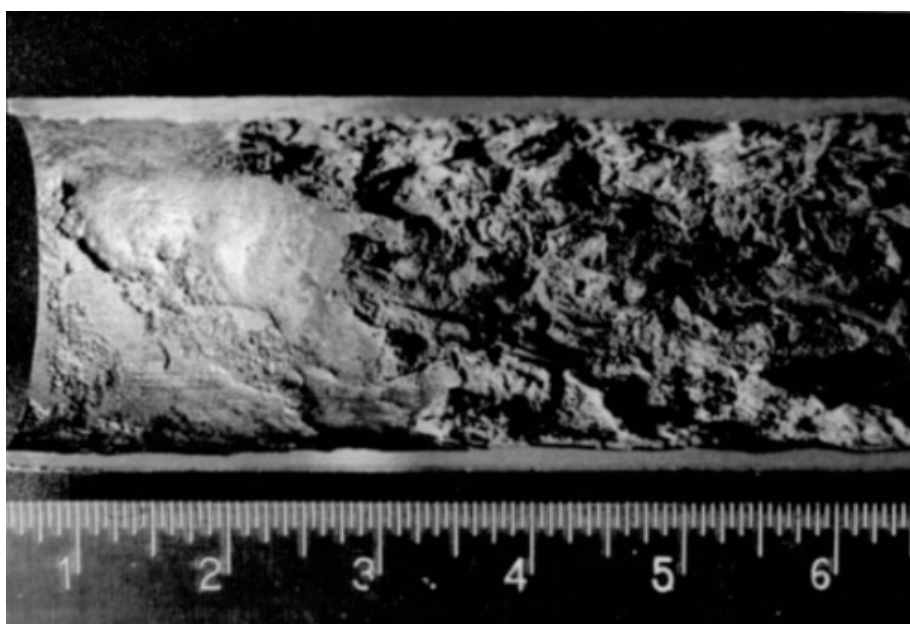
**Figure 4-83 – General metal loss (left end of tube) on steel resulting from oxygen corrosion. The color of hydrous ferric oxide is orange to red brown.**

- a) Corrosion from oxygen tends to be a pitting type damage and can show up anywhere in the system even if only very small quantities break through the scavenging treatment. Oxygen is particularly aggressive in equipment such as closed heaters and economizers where there is a rapid water temperature rise (Figure 4-82).
- b) Corrosion in the condensate return system tends to be due to carbon dioxide although some oxygen pitting problems can occur if the oxygen scavenging treatment is not working correctly. Carbon dioxide corrosion tends to be a smooth grooving of the pipe wall (Figures 4-83 and 4-84).

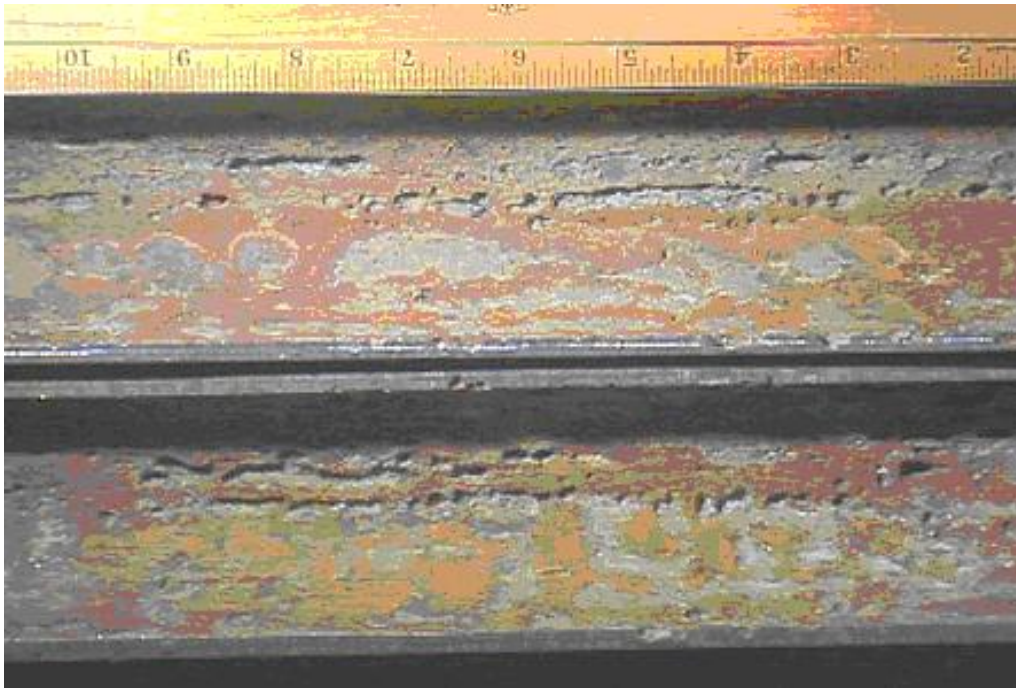
**Figure 4-85 – CO<sub>2</sub> corrosion of a carbon steel oil and gas production flow line.**

- Localized thinning and/or pitting corrosion of carbon steel ([Figure 4-85](#), [Figure 4-86](#) and [Figure 4-87](#)).
- Carbon steel may suffer deep pitting and grooving in areas of turbulence ([Figure 4-88](#)).
- Corrosion generally occurs in areas of turbulence and impingement and sometimes at the root of piping welds.

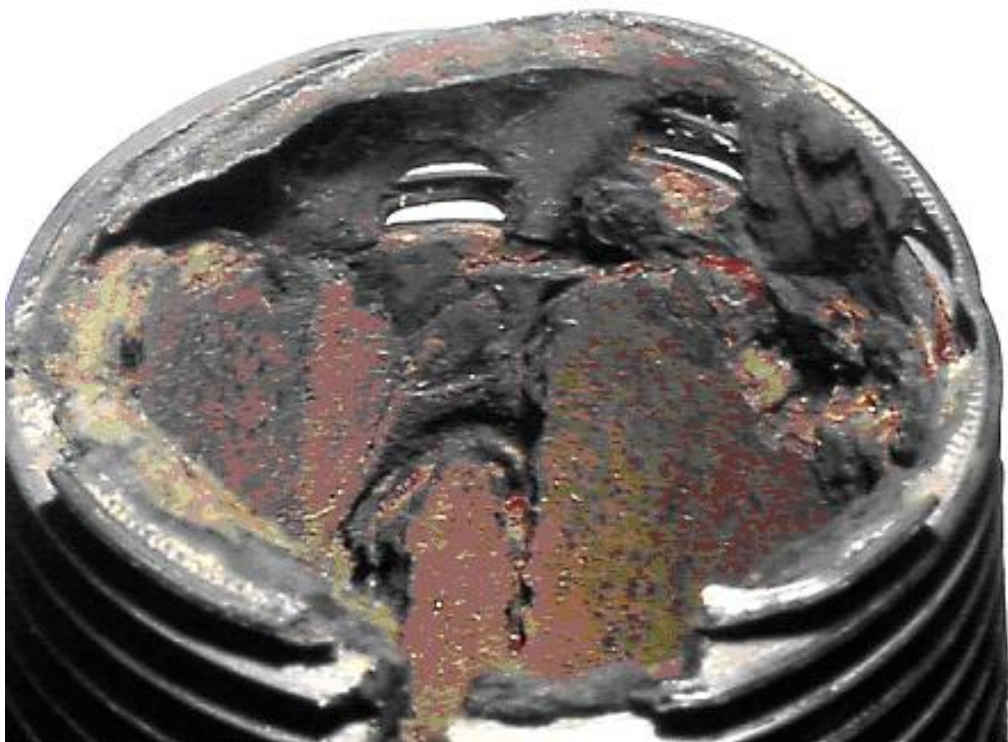
**Figure 4-87 – CO<sub>2</sub> corrosion of CS pipe nipple in CO<sub>2</sub> contaminated water.**

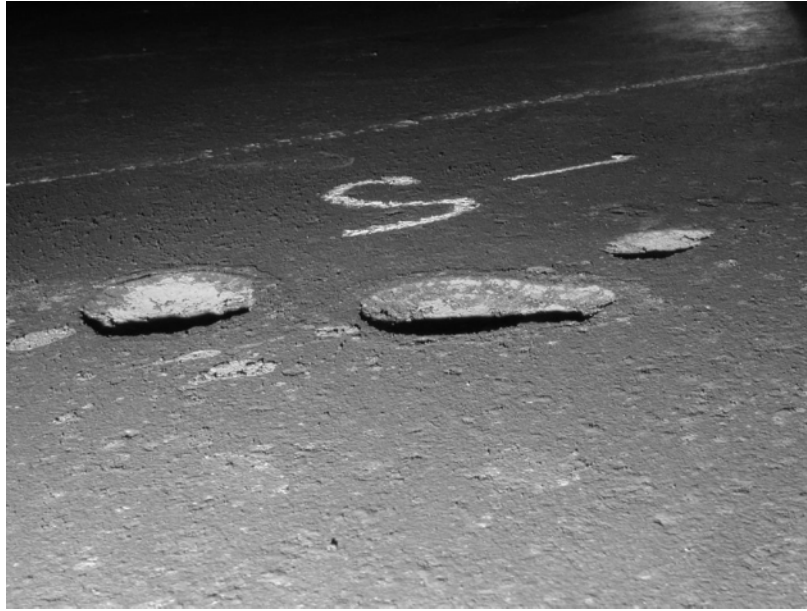
**Figure 4-89 – MIC of diesel tank bottom.**

- a) MIC corrosion is usually observed as localized pitting under deposits or tubercles that shield the organisms.
- b) Damage is often characterized by cup-shaped pits within pits in carbon steel or subsurface cavities in stainless steel ([Figure 4-89](#) through [Figure 4-95](#)).

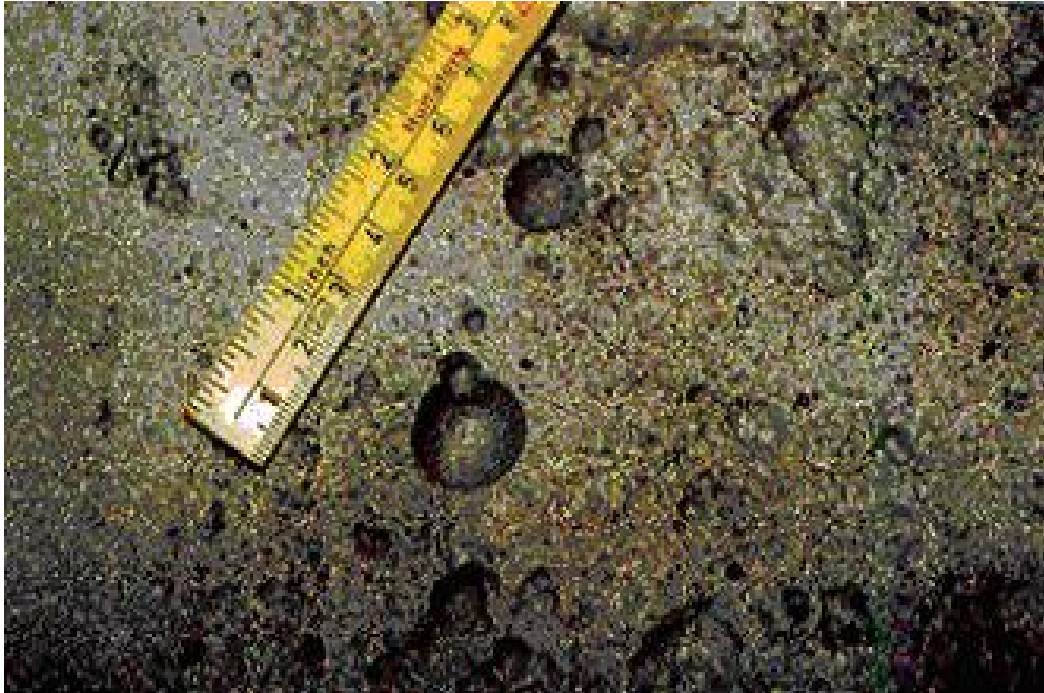
**Figure 4-93 – Same oil line as Figure 4-92. Hemispherical pitting typical of MIC can be seen after grit blasting to remove the scale.**

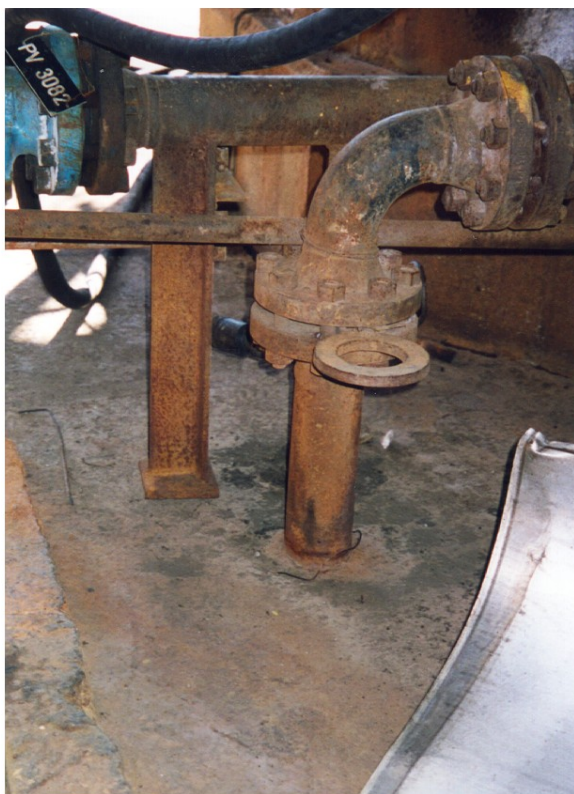
**Figure 4-96 – Corrosion of carbon steel pipe at the soil-air interface where the pipe emerges from underground.**

- d) Soils having high moisture content, high dissolved salt concentrations, and high acidity are usually the most corrosive.
- e) Soil-to-air interface areas are often much more susceptible to corrosion than the rest of the structure because of moisture and oxygen availability ([Figure 4-96](#)).

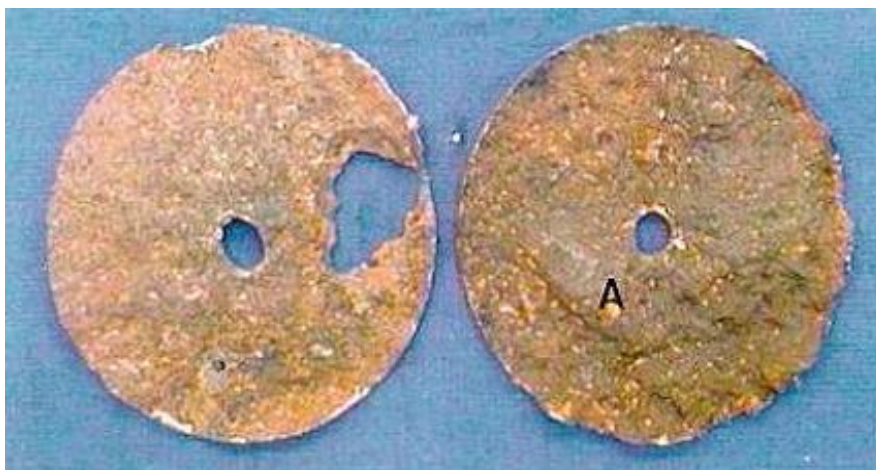
**Figure 4-97 – Coupons removed from the bottom of an unprotected steel condensate storage tank after 3 years of service. The external surface is shown.**

- a) Underground piping and equipment as well as buried tanks and the bottoms of above ground storage tanks ([Figure 4-97](#)).
- b) Ground supported metal structures ([Figure 4-98](#)).

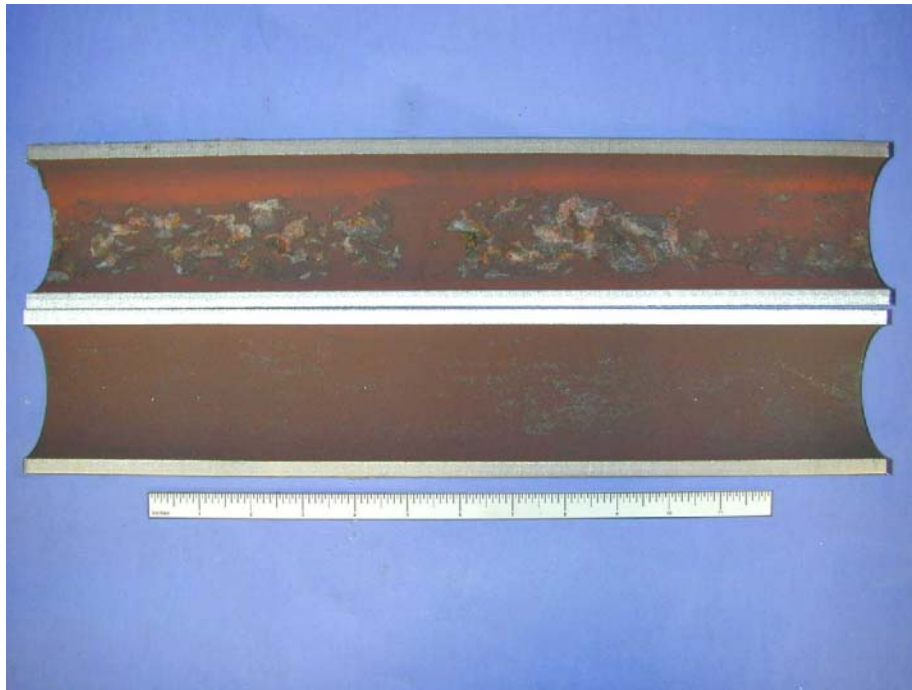
**Figure 4-99 – I.D. deposits on CS boiler tube with damage due to caustic corrosion.**

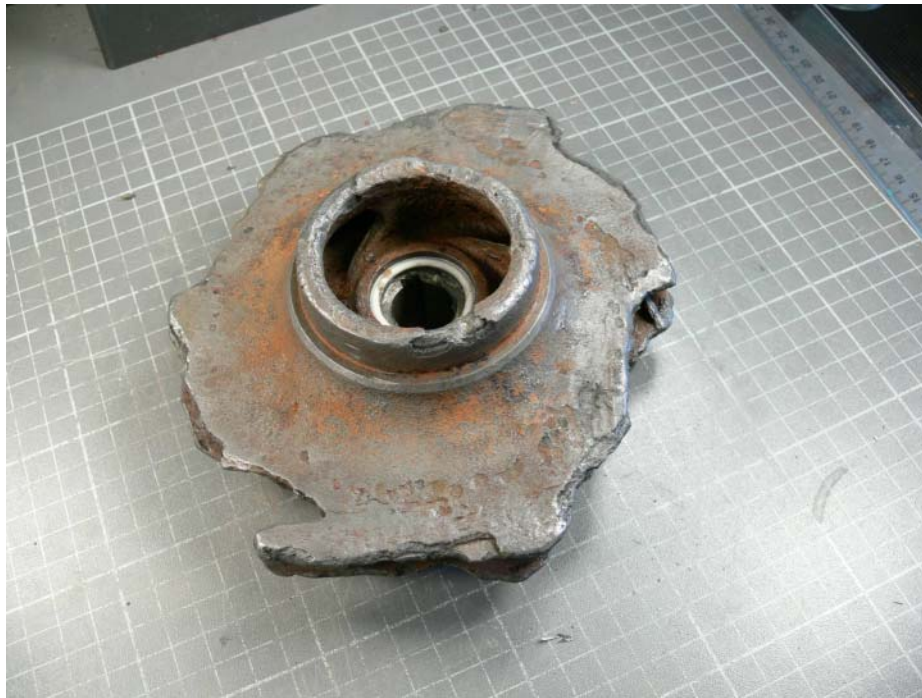
**Figure 4-103 – Graphitic Corrosion of cast iron impeller due to glycol acidification.**

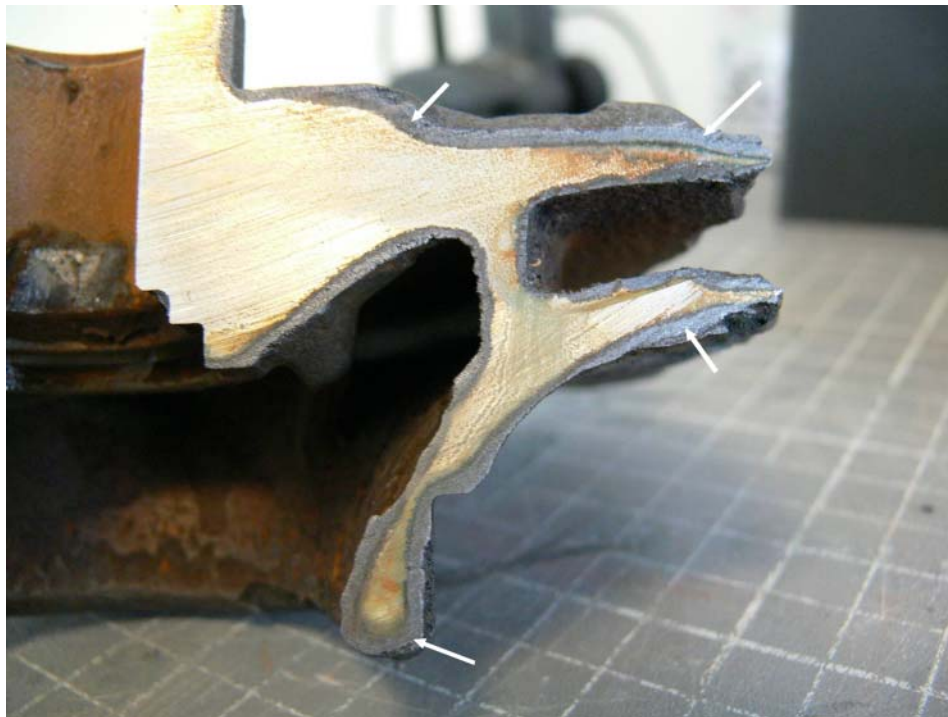
**Figure 4-104 – Cut away of cast iron impeller shown above. The dark phase around the outside perimeter (at arrows) is graphite which surround the unaffected metal in the middle.**

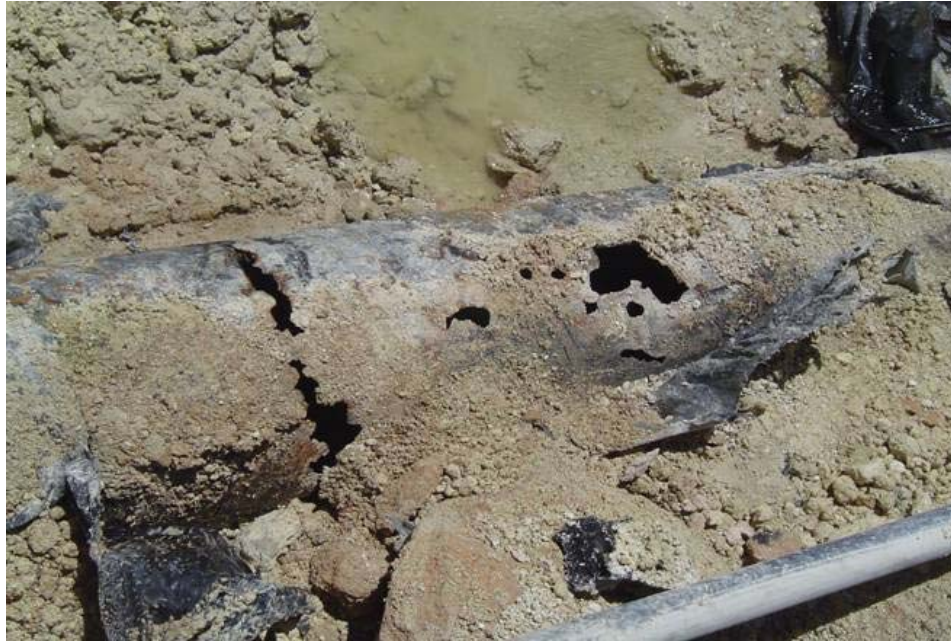
**Figure 4-105 – View of the outside of an underground concrete-lined salt water service line that failed from graphitic corrosion.**

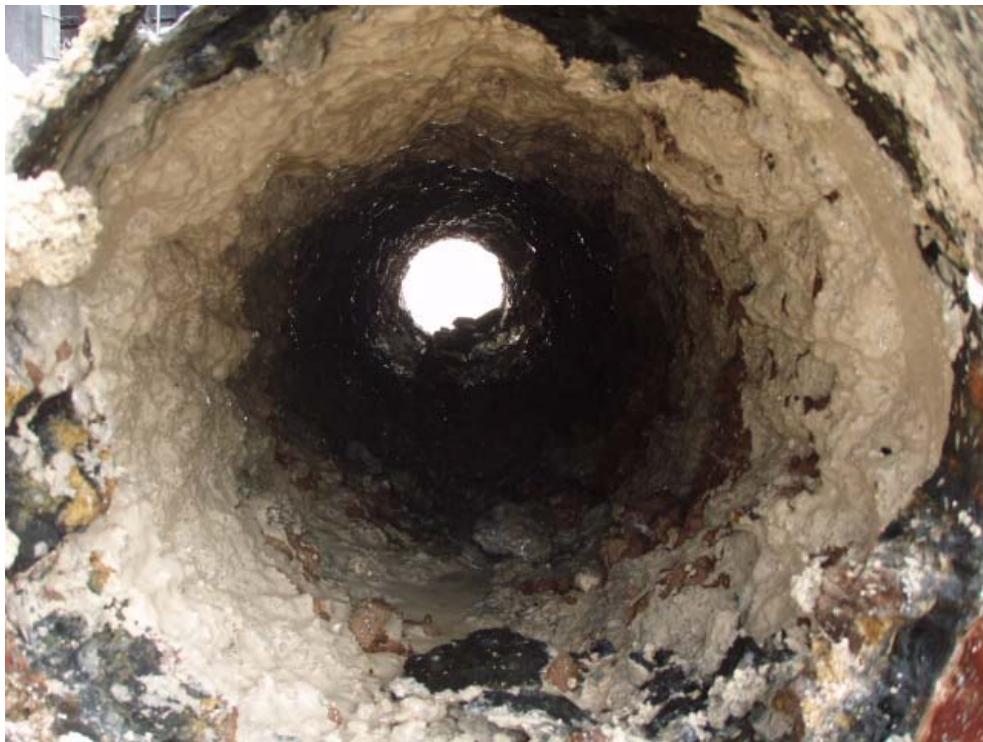
**Figure 4-106 – View of concrete lining inside the failed line shown in Figure 105.**

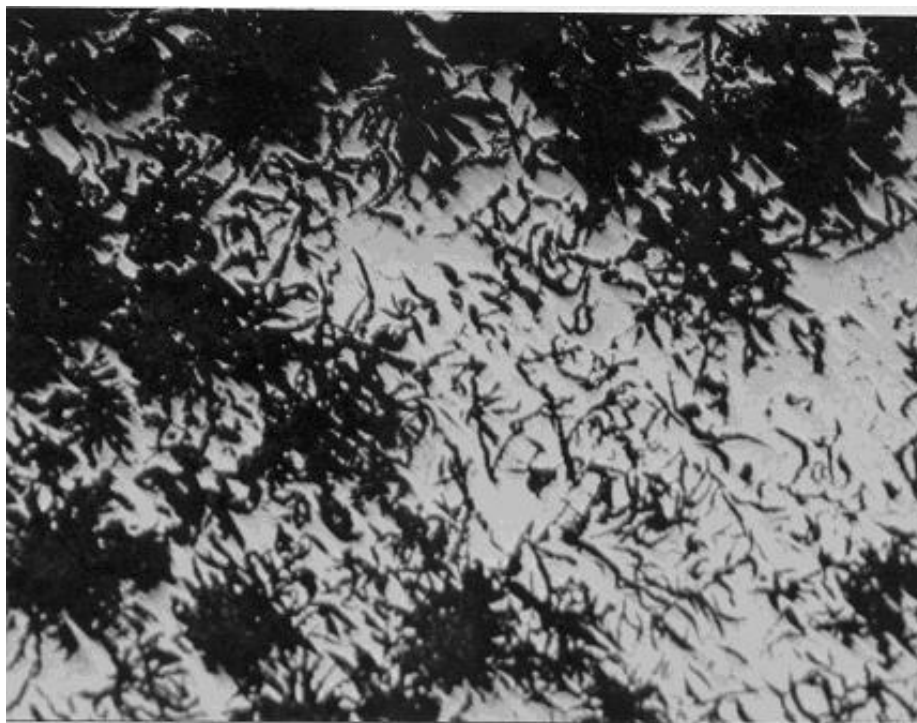
**Figure 4-110 – Higher magnification view of the damage from shown in 4-108 (area “B”).**

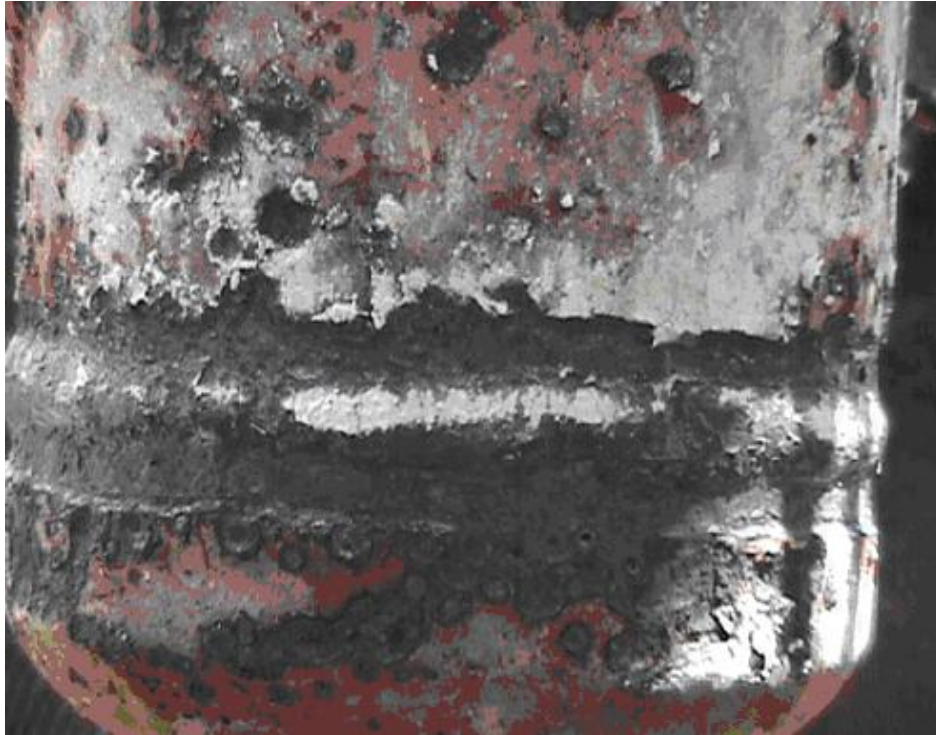
**Figure 4-113 – Oxidation of the O.D. of a carbon steel furnace transfer line.**

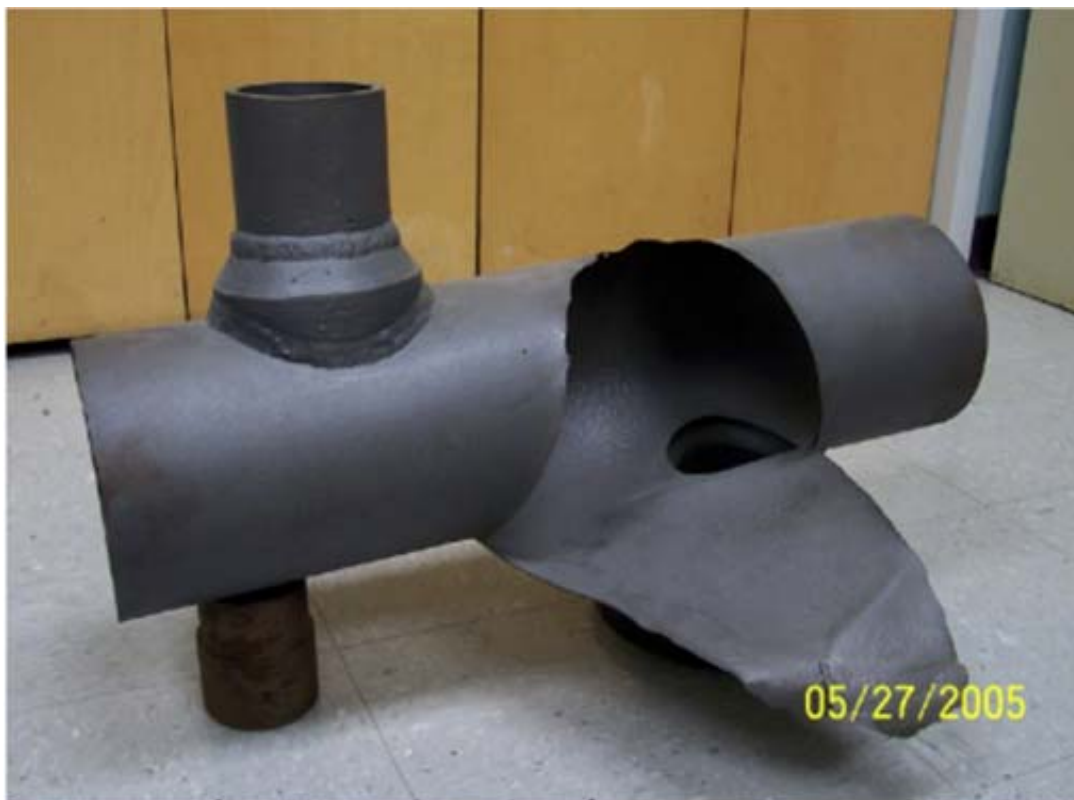
**Figure 4-116 – Sulfidation failure of NPS 8 carbon steel pipe. Note the relatively uniform thinning that resulted in a sizeable rupture.**

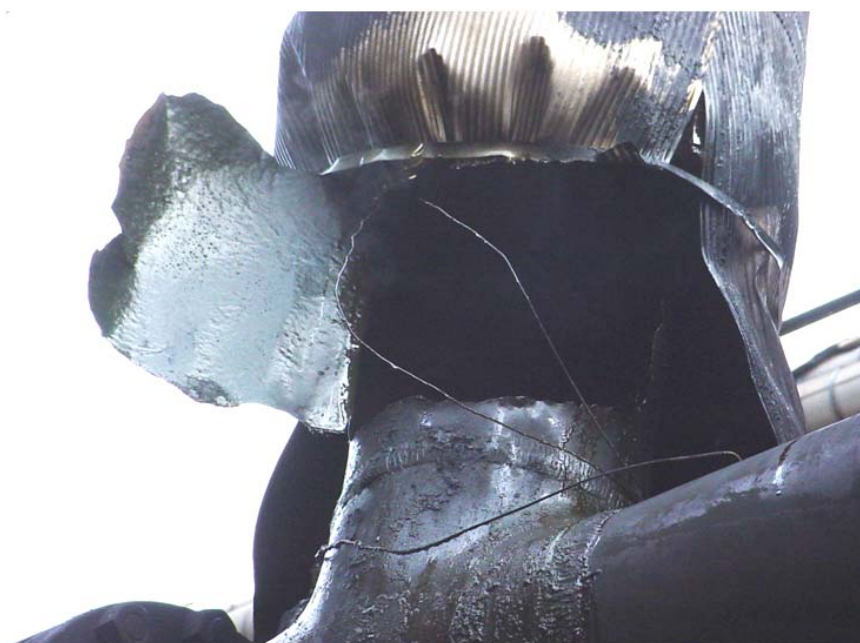
**Figure 4-117 – Sulfidation failure illustrating the effect of accelerated corrosion due to low silicon content. This 8 inch NPS pipe section in FCC bottoms piping was in service at 150 psig (1Mpa) at 650° to 700°F (340° to 370°C). The piping sketch in Figure 118 illustrates the difference in corrosion rate as compared to adjacent high-silicon components.**

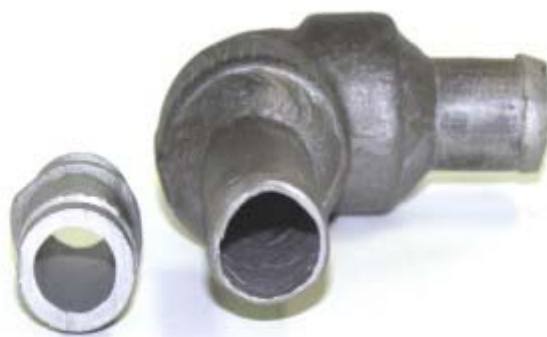
Figure 4-119 – Sulfidation failure of carbon steel sight glass nipple on the right after 2 years in crude unit. Original thickness is shown on left for comparison. Material was supposed to be 9Cr-1Mo.

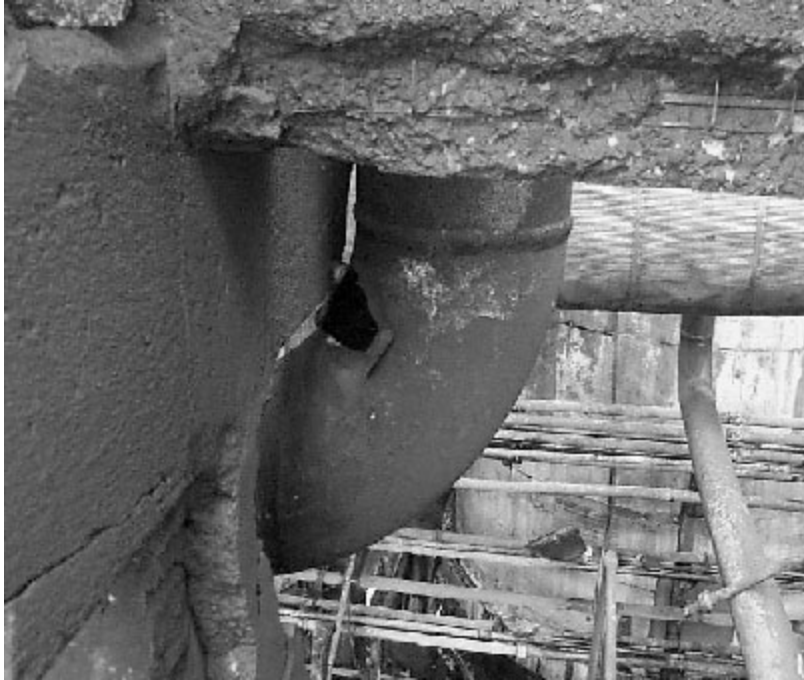
**Figure 4-120 – Sulfidation failure of piping elbow.**

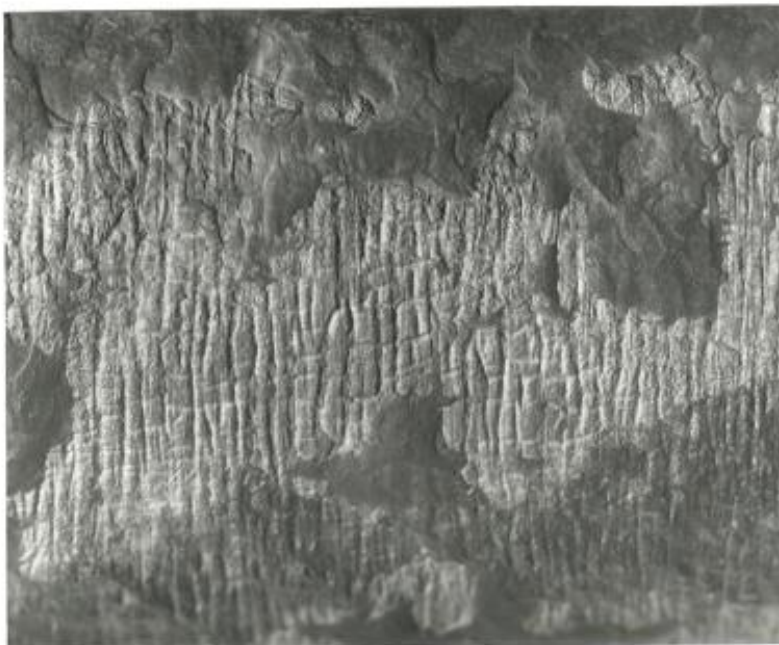
**Figure 4-127 – The “alligator hide” morphology of liquid coal-ash corrosion is evident when the dense, glassy deposit is removed. Mag. 2.4X**

- b) Metallographic examination and deposit-analysis techniques can be used to verify the presence of fuel ash corrosion.
- c) For oil ash corrosion of superheaters and reheaters, the appearance of the ash deposit will be in at least two distinct layers. The important deposit is adjacent to the component, which will have a dark gray or black appearance at room temperature. As the liquid sulfates sinter the corrosion debris to the surface, a hard, glassy, tenacious scale is formed. When removed, the surface of the steel will have an “alligator-hide” appearance (Figure 4-127 and Figure 4-128) as shallow grooves will have penetrated the steel in a cross-hatched pattern.

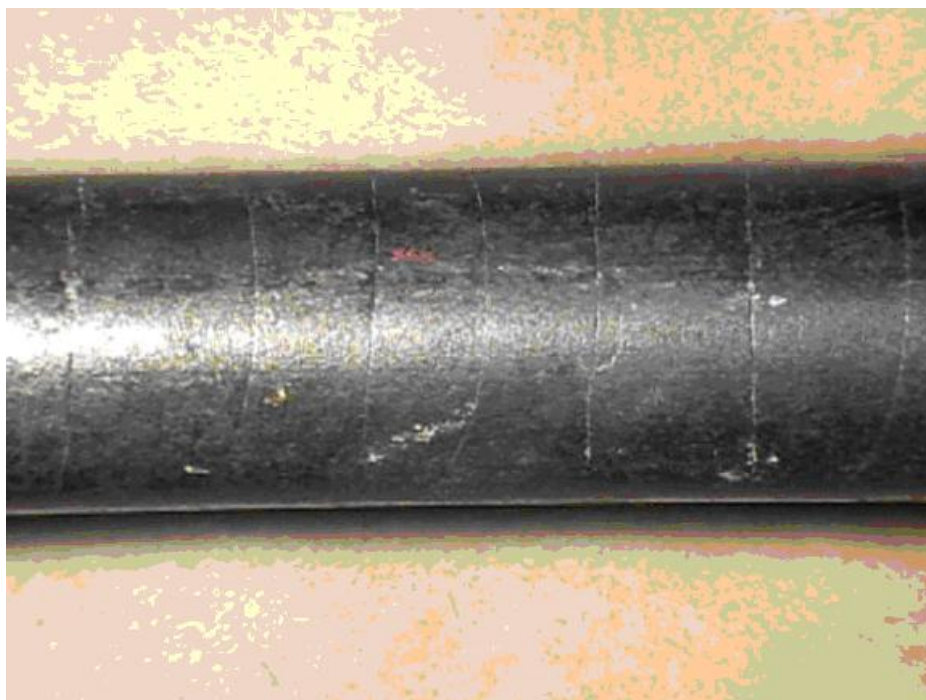
**Figure 4-130 – A nitrided 5Cr-0.5Mo thermowell from an ammonia synthesis plant with surface cracking.**

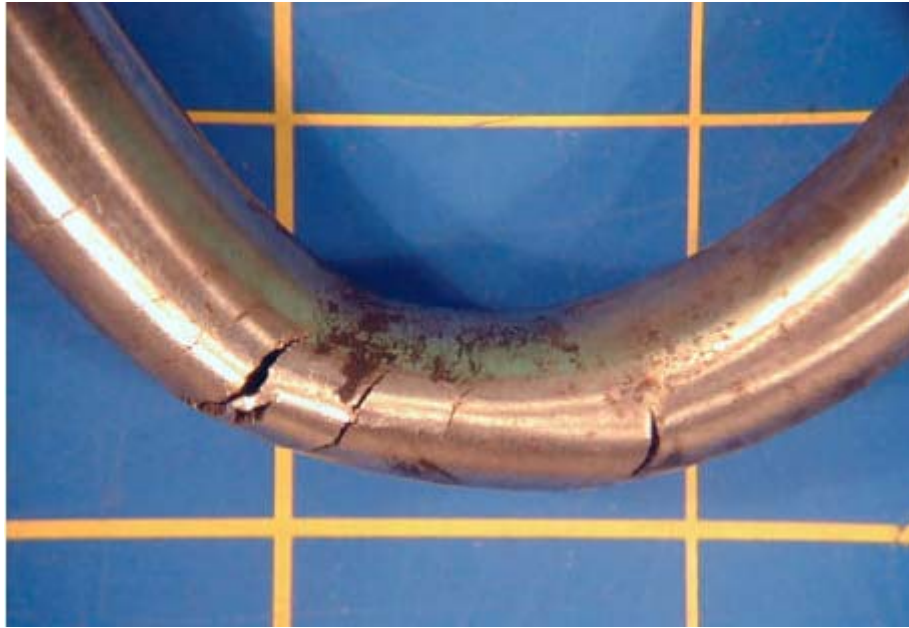
**Figure 4-133 – External cracking of Type 304SS instrument tubing under insulation.**

- a) Surface breaking cracks can occur from the process side or externally under insulation (Figures 4-133 to 4-134).
- b) The material usually shows no visible signs of corrosion.
- c) Characteristic stress corrosion cracks have many branches and may be visually detectable by a craze-cracked appearance of the surface (Figure 4-135 to Figure 4-136).
- d) Metallography of cracked samples typically shows branched transgranular cracks (Figure 4-137 to 4-139).
- e) Sometimes intergranular cracking of sensitized 300 Series SS may also be seen.
- f) Welds in 300 Series SS usually contain some ferrite, producing a duplex structure that is usually more resistant to CI–SCC.
- g) Corrosion-resistant nickel-based alloys are also susceptible to cracking under severe conditions (Figure 4-140).
- h) Fracture surfaces often have a brittle appearance.

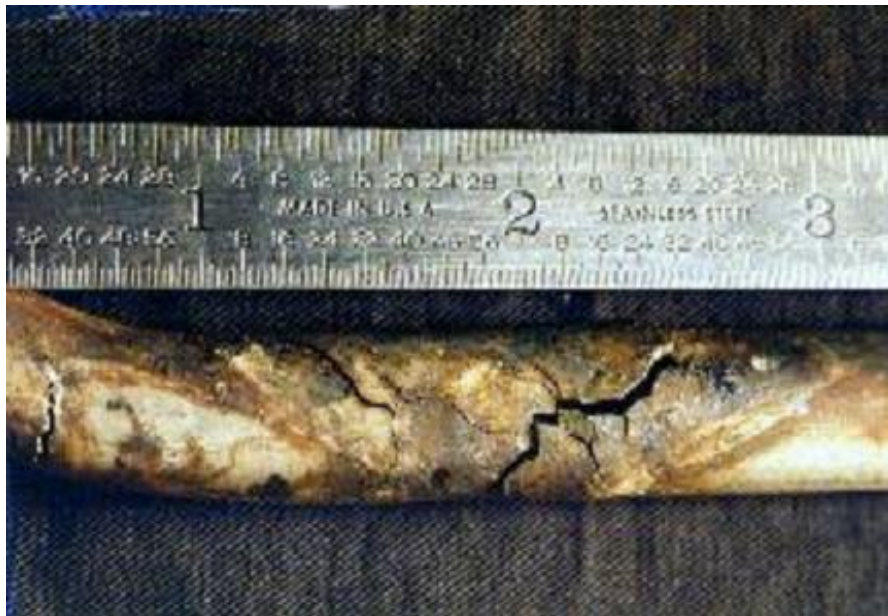
**Figure 4-134 – External cracking of Type 304SS instrument tubing under insulation.**

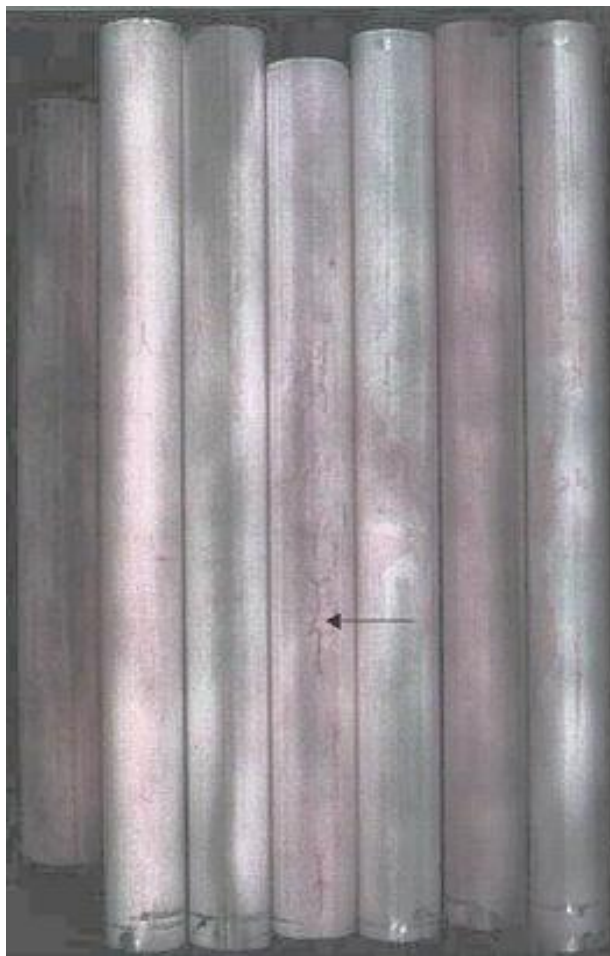
**Figure 4-135 – Cracking on the shell side of Type 316L SS tubes in steam service at 450°F (232°C), showing tubes after PT inspection. The cracks can be seen in the center tube (arrow).**

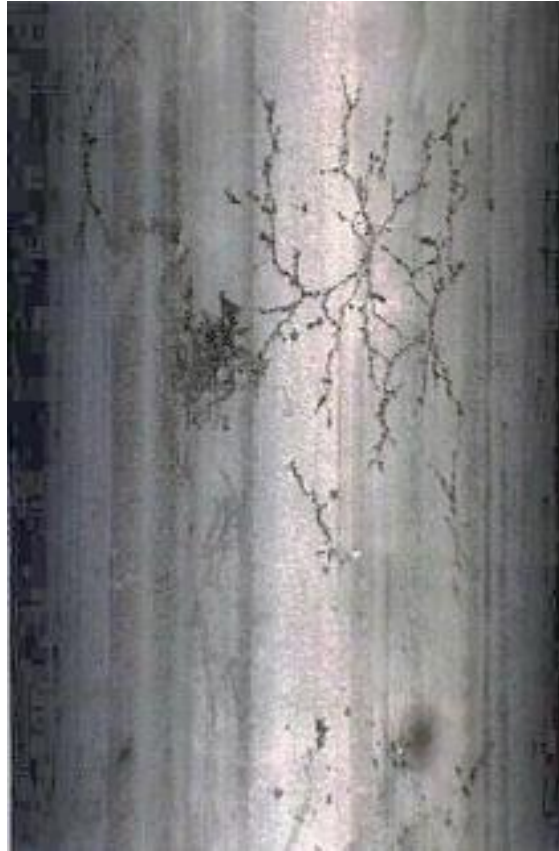
**Figure 4-136 – Close-up of the tube in Figure 4-135 showing tight cracks with a spider web appearance.**

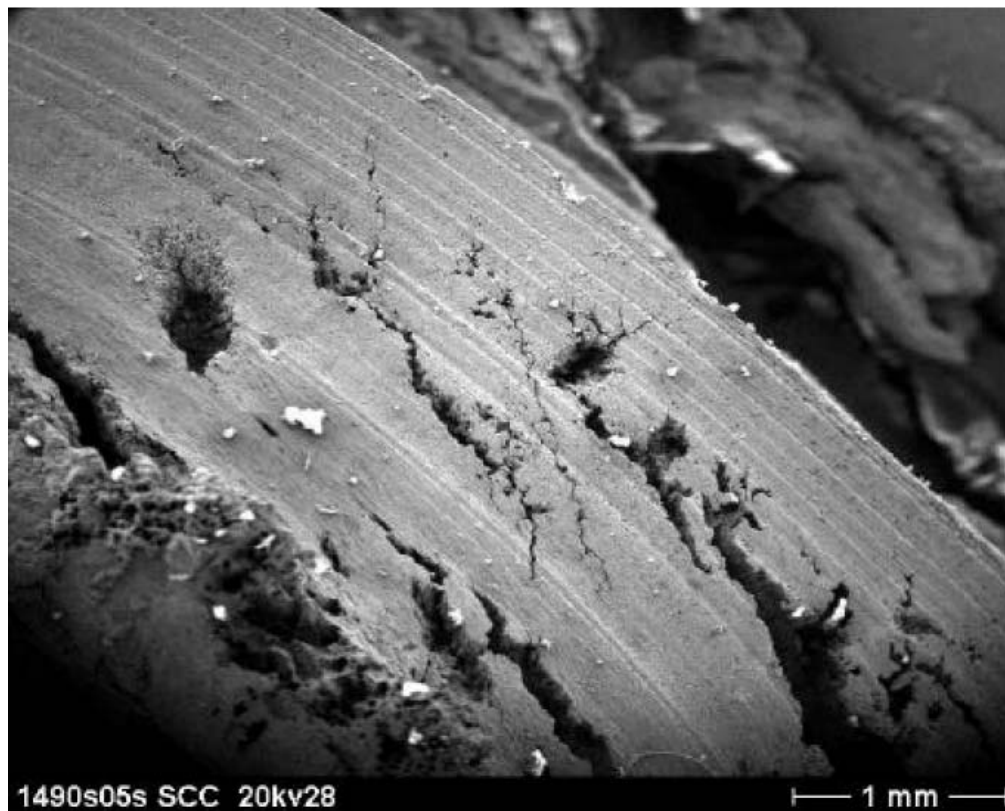
**Figure 4-139 – Chloride SCC on the thread surface of a failed 303SS bolt.**

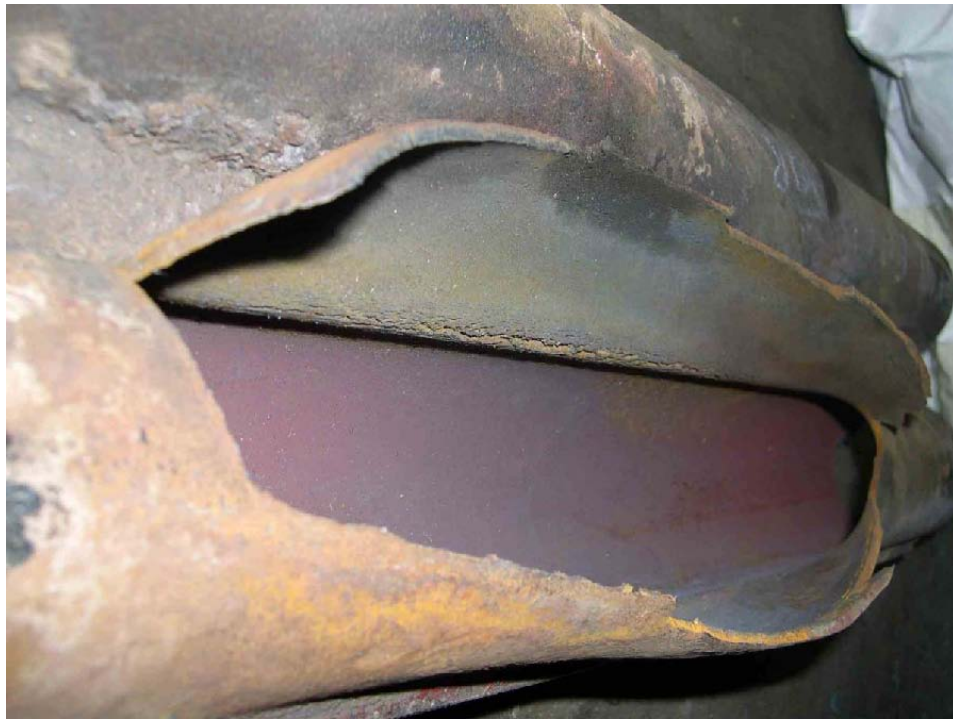
**Figure 4-141 – Corrosion fatigue failure of a boiler tube.**

- c) In cycling boilers, the damage usually appears first on the water side of buckstay (structural) attachments (Figure 4-141). The cracking pattern may be circular cracks surrounding the weld between the buckstay attachment and the waterwall tube. In cross-section, the cracks tend to be bulbous with numerous lobes (Figure 4-142). The crack tips themselves may be somewhat blunted but are oxide filled and transgranular Figure 4-143 to 4-145).
