# Damage Mechanisms Affecting Fixed Equipment in the Refining Industry

API RECOMMENDED PRACTICE 571  
SECOND EDITION, APRIL 2011

**Downstream Segment**

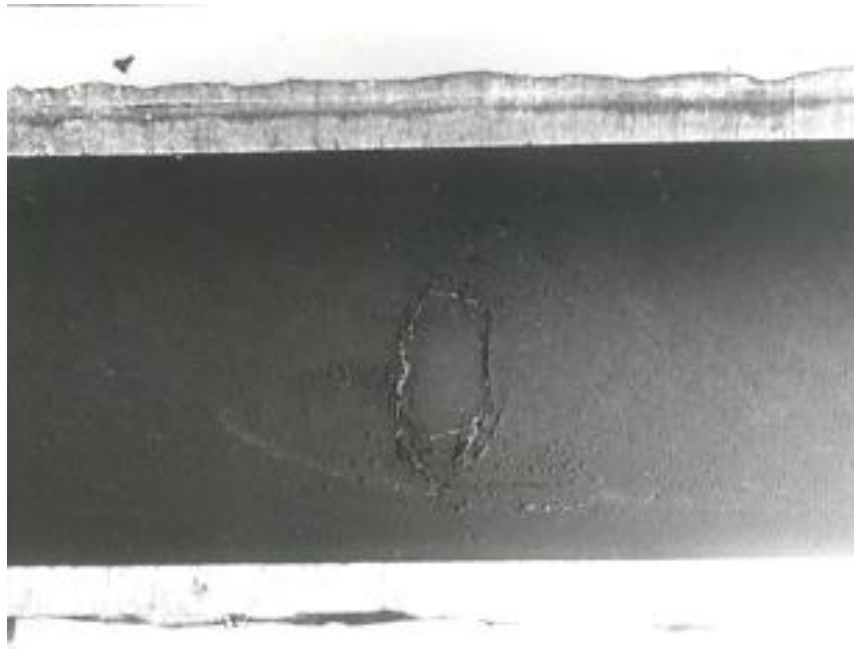
**Figure 4-144 – Photograph of a carbon steel boiler tube cut in half lengthwise. Corrosion fatigue cracks initiate at the I.D. of a tube, opposite a buckstay attachment on the O.D. (Mag. 1X)**

- c) In cycling boilers, the damage usually appears first on the water side of buckstay (structural) attachments (Figure 4-141). The cracking pattern may be circular cracks surrounding the weld between the buckstay attachment and the waterwall tube. In cross-section, the cracks tend to be bulbous with numerous lobes (Figure 4-142). The crack tips themselves may be somewhat blunted but are oxide filled and transgranular Figure 4-143 to 4-145).

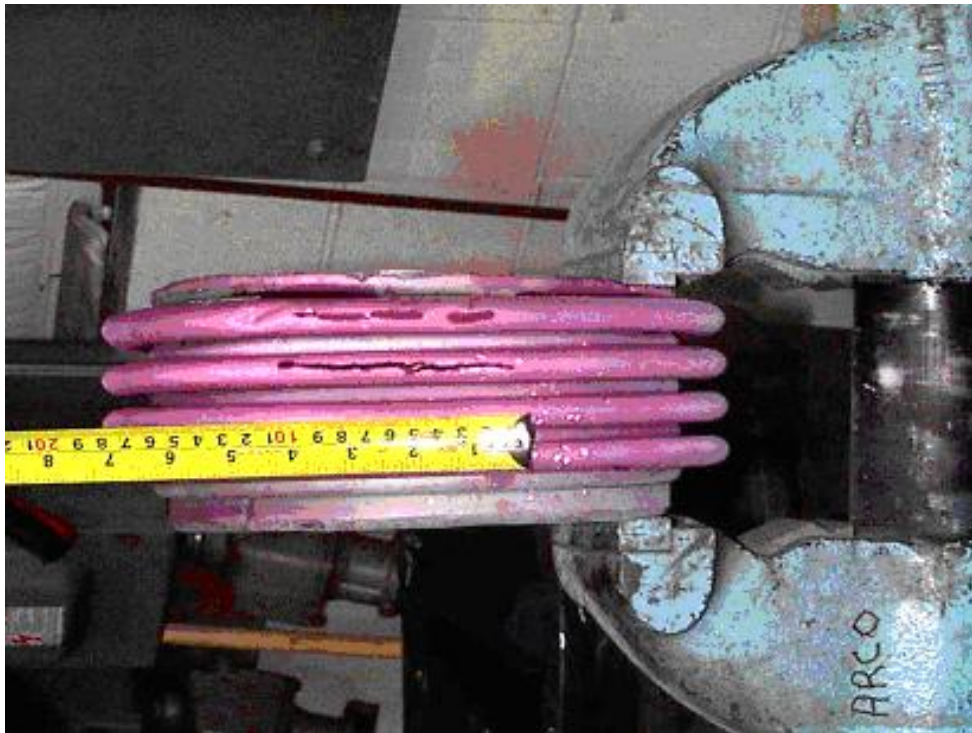
**Figure 4-153 – Stainless steel expansion bellows from a steam-driven turbine previously subjected to a caustic carryover upset condition.**

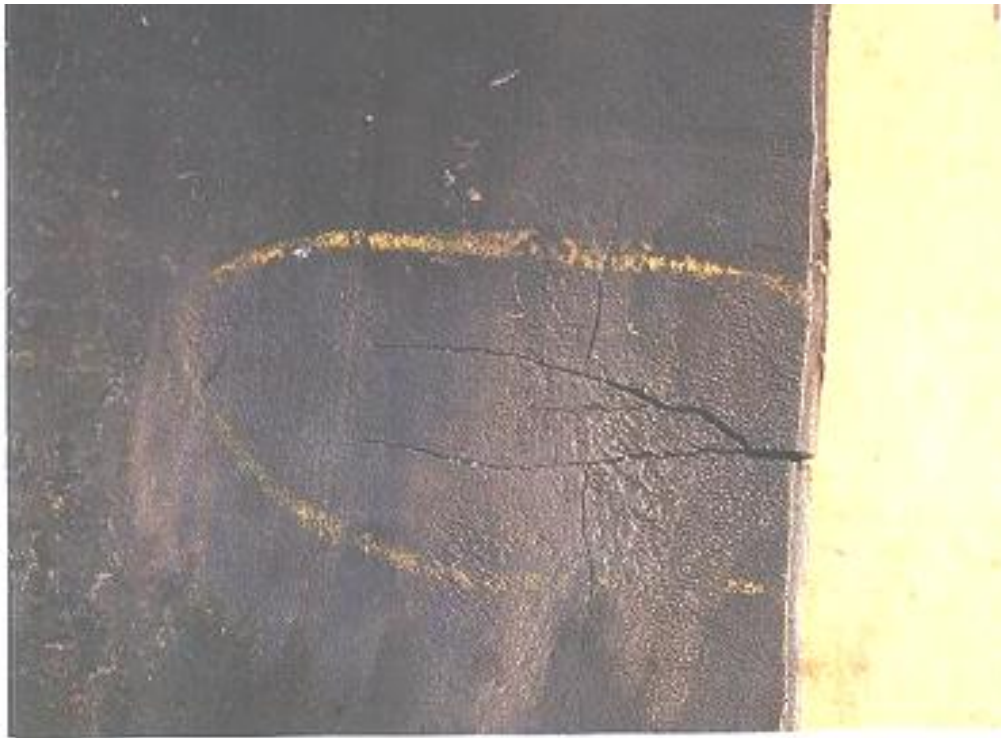
**Figure 4-159 – Liquid metal embrittlement of Monel caused by mercury in an FCC gas plant overhead drum.**

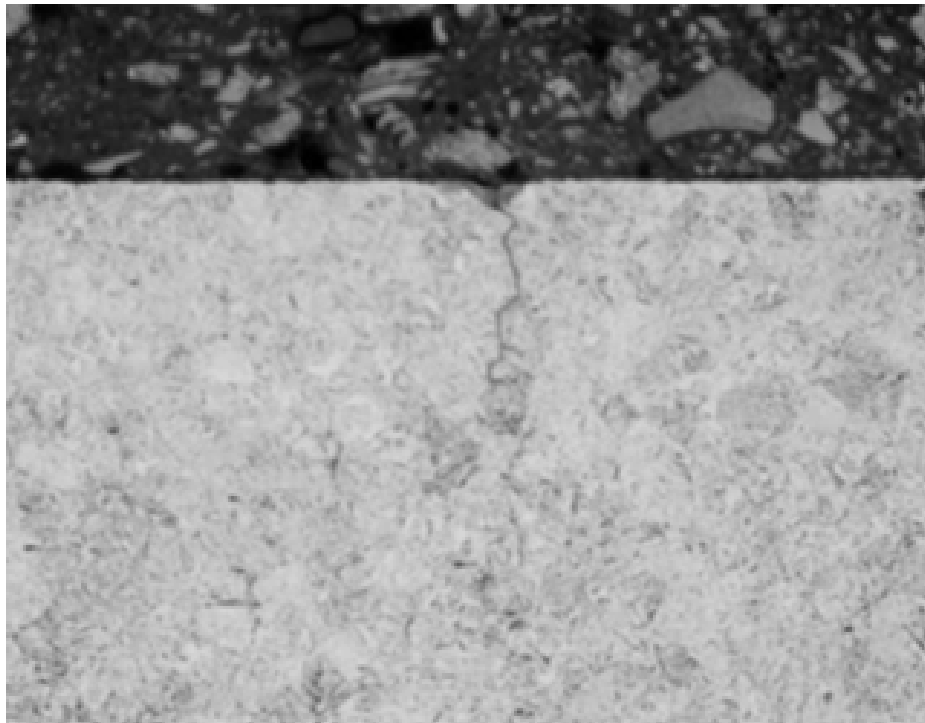
**Figure 4-160 – a.) Cracking due to hydrogen embrittlement of a carbon steel tube. b.) Intergranular crack emanating from surface in the tube.**

- a) Cracking due to HE can initiate sub-surface, but in most cases is surface breaking ([Figure 4-160 to 4-161](#)).
- b) HE occurs at locations of high residual or tri-axial stresses (notches, restraint) and where the microstructure is conducive, such as in weld HAZ's.
- c) On a macro-scale, there is often little evidence, although some materials will appear to have brittle fracture surfaces. On a microscale, the material will contain less ductile fracture surface, but must often be compared to a fracture without the presence of hydrogen.
- d) In higher strength steels, cracking is often intergranular.

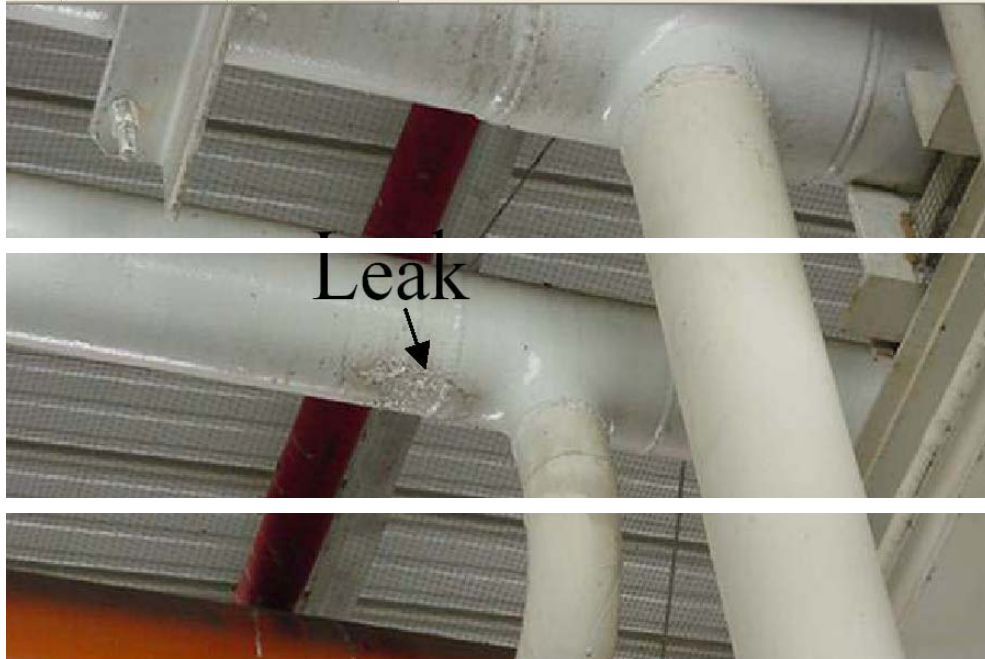
**Figure 4-164 – A leak in piping resulting from an ethanol SCC adjacent to the weld.**

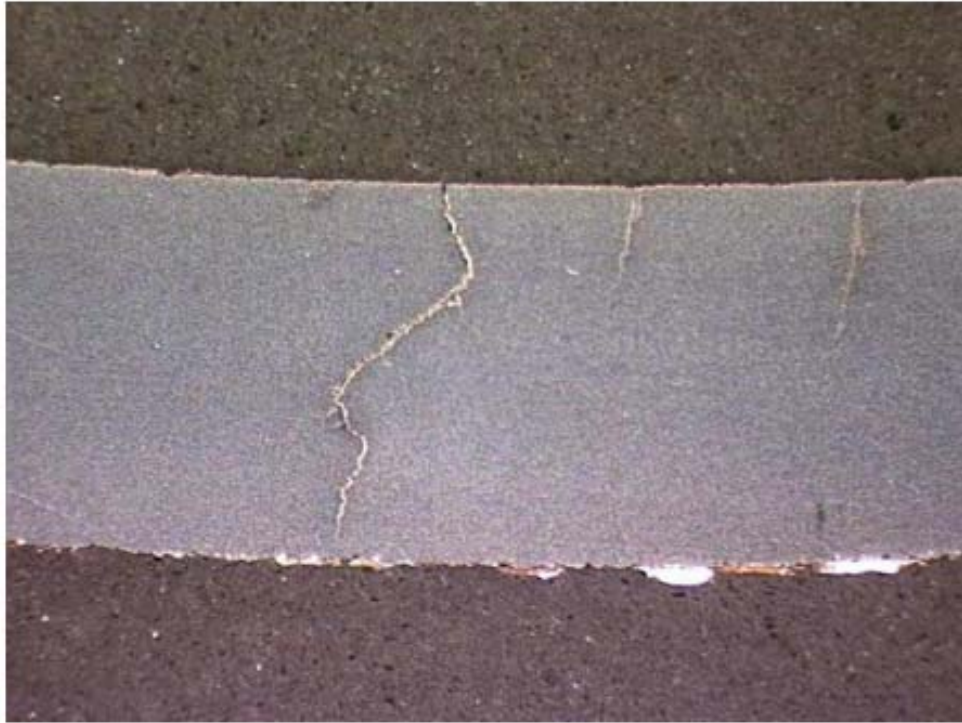
**Figure 4-168 – Transverse cross-section of a piping section exposed to fuel ethanol showing multiple crack initiation sites characteristic of SCC.**

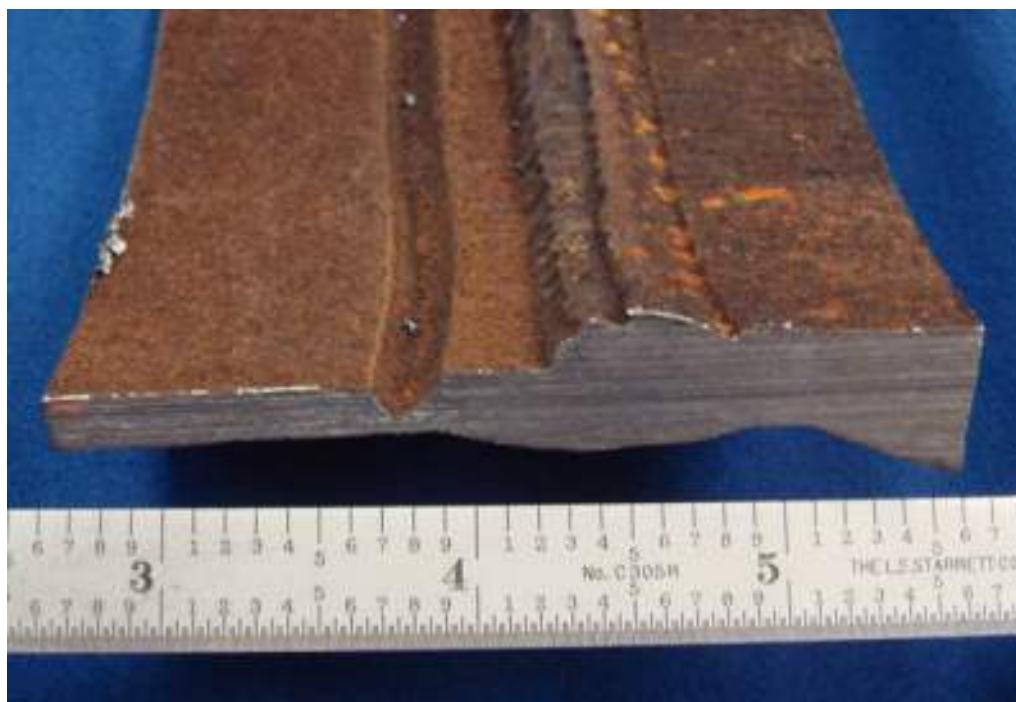
**Figure 5-2 – Hot Lean Amine Corrosion of Carbon Steel:**

- a) Carbon steel and low alloy steels suffer general uniform thinning, localized corrosion or localized underdeposit attack ([Figure 5-1 to 5-6](#)).
- b) Thinning will be uniform in nature when the process stream velocity is low while it will be localized for high velocities associated with turbulence.

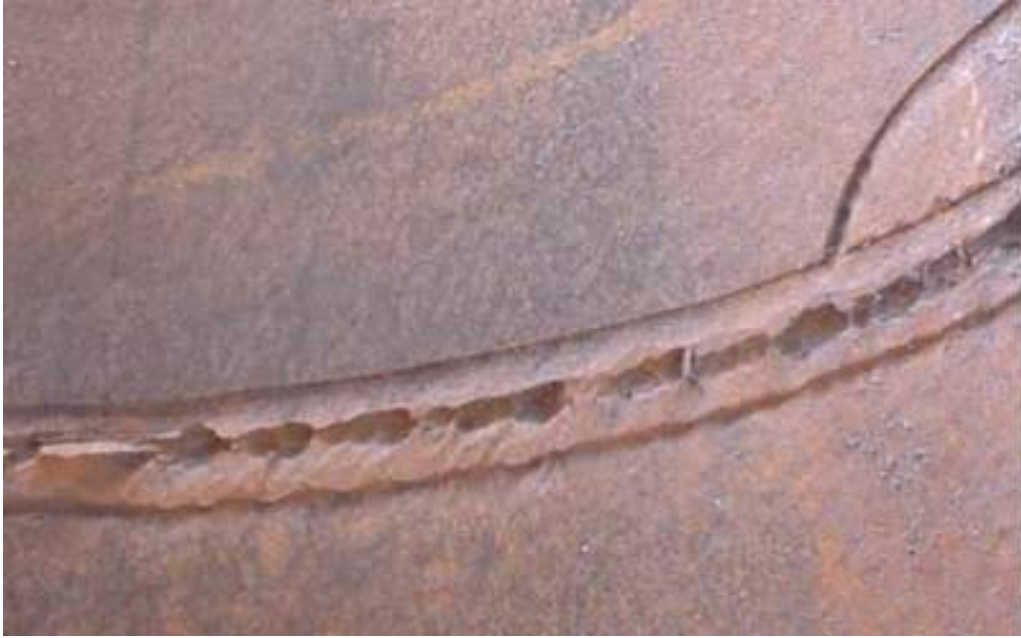
**Figure 5-3 – Preferential weld corrosion in lean amine (Reference 5)**

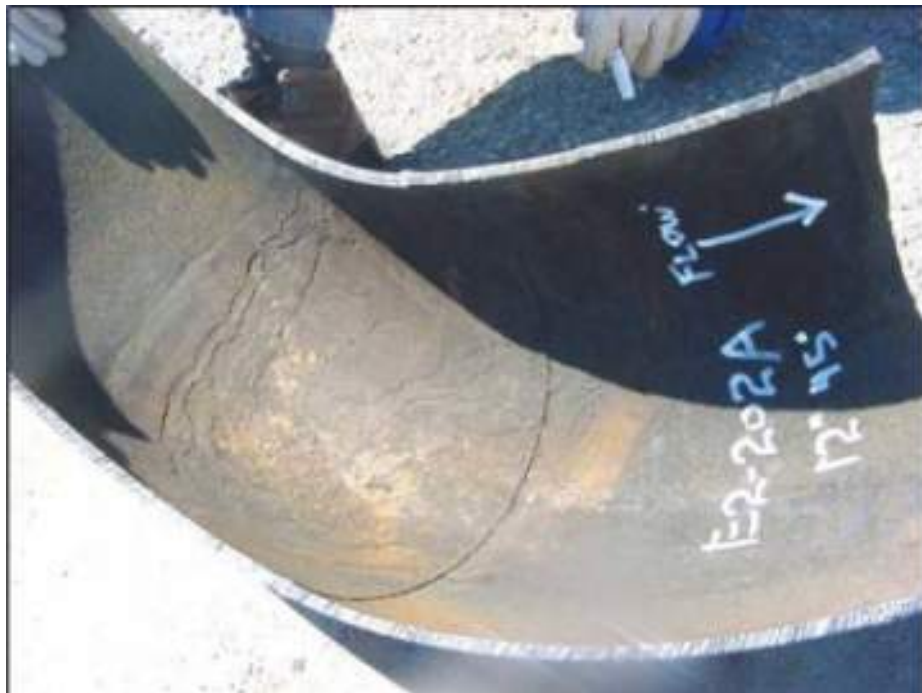
**Figure 5-4 – Preferential corrosion in amine regenerator reboiler return elbow (Reference 6).**

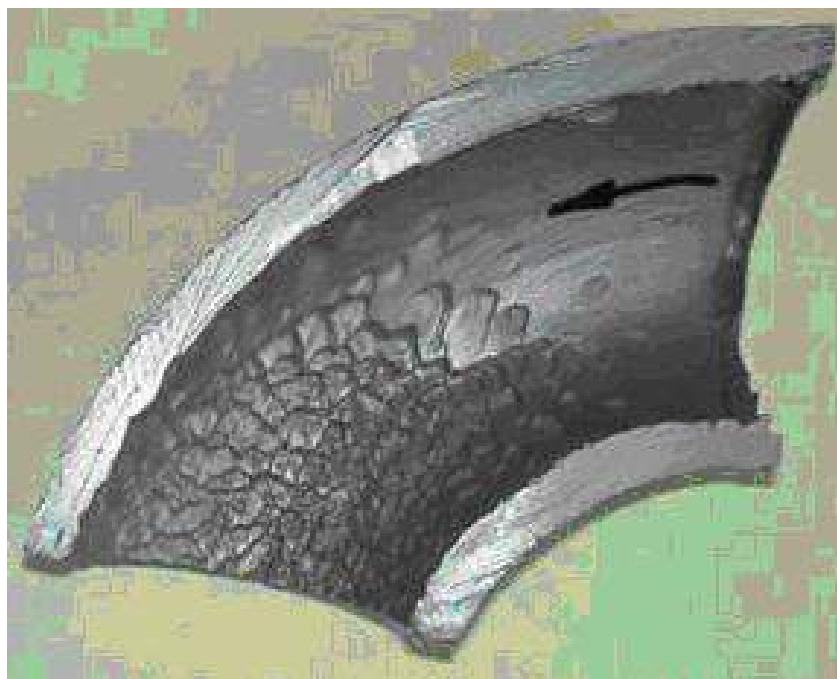
**Figure 5-7 – 2-inch CS elbow and straight section in a sour water line off the cold HPS on an HDT unit.**

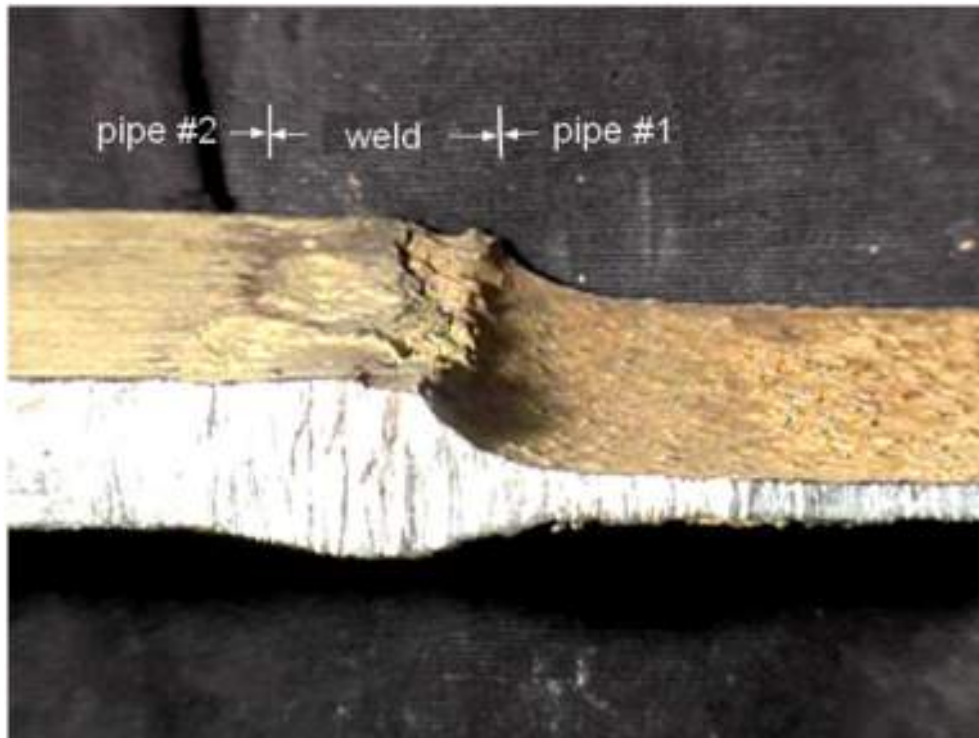
**Figure 5-12 – Cross-section of a carbon steel pipe showing preferential corrosion of the pipe with high residual element content on the right, as compared to the low residual pipe section to the left of the weld (Reference 3).**

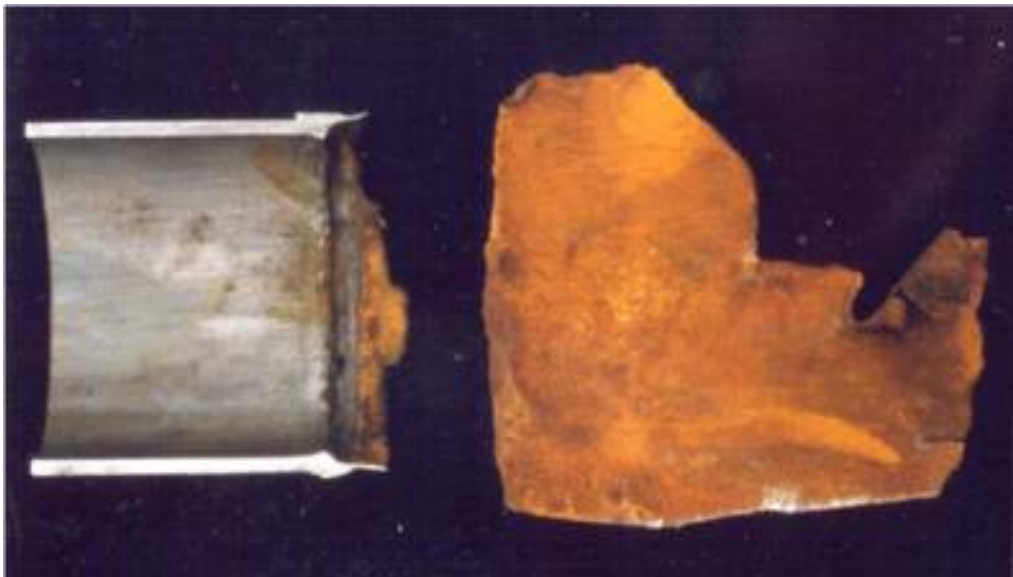
**Figure 5-13 – Ruptured NPS 3 Sch. 80 0.216 in (5.49 mm) Depropanizer Feed Line operating <120°F**  
Residual element content is as follows:  
Both Base metals: %C > 0.18 & %Cu + %Ni < 0.15  
Weld Metal: %Cu + %Ni + %Cr < 0.15

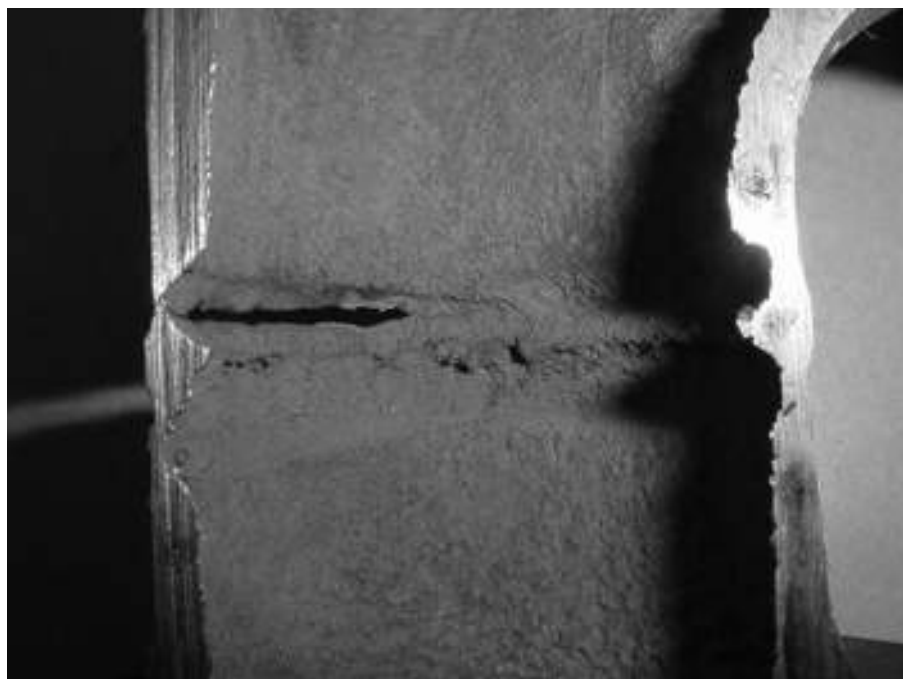
**Figure 5-15 – Accelerated corrosion in the heat affected zone of a carbon steel weldment.  
Residual element content is as follows (Reference 8):  
Both Base metals: %C > 0.18 wt. & %Cu + %Ni < 0.15  
Weld Metal: %Cu + %Ni + %Cr < 0.15**

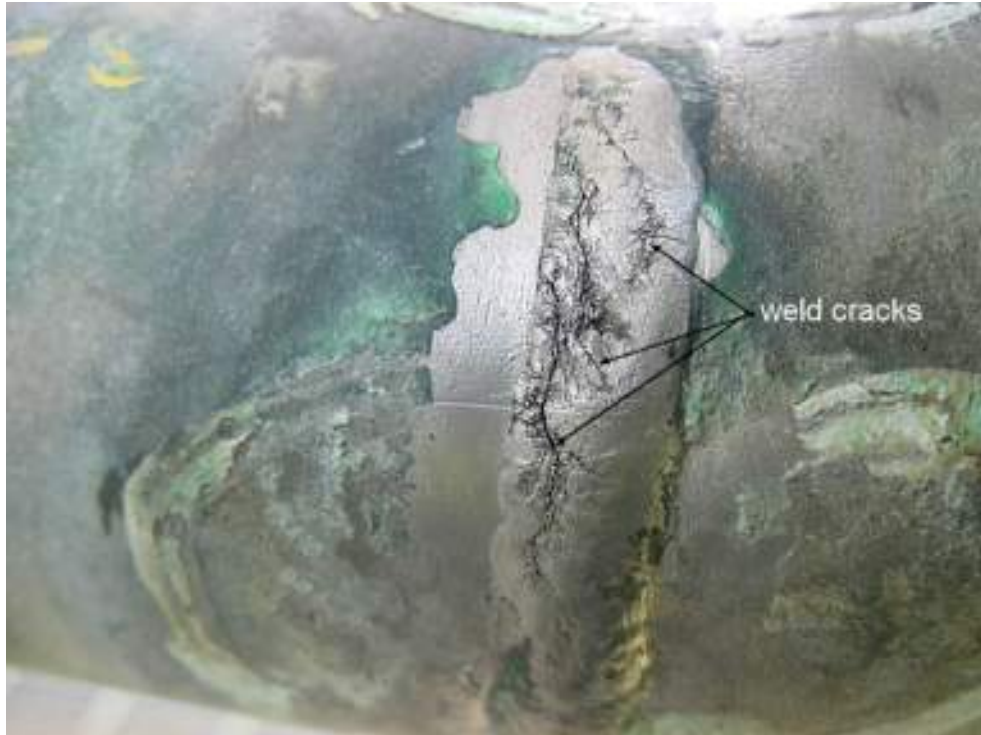
**Figure 5-16 – HF stress corrosion cracking of Alloy 400 vent line in an acid dump system (Reference 8).**

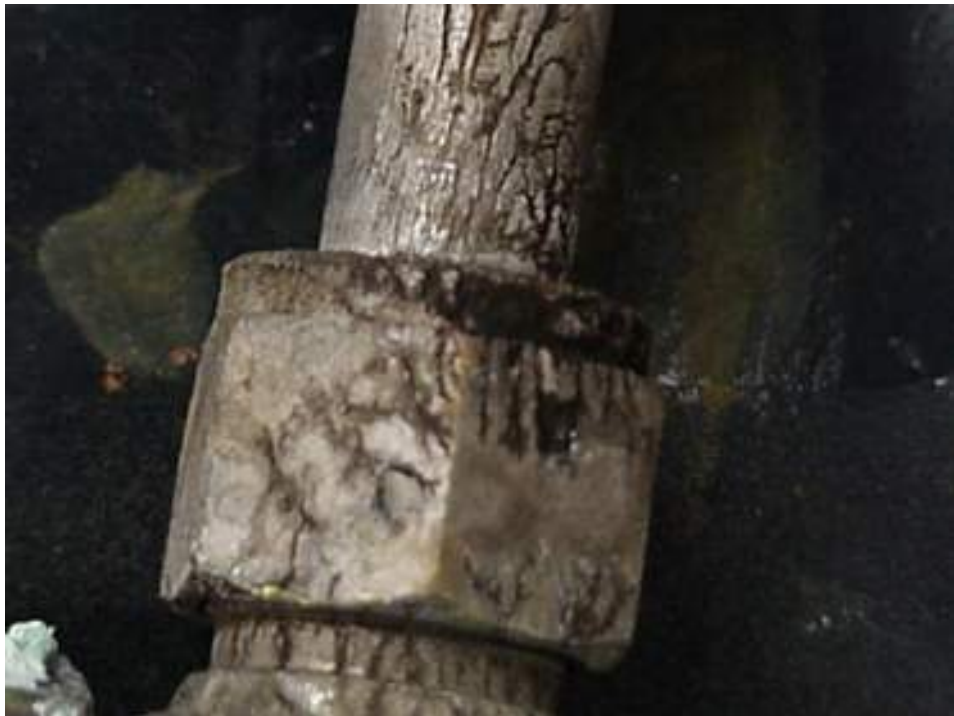
**Figure 5-17 – HF stress corrosion cracking of Alloy 400 instrument tubing (Reference 8).**

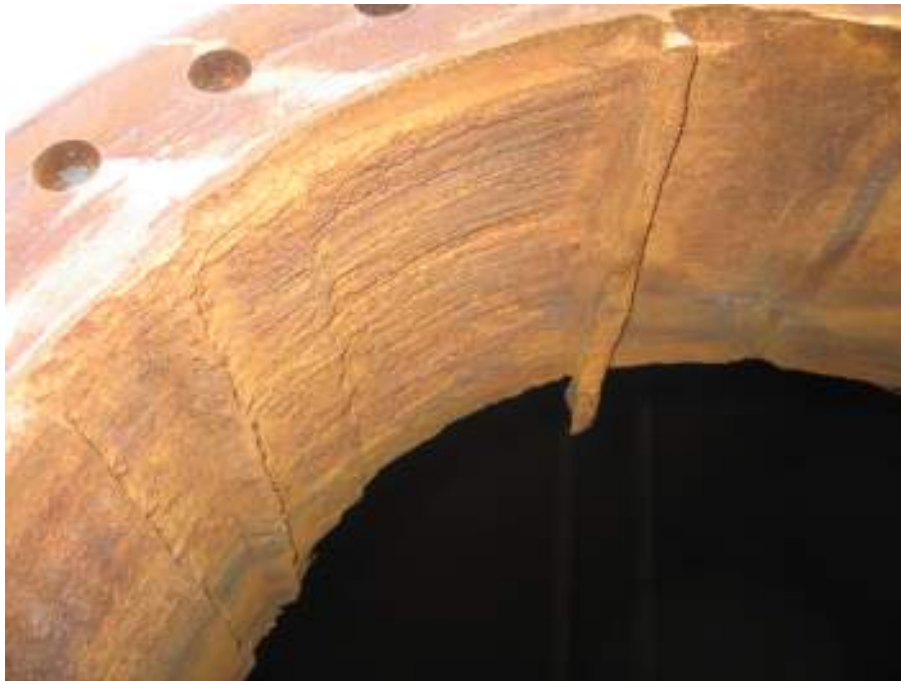
**Figure 5-18 – HF Corrosion at manway in HF acid storage service.**

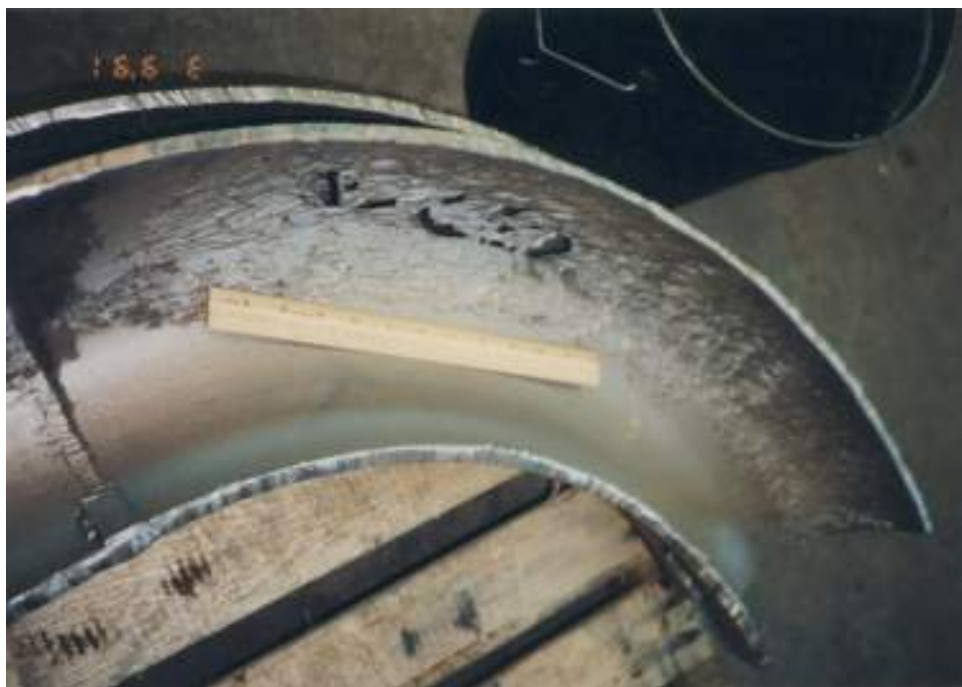
**Figure 5-19 – Erosion-corrosion damage due to NAC in a 10-inch 5Cr elbow in the outlet of a vacuum heater in a VDU.**

- a) NAC is characterized by localized corrosion, pitting corrosion, or flow induced grooving in high velocity areas (Figure 5-19 and Figure 5-20).
- b) In low velocity condensing conditions, many alloys including carbon steel, low alloy steels and 400 Series SS may show uniform loss in thickness and/or pitting.

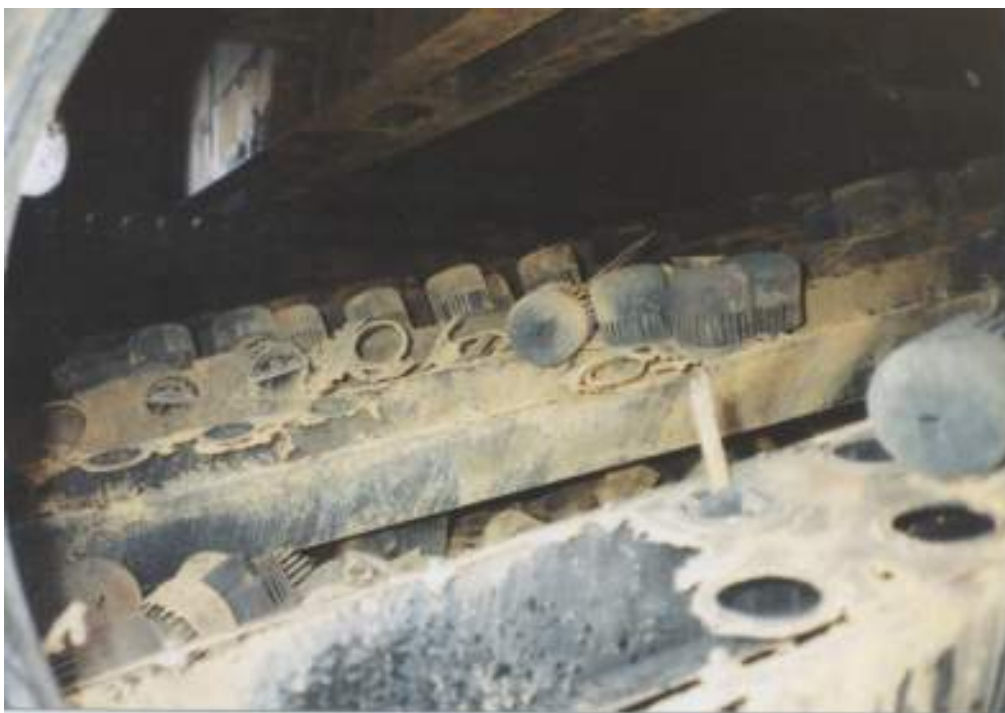
**Figure 5-20 – Severe NAC of 410 SS trays and bubble caps in the HVGO section of the vacuum tower fed by the vacuum heater in Figure 5-19.**

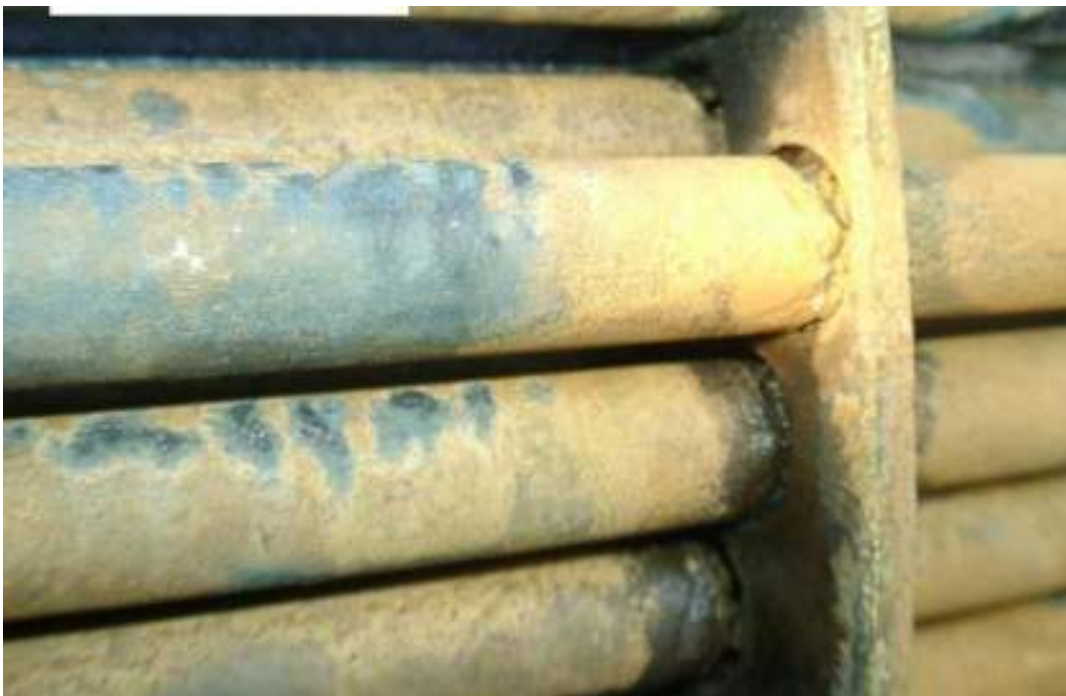
Figure 5-22 – Accelerated corrosion under a baffle.

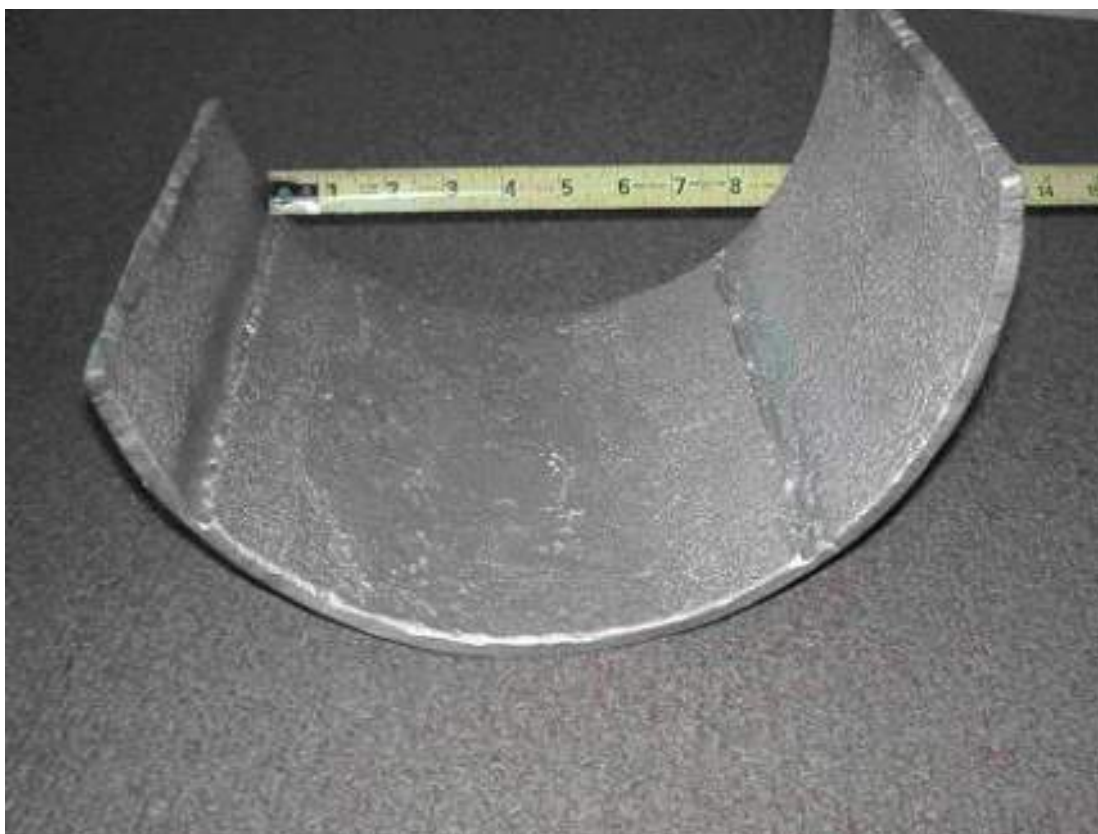
**Figure 5-23 – Grooving corrosion in the carbon steel vapor line from an alkaline water wash drum in a sulfuric acid alkylation unit.**

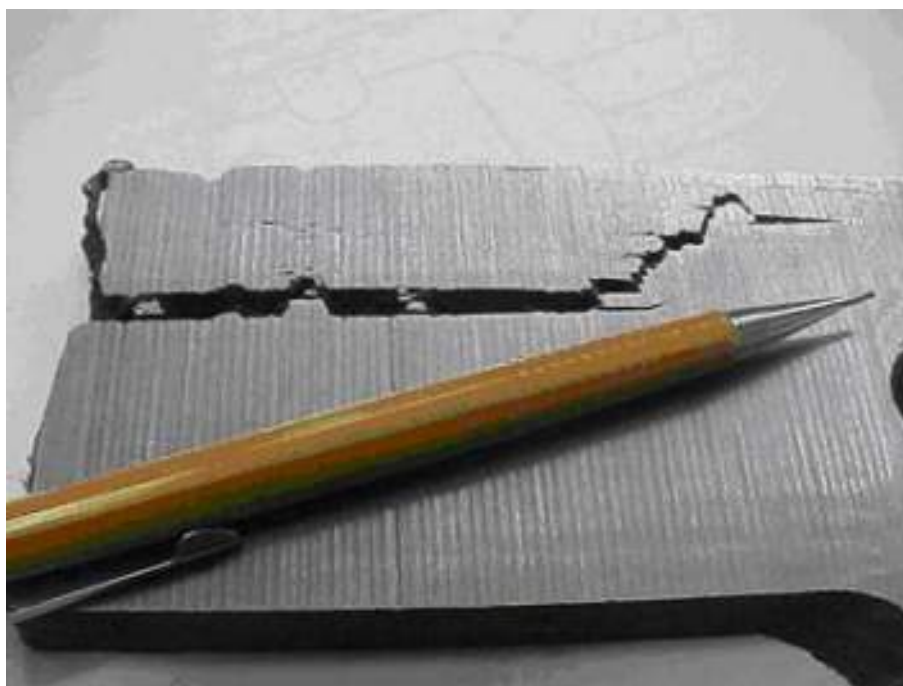
**Figure 5-36 – Cross-section of plate showing HIC damage in the shell of a trim cooler which had been cooling vapors off a HHPS vessel in a hydroprocessing unit.**

Hydrogen blisters can form at many different depths from the surface of the steel, in the middle of the plate or near a weld. In some cases, neighboring or adjacent blisters that are at slightly different depths (planes) may develop cracks that link them together. Interconnecting cracks between the blisters often have a stair step appearance, and so HIC is sometimes referred to as "stepwise cracking" (Figure 5-36, Figure 5-37 and Figure 5-38).

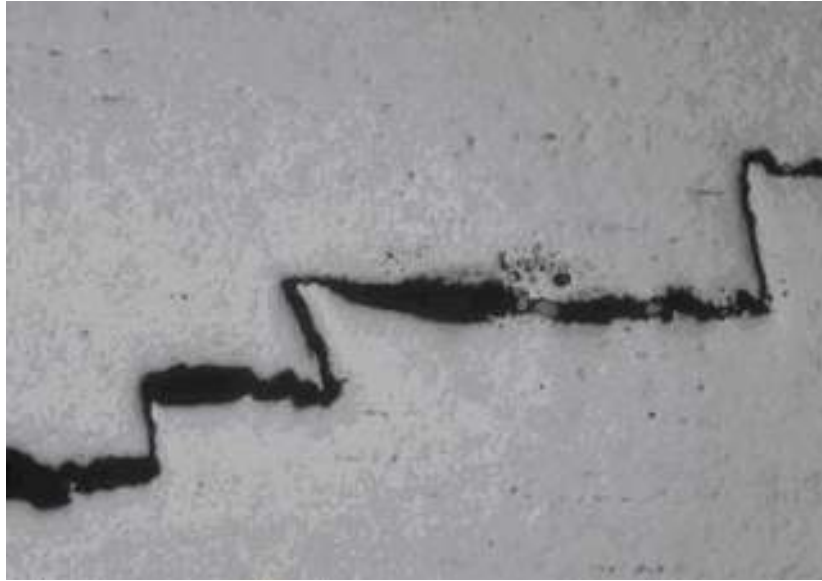
**Figure 5-38 – High magnification photomicrograph showing stepwise cracking nature of HIC damage.**

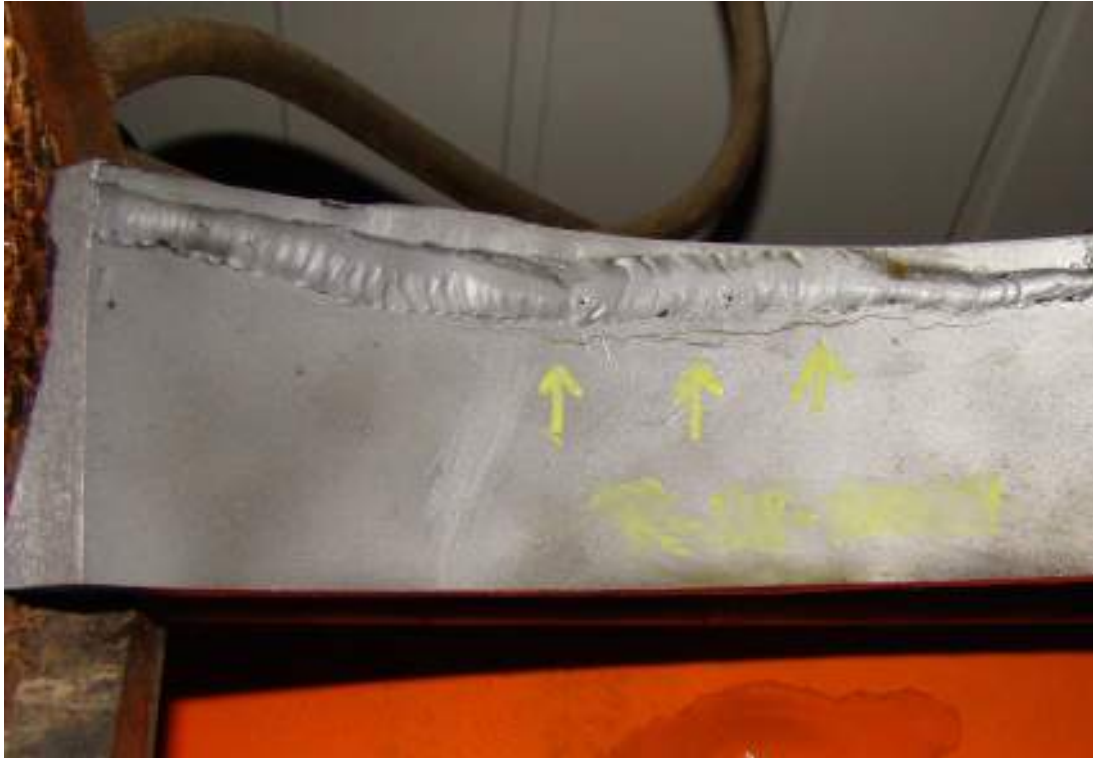
**Figure 5-46 – Overhead interstage knockout drum vapor outlet nozzle.**

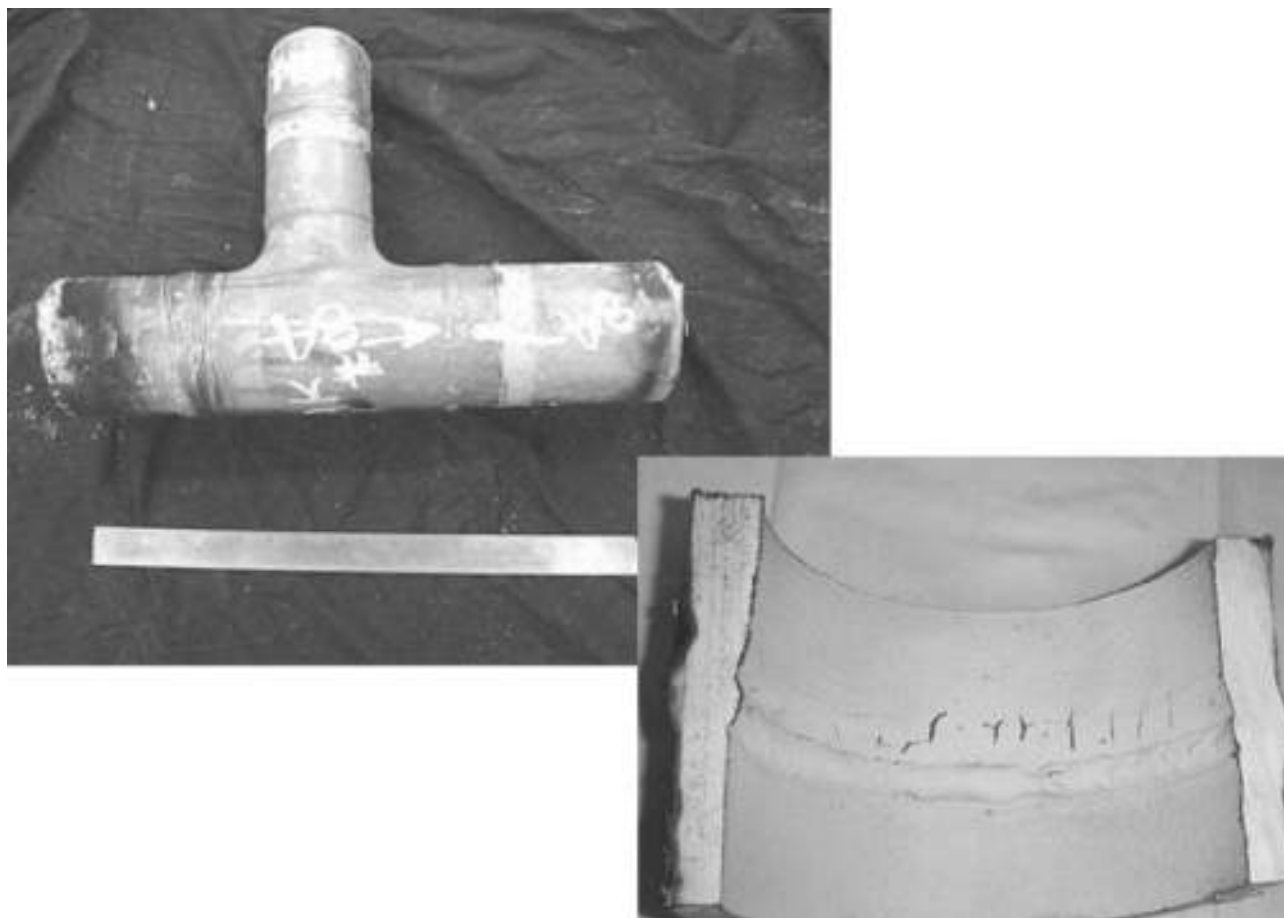
**Figure 5-55 – A 3 in x 4 in (76 mm x 100 mm) diameter tee in a hydrocarbon line off a water knockout pot in the FCC light ends recovery section. Cracking developed after 6 months service.**

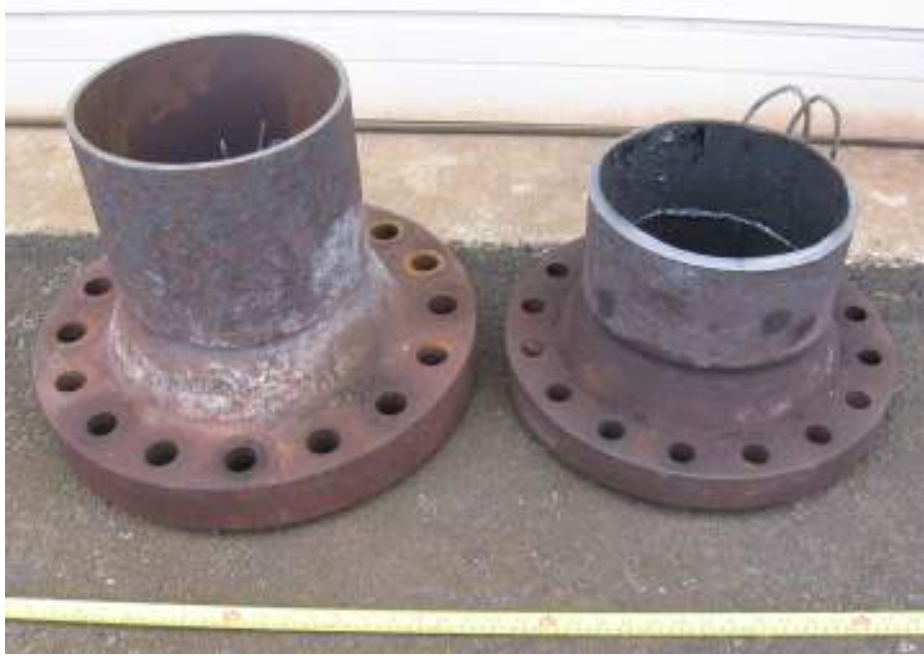
**Figure 5-57 – A pair of 10 inch Carbon-0.5Mo flanged pipe sections (SA335-P1 & SA234-WP1) from a hot bypass line in a catalytic reformer that was designed to remain closed but operated partially or fully open for unknown lengths of time. They were in service for ~34 years at temperatures up to 960°F (516°C) and a hydrogen partial pressure of 198 psig (1.37 MPa).**

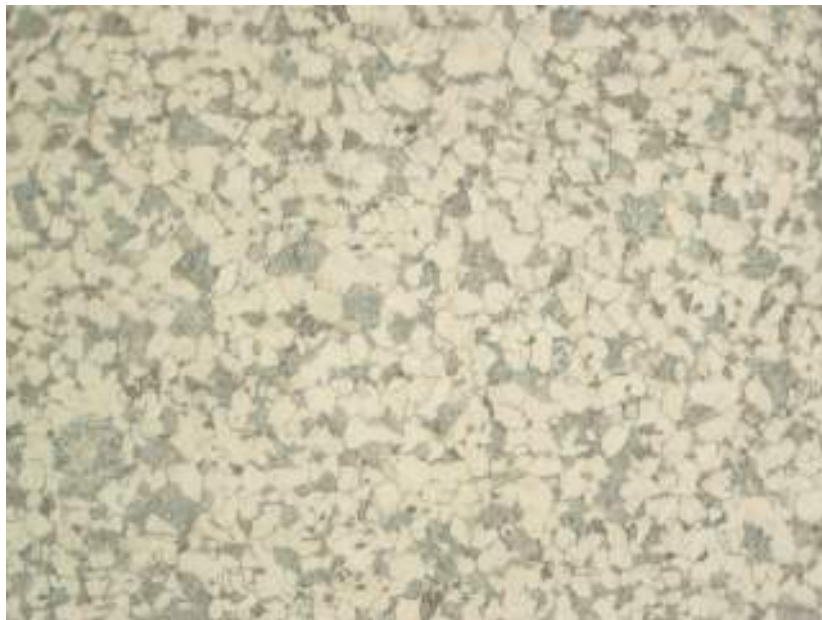
**Figure 5-58 – A photomicrograph of the outside surface of a pipe section, shown in the previous figure, exhibits a normal ferritic-pearlitic structure. Mag. 200X**

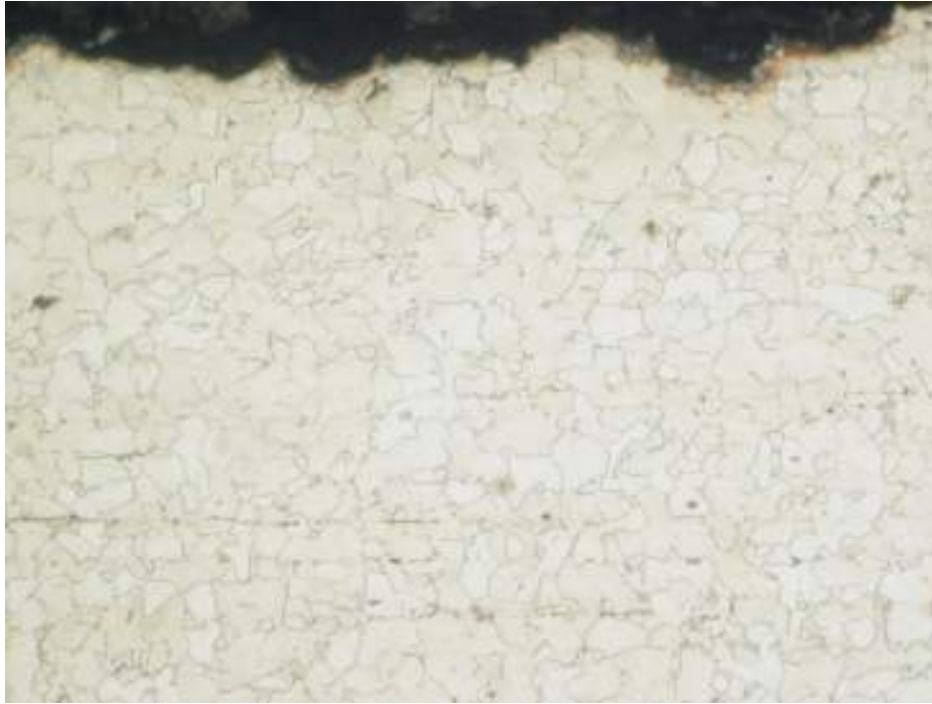
**Figure 5-59 – A photomicrograph at the pipe ID surface exhibiting of the pipe shown in the previous pictures, exhibiting complete decarburization of the original structure. Mag. 200X**

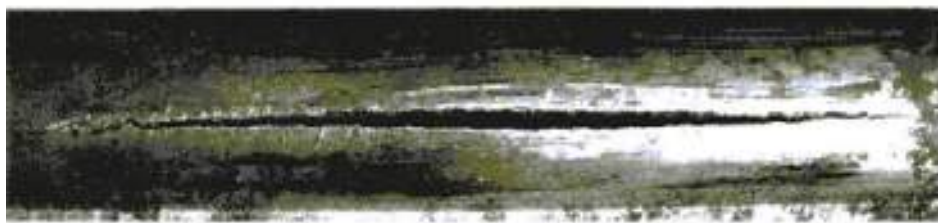
**Figure 5-62 – Titanium heat exchanger tube that failed from hydriding in a sour water cooler. The cooling medium is sea water.**

- a) Titanium hydriding is a metallurgical change that is not readily apparent, and can only be confirmed through metallurgical techniques (Figure 5-62, Figure 5-63 and Figure 5-64) or mechanical testing.
